# DURABILITY OF INCRALAC, EXAMINATION OF A TEN YEAR OLD TREATMENT

David Erhardt, Walter Hopwood, Tim Padfield and Nicholas Veloz

THE DURABILITY OF INCRALAC: EXAMINATION OF A  
TEN YEAR OLD TREATMENT

Conservation Analytical Laboratory  
Smithsonian Institution  
Washington, D.C. 20560 USA

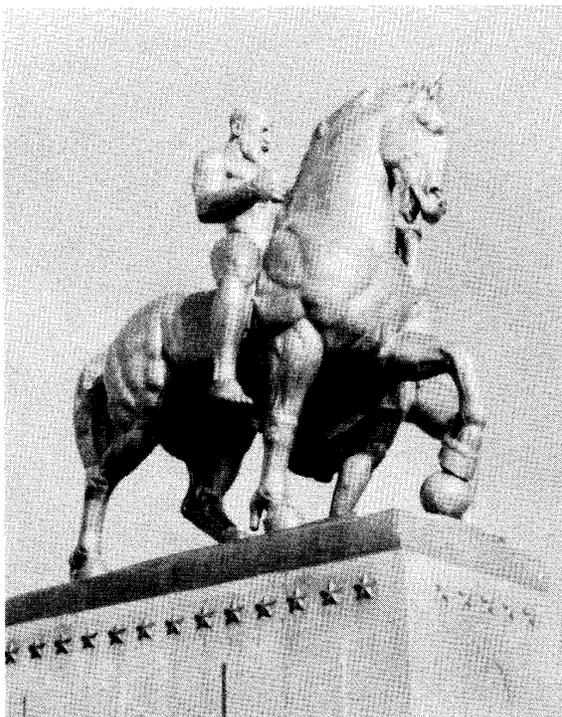
Figure 1 The gilded bronze 'Valor' on the southeast corner of the Arlington Memorial Bridge.

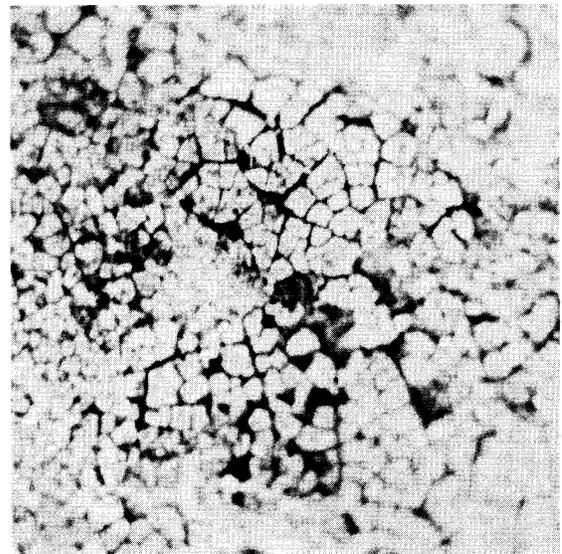
Figure 2 Fragmentary remnants of Inctalac on the base of 'Valor'. This area is 12 mm across.

The Inctalac coating on these statues has failed as a coherent protective layer, and it has failed to remain soluble. The failure has not resulted in any major damage to the statues. Corrosion was not evident except at points such as soldered seams or casting pits where the nickel and gold plating was imperfect or at weep holes where corrosion products were washed out of the unplated interior. The plating withstood the harsh measures required to remove the insoluble Inctalac.

The mechanical failure of the film may be due to thermal stress. The B-44 used to formulate Inralac is one of the harder acrylics, with a glass transition temperature of 60°C.<sup>3</sup> Below this temperature, B-44 becomes brittle and resistant to flow. Acrylics have a coefficient of thermal expansion about five times that of copper alloys.<sup>9</sup> Changes in temperature will cause differential contraction or expansion of Inralac and metal, and set up stresses within the Inralac. Crosslinking of the Inralac will make it even more brittle, and reduce its ability to relieve stress. Thermal extremes combined with crosslinking of the Inralac may eventually result in the mechanical failure observed.

The Inctalac coating proved resistant to solvents and paint strippers which readily dissolve fresh Inctalac. These did not dissolve or emulsify the Inctalac, but they did soften it enough to allow mechanical removal. The method found to be most effective was repeated applications of methylene chloride based paint stripper followed by cold water spray at a line pressure of 6 Meganewtons per square metre. The gold layer was adherent enough to withstand the water spray. Loss of gold was insignificant. The statues were then washed with nonionic detergent solution (Igepal CO 630), coated with an aqueous solution of benzotriazole (BTA) and finally covered with paste wax containing BTA.<sup>2</sup>

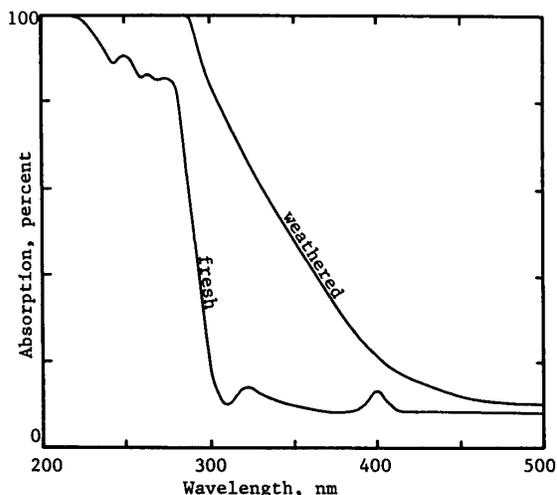
Infrared spectra of this aged and fresh Inctalac<sup>5</sup> are essentially the same. Their UV spectra, however, are quite different (Figure 3). The increased absorption of aged Inctalac could be due either to the

reaction products of degradation, or to absorption of UV absorbing pollutants from jet fuel or car exhausts, for example.

Figure 3 Ultraviolet spectra of fresh and of weathered Inctalac.
