Museum environmental standards

in an age of
Energy Anxiety

Tim Padfield

May 2014

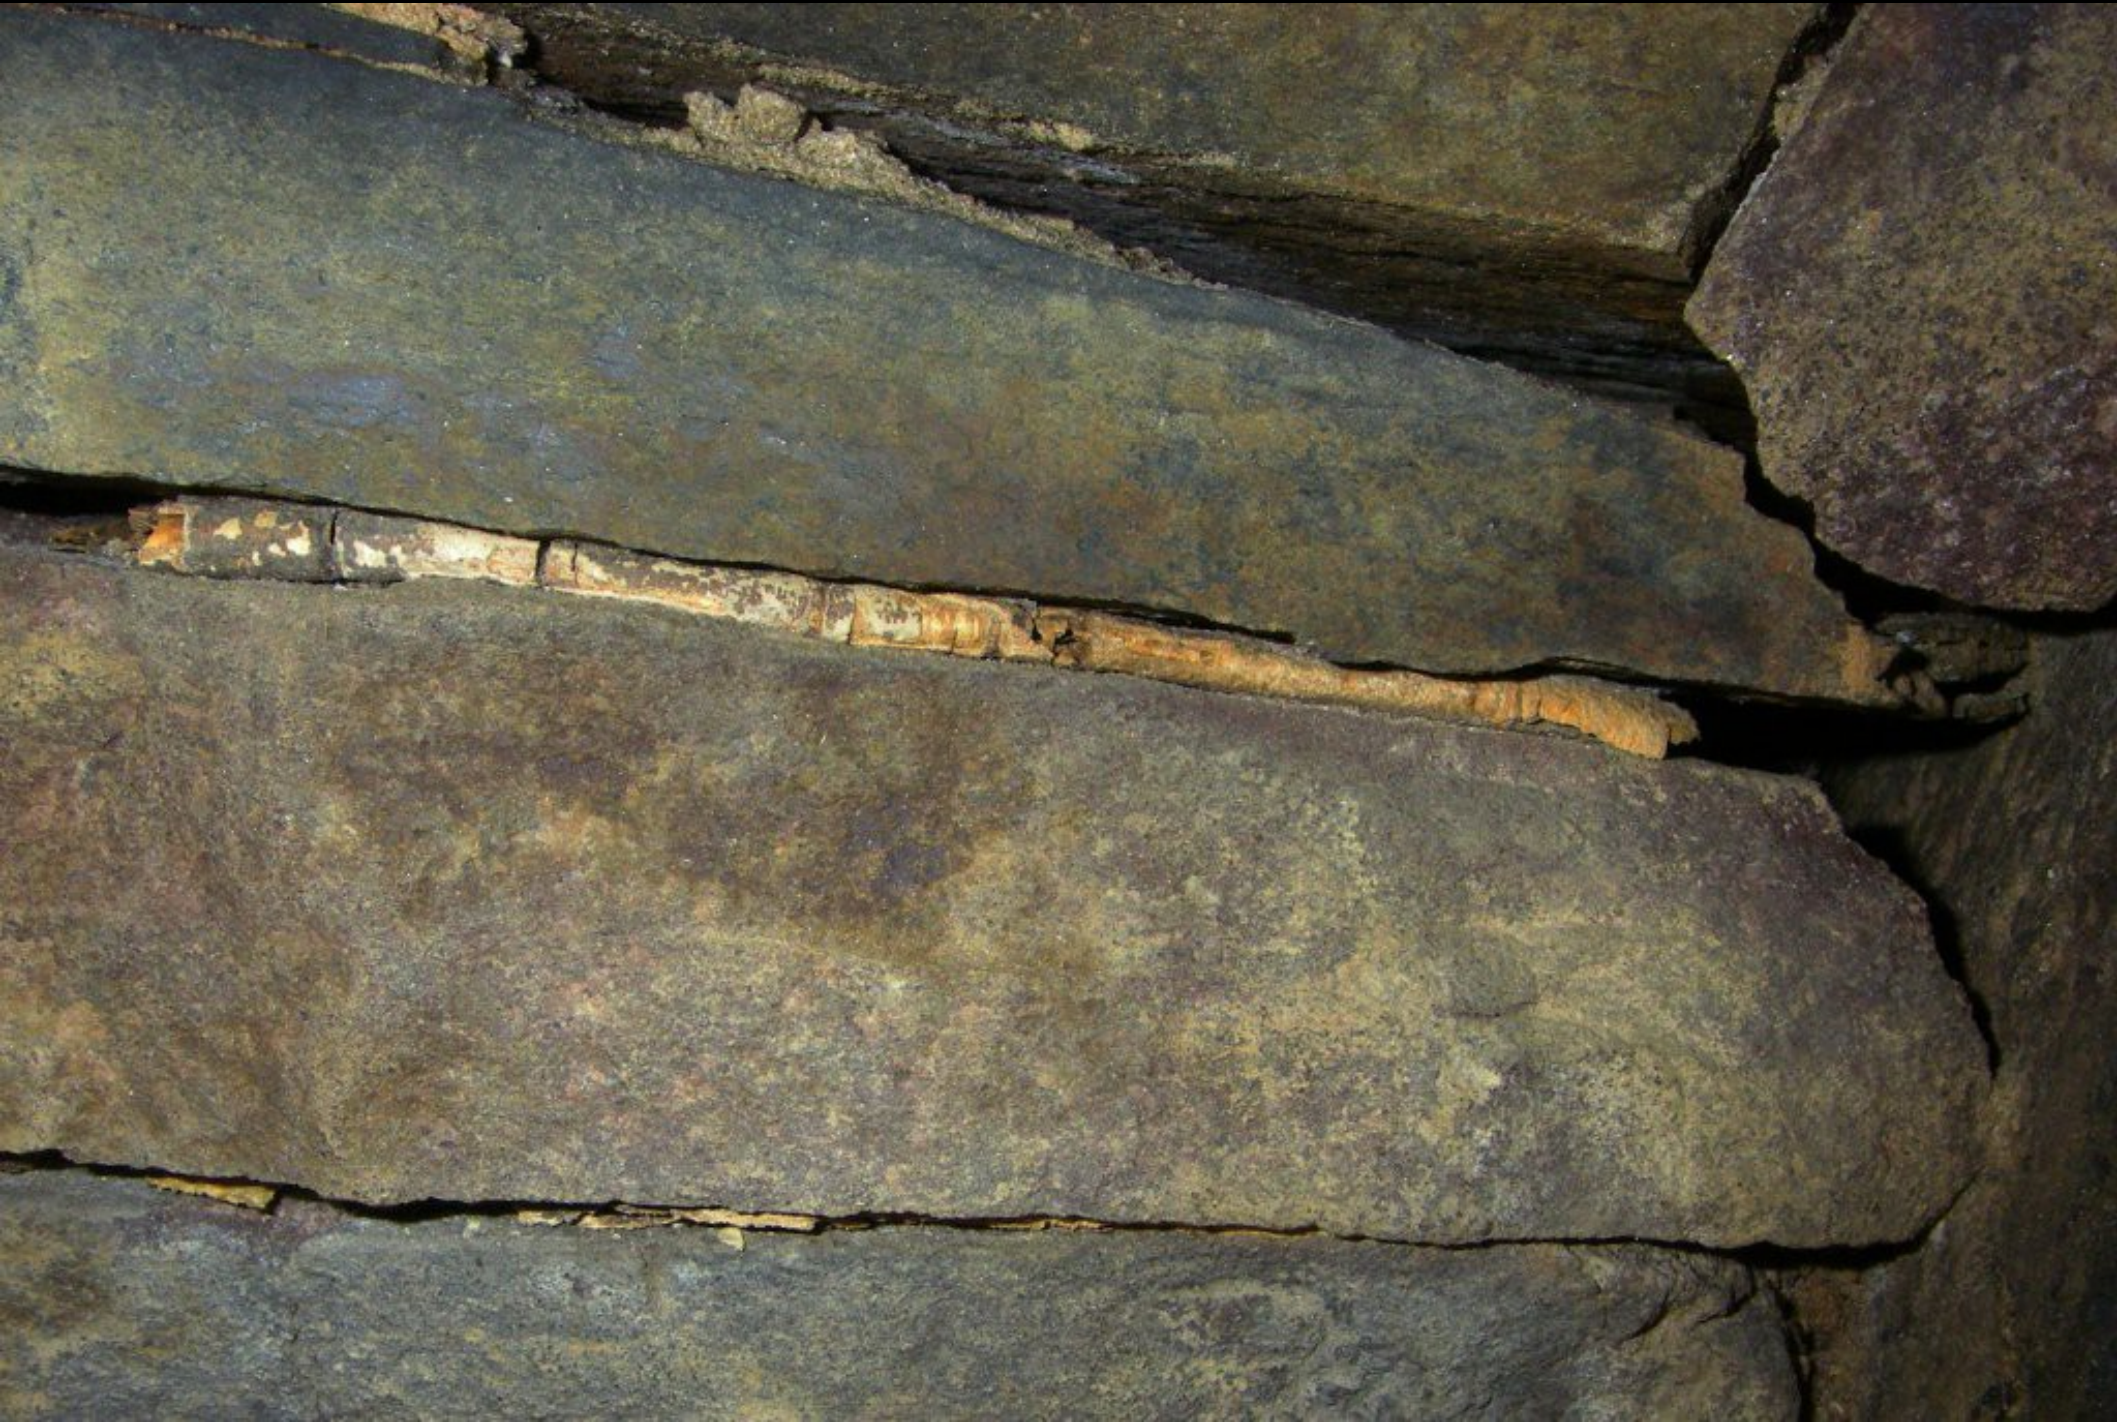
Maglehøj, Denmark. 5000 year old birch bark

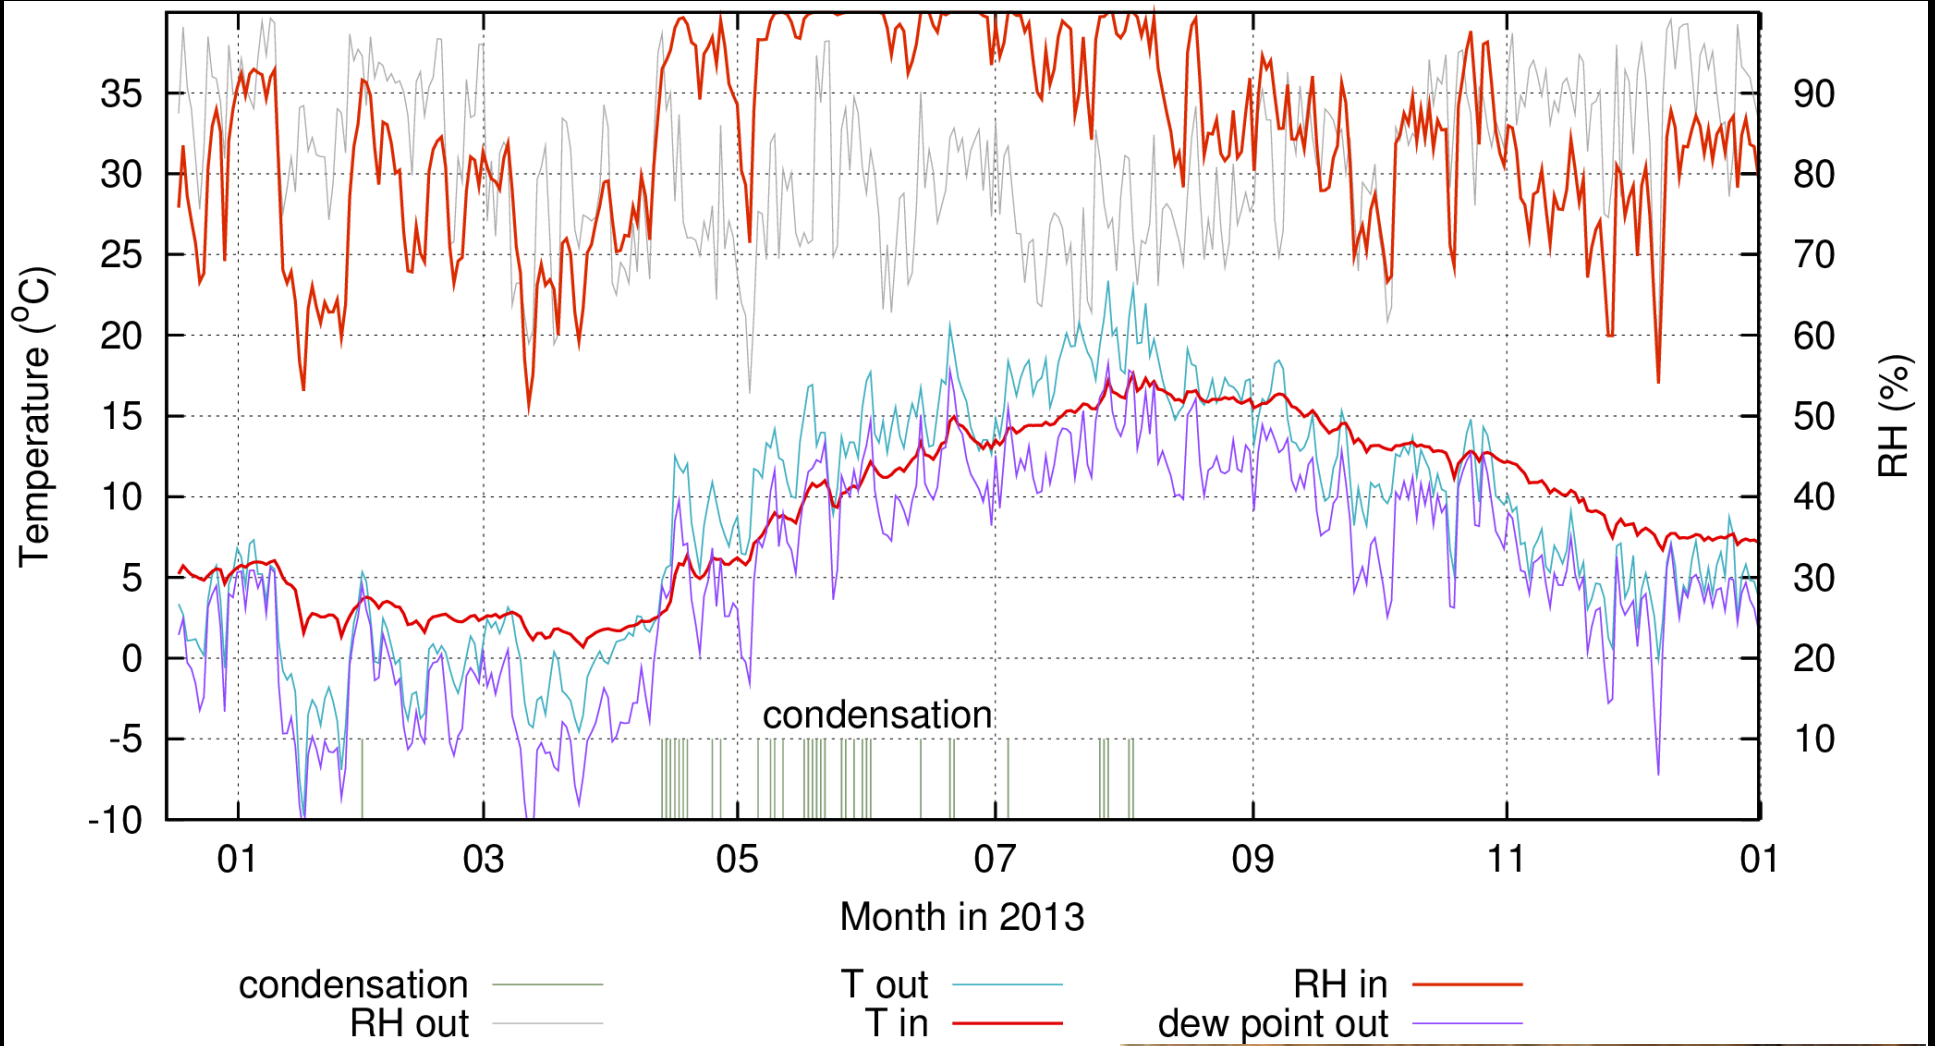
Maglehøj: condensation within the ventilated chamber, in graphic and photographic images.

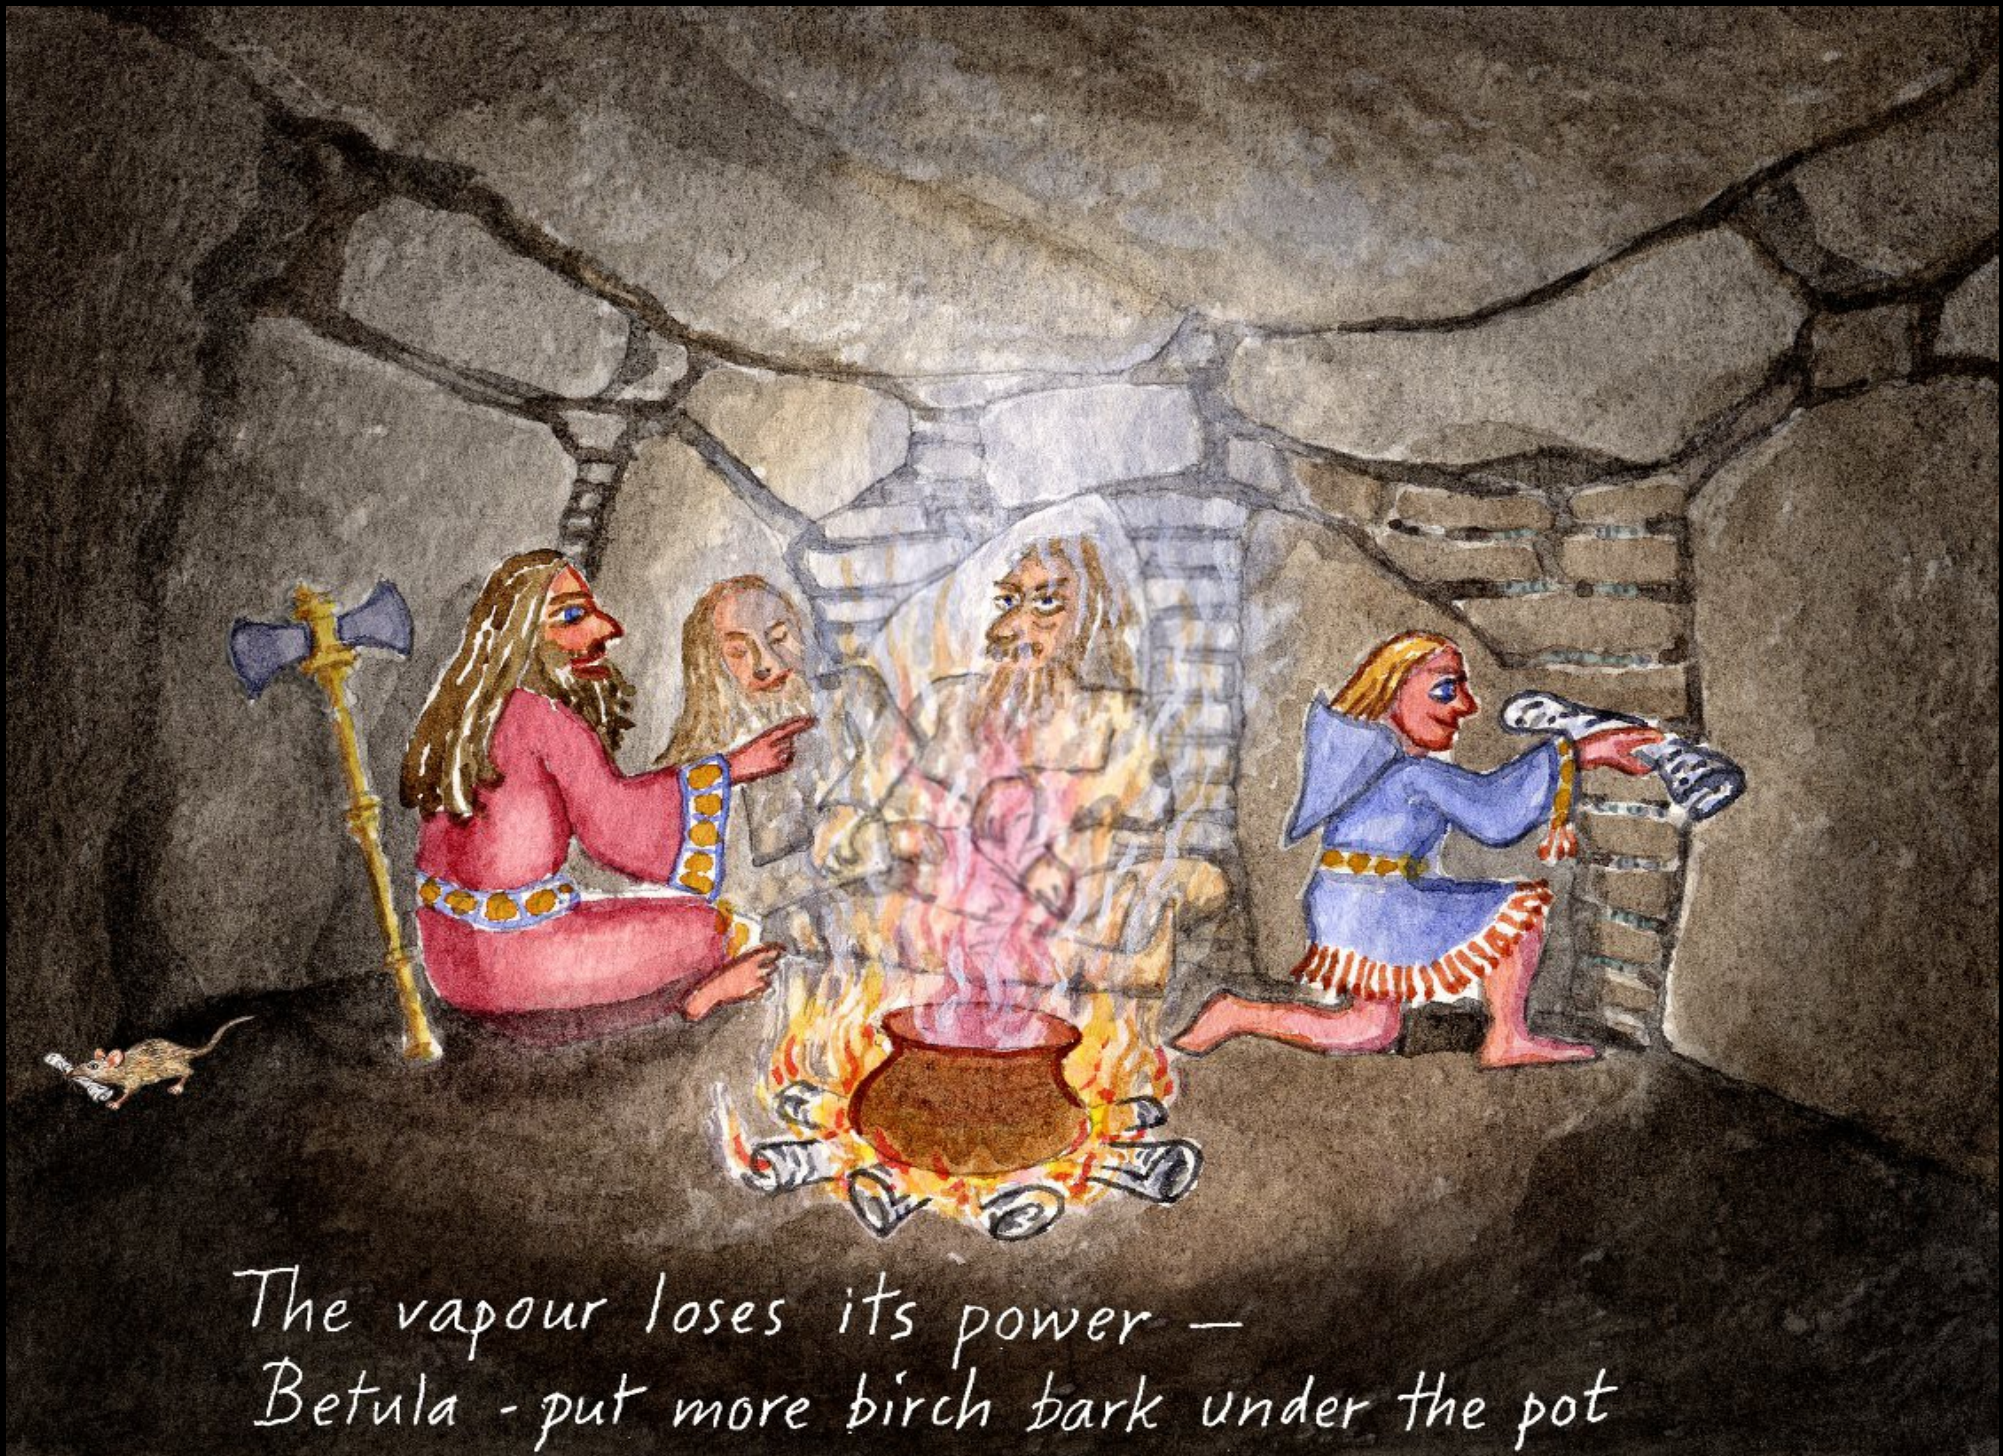
The vapour loses its power —
Betula - put more birch bark under the pot

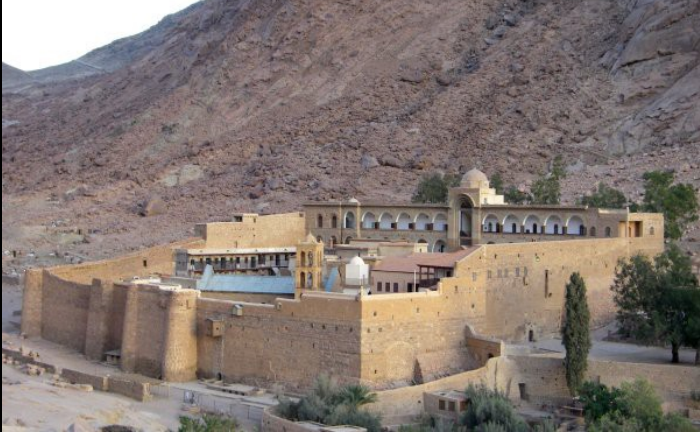
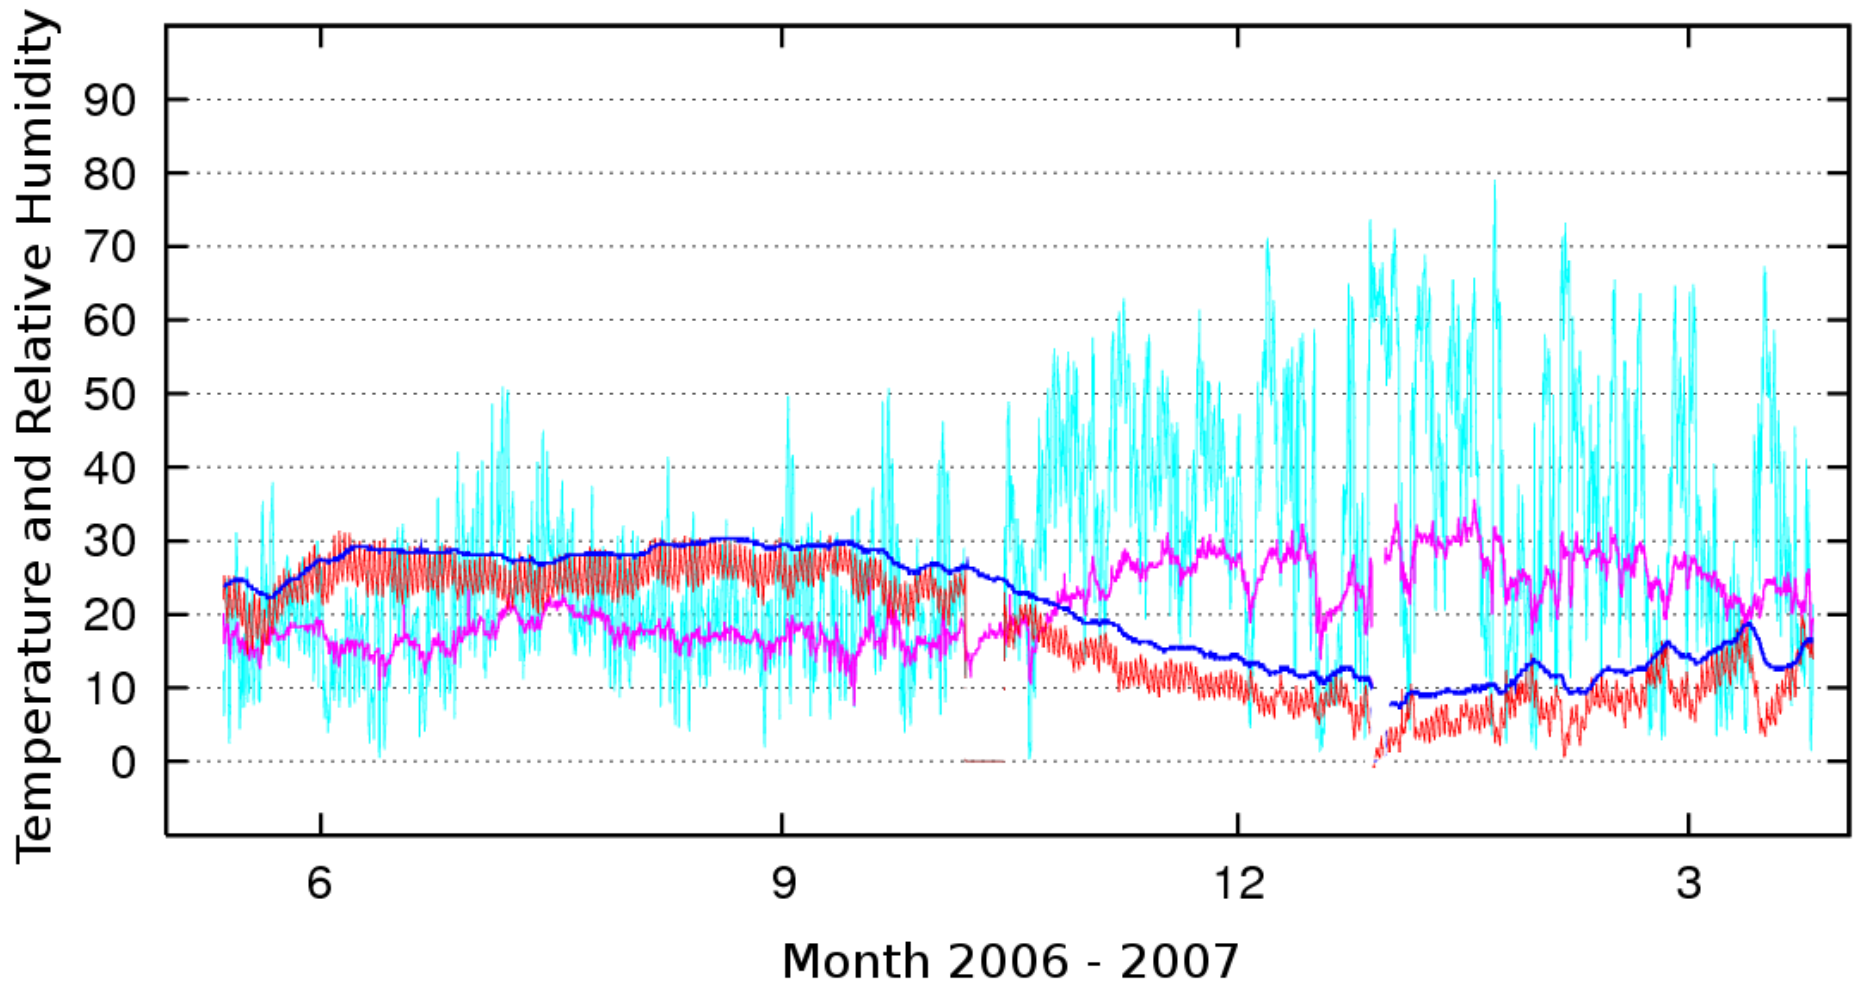
St Catherines Monastery, Sinai, Egypt

RH outside —
RH library —

Temperature outside —
Temperature library —

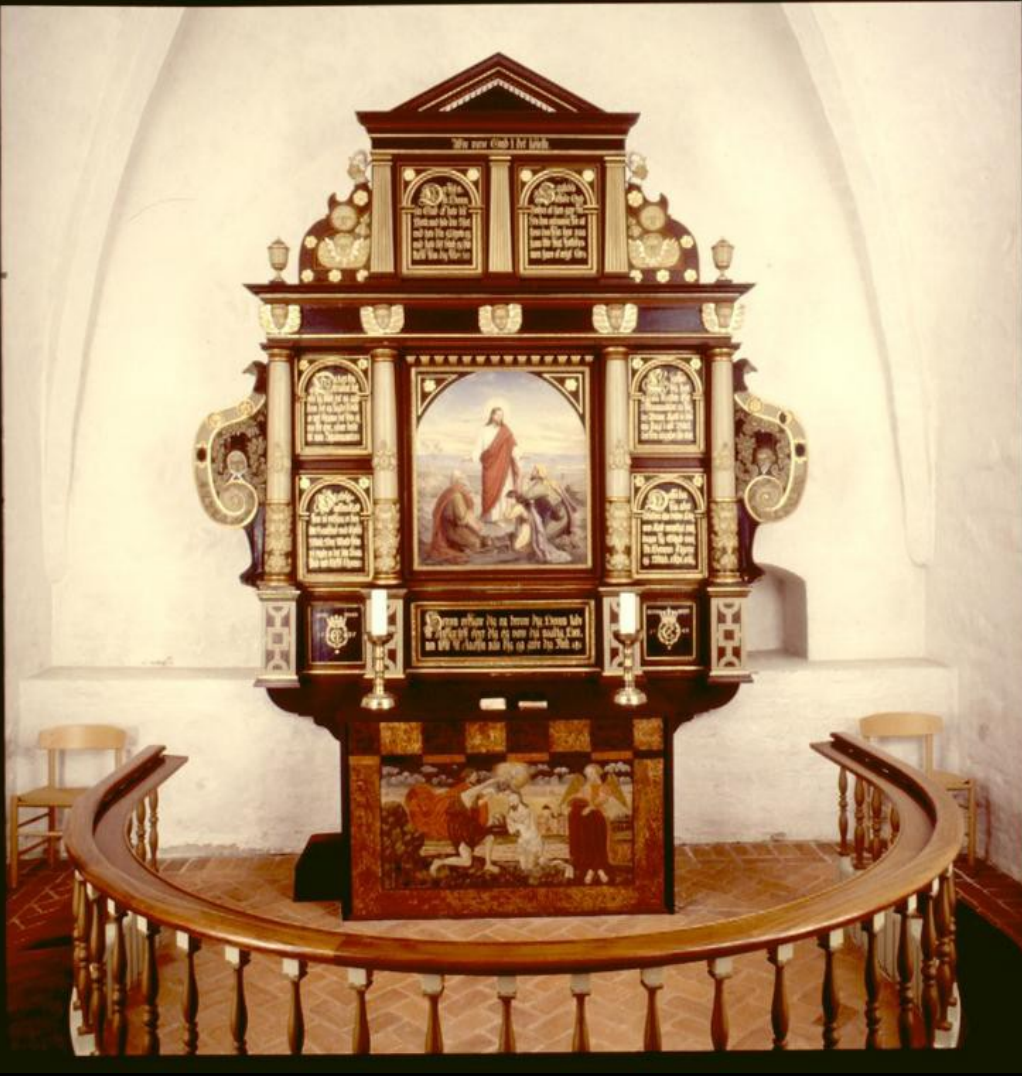
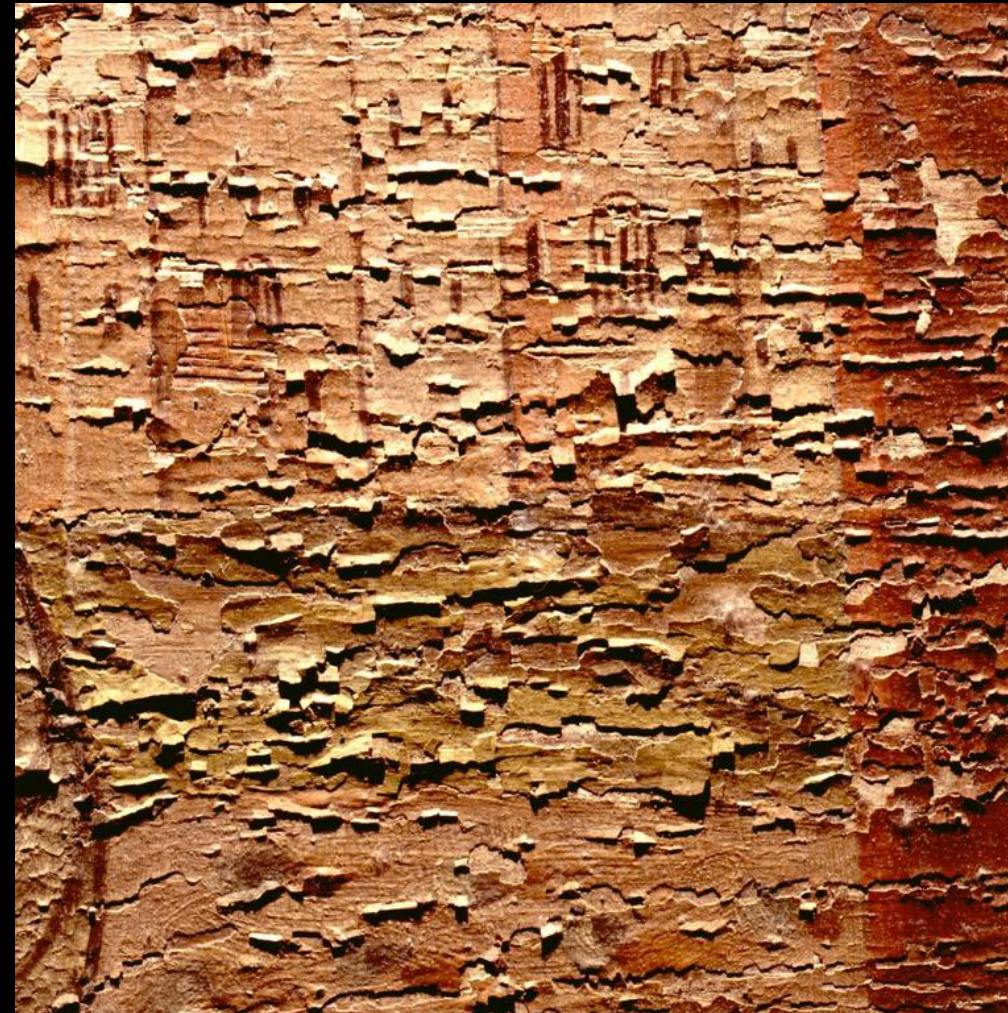
A painting which
hardened at very high RH
cannot endure the
standard museum climate

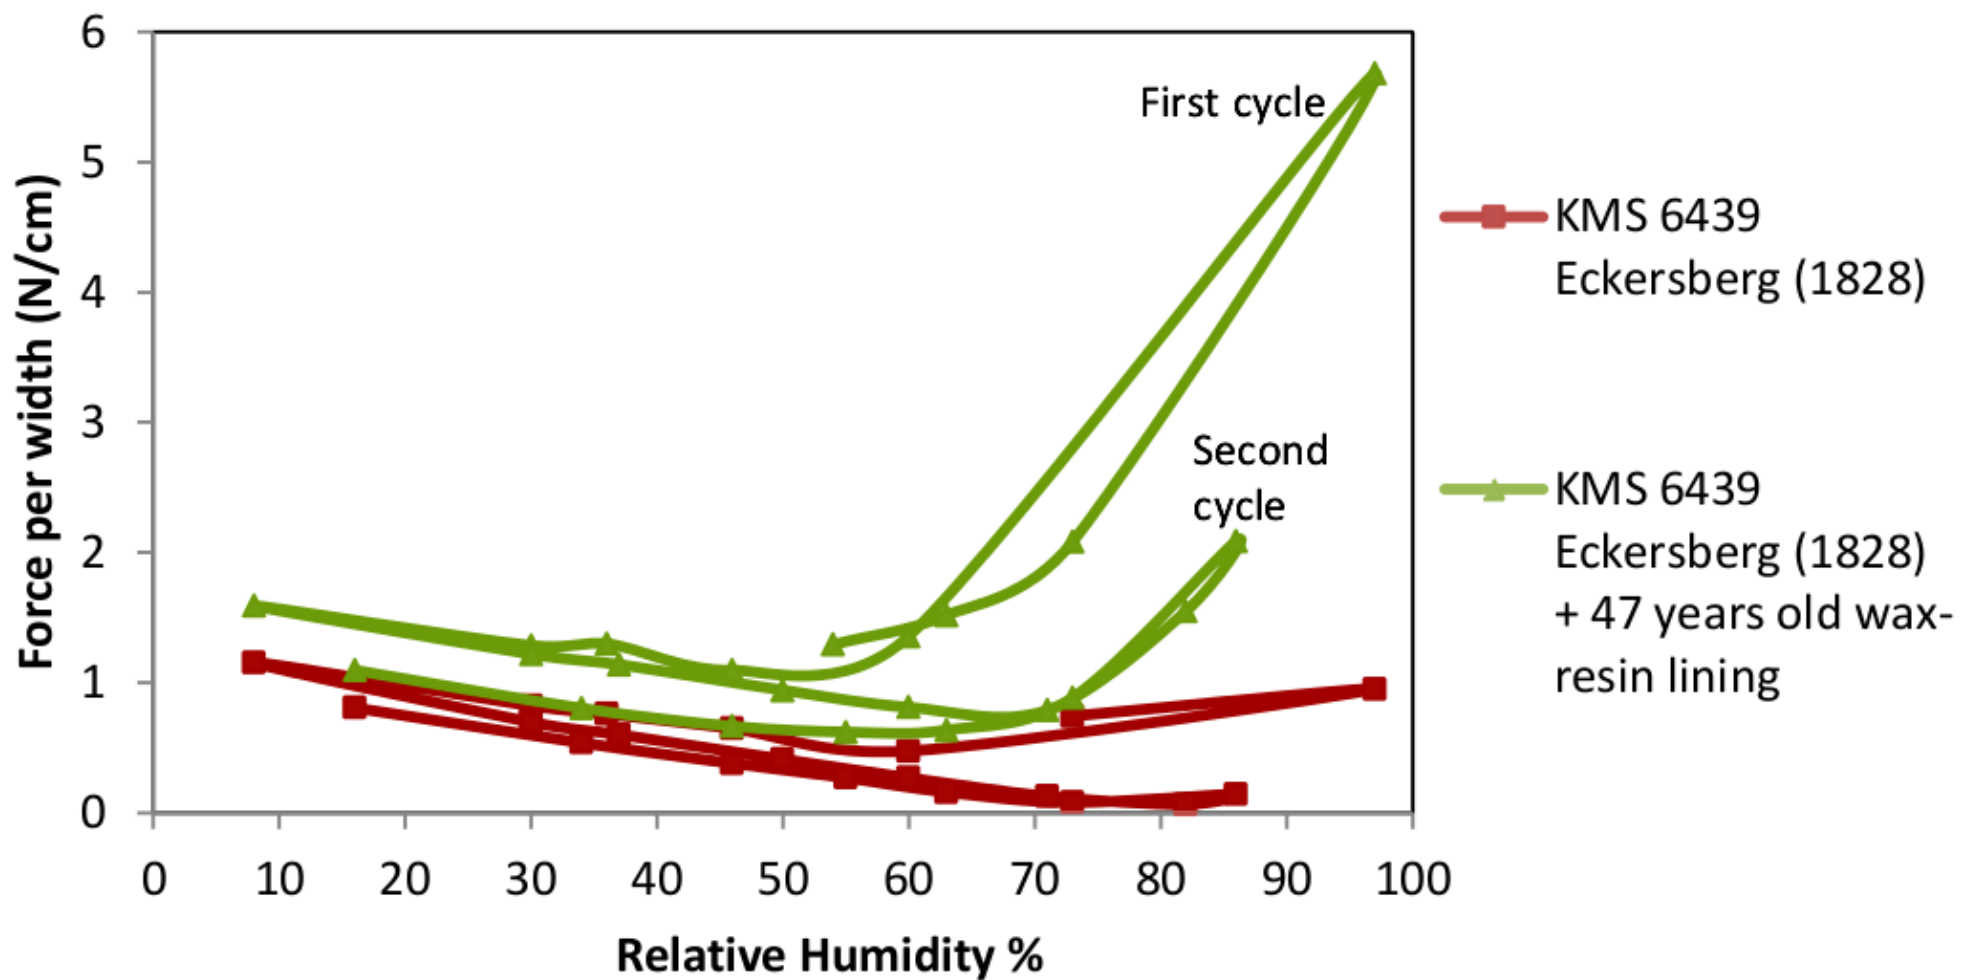
Figure 58. Restrained tests of Eckersberg sample (SMK6439) before and after lining. The lining has a wax-resin lining from 1965. The painting had not been lined prior to the wax-resin lining. The wax-resin lining causes a marked contraction of the lined sample in high RH. In the second cycle the response is lower and the sample has lost some tension.

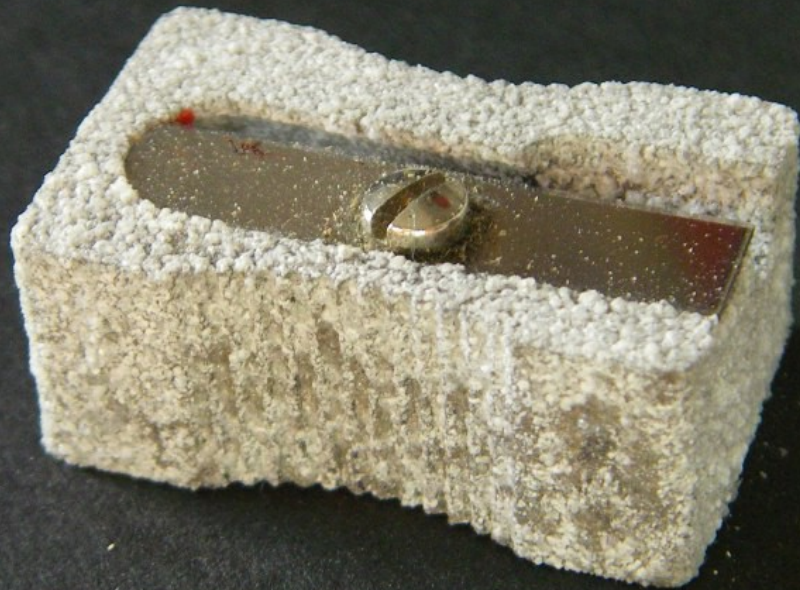
Some objects have "Inherent Vice" and cannot be preserved in air. This is a zinc die casting alloy, only used for a short time until its instability became known.

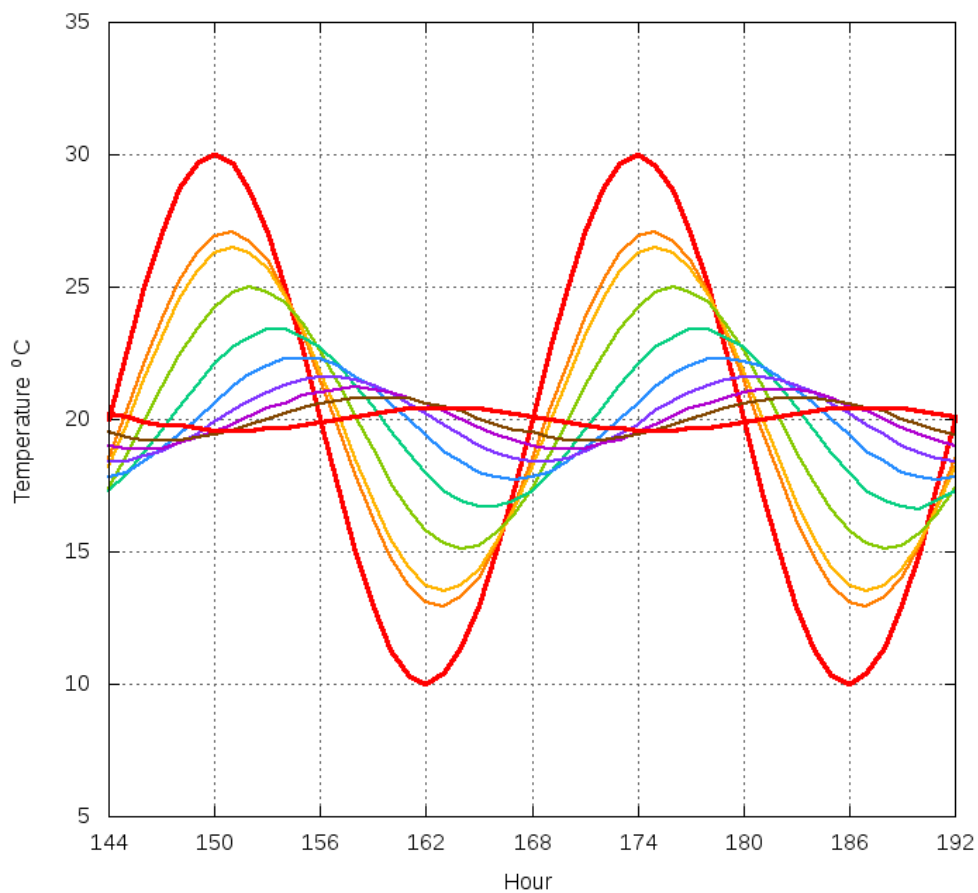
Brick wall
240 mm

Outside	—	layer 2	—	layer 5	—	Heatsink	—
Surface	—	layer 3	—	layer 6	—		
layer 1	—	layer 4	—	layer 7	—

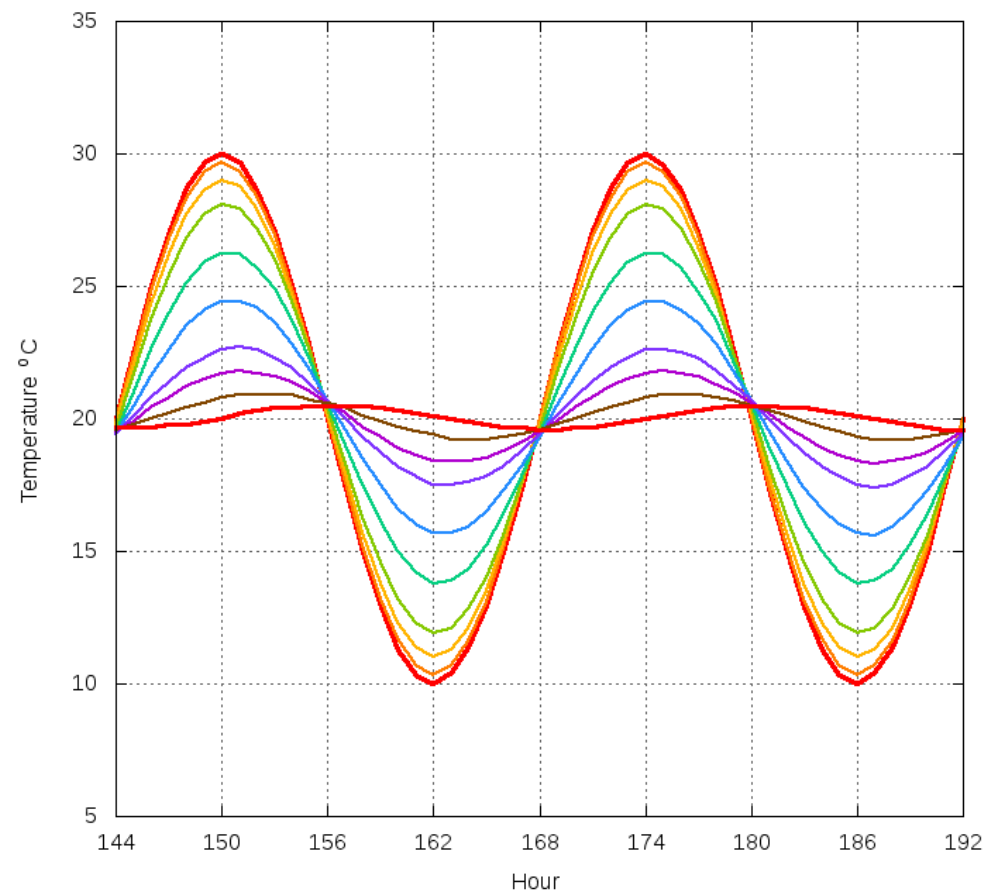
Foam wall
100 mm

Outside	—	layer 2	—	layer 5	—	Heatsink	—
Surface	—	layer 3	—	layer 6	—		
layer 1	—	layer 4	—	layer 7	—

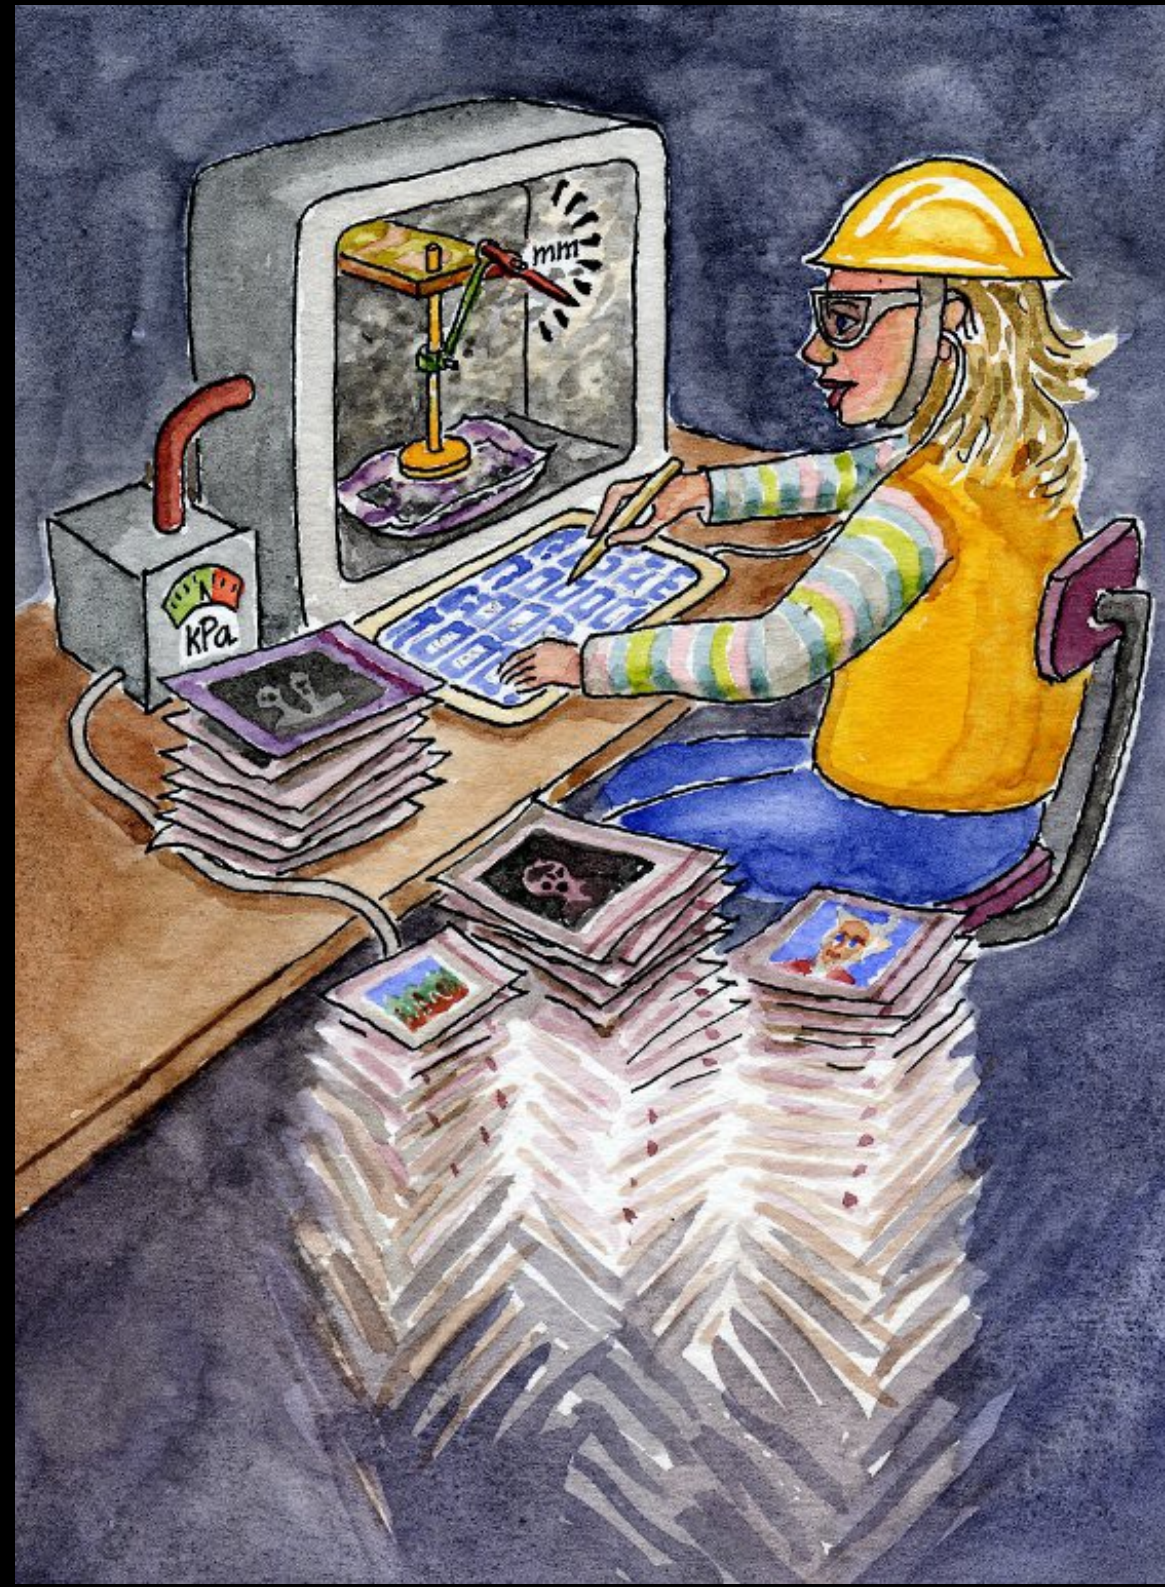
PD5454

4.3.3 Cold Storage

[There is no RH specified because:] All materials ...should be ... packaged [in] sealable and airtight bags or boxes. Humidity indicators should be incorporated

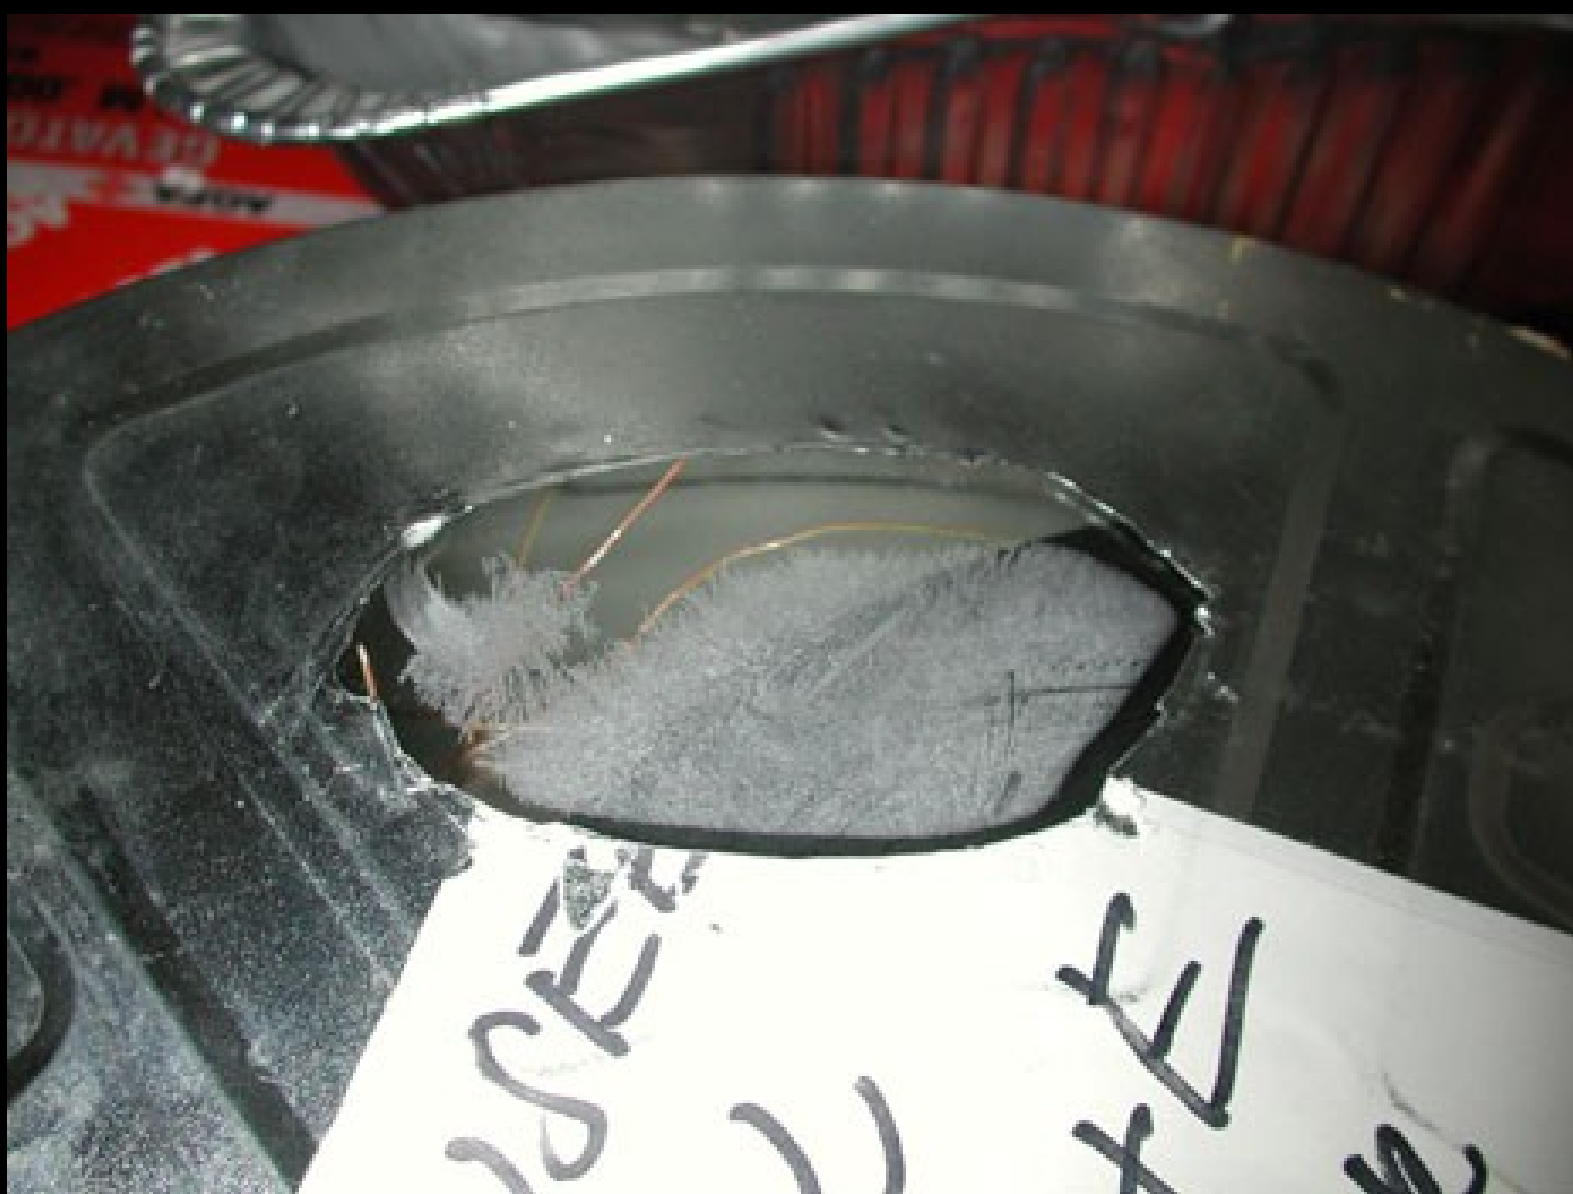
Frost forming inside a film can after insertion in a cold store. Moisture from the still-warm gelatin film is the source of the condensation

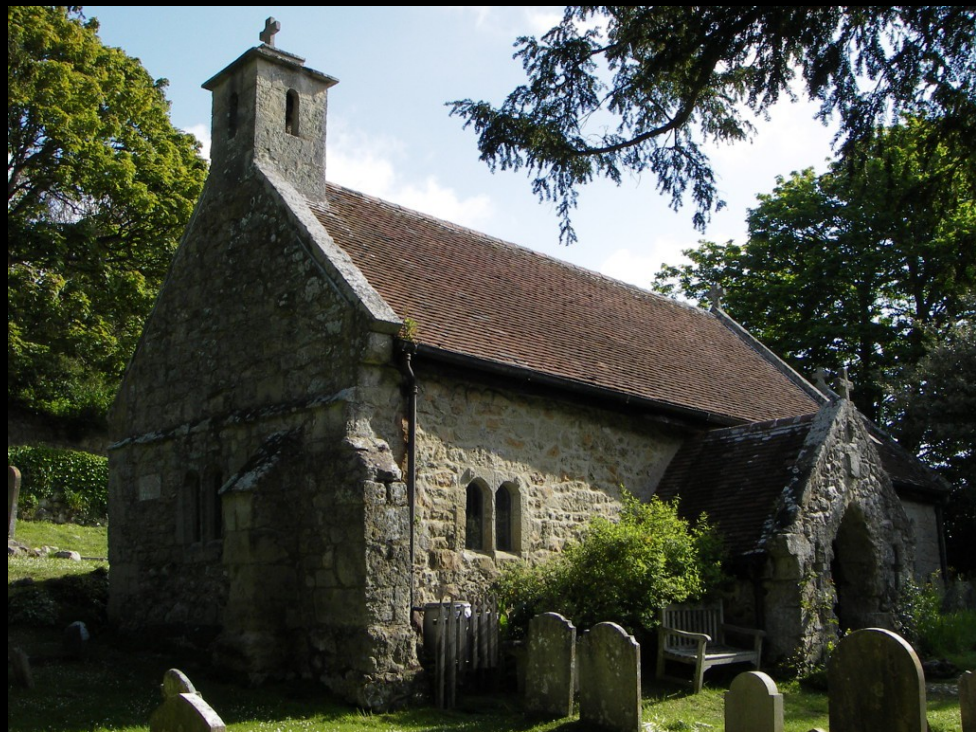
EN 15757:2010

T & RH to limit mechanical damage to organic hygroscopic materials in historic structures without air conditioning

A complicated manipulation of measured data results in a permitted variation less than the normal variation but greater than that provided by air conditioning – but it requires some form of air conditioning.
