Building to the new relaxed climate standards

Tim Padfield

Will PD5454 set us free to design low-energy museum buildings - or is it a disastrous concession to the energy pessimists, or is it not quite as generous as it seems?

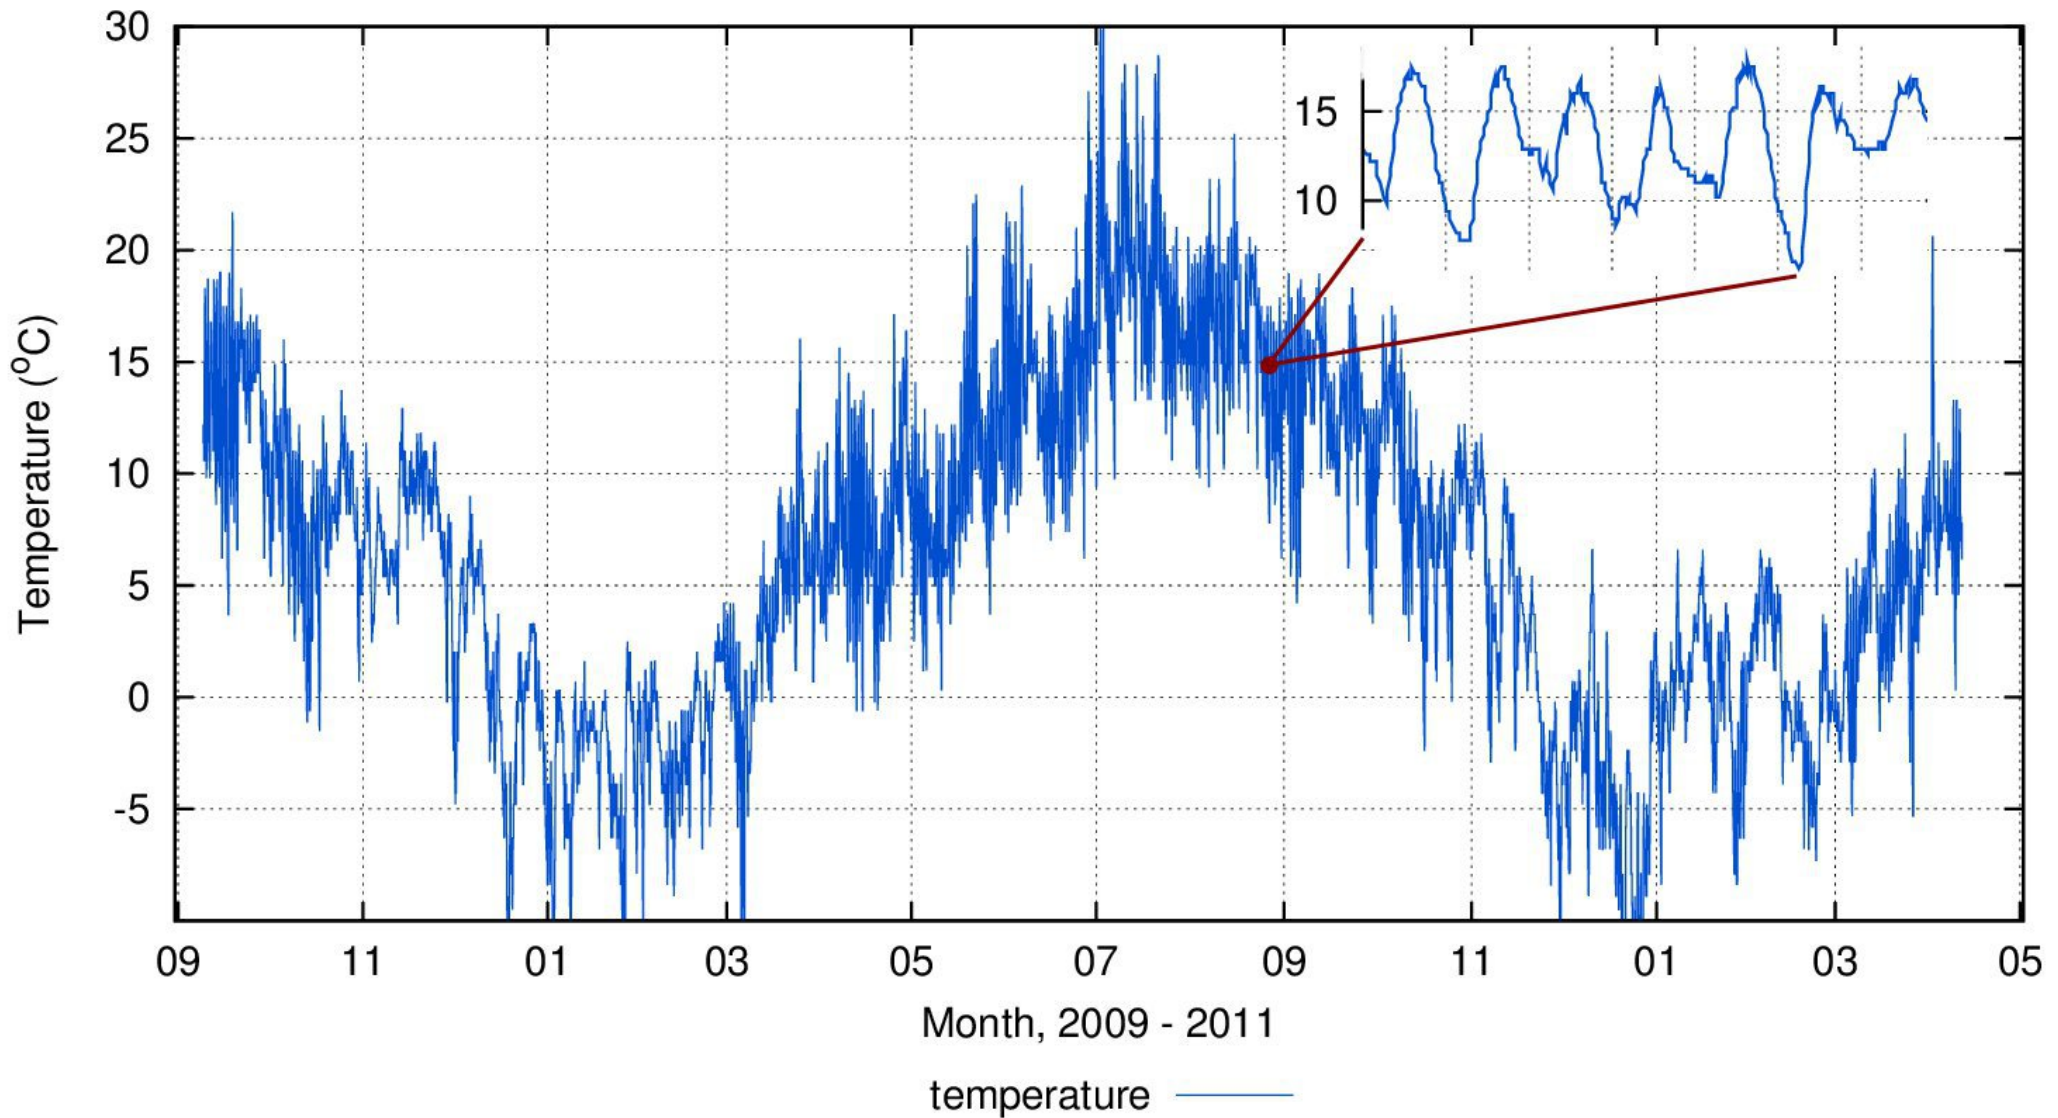
The temperature in Ribe, Denmark
The daily cycles are expanded in the insert

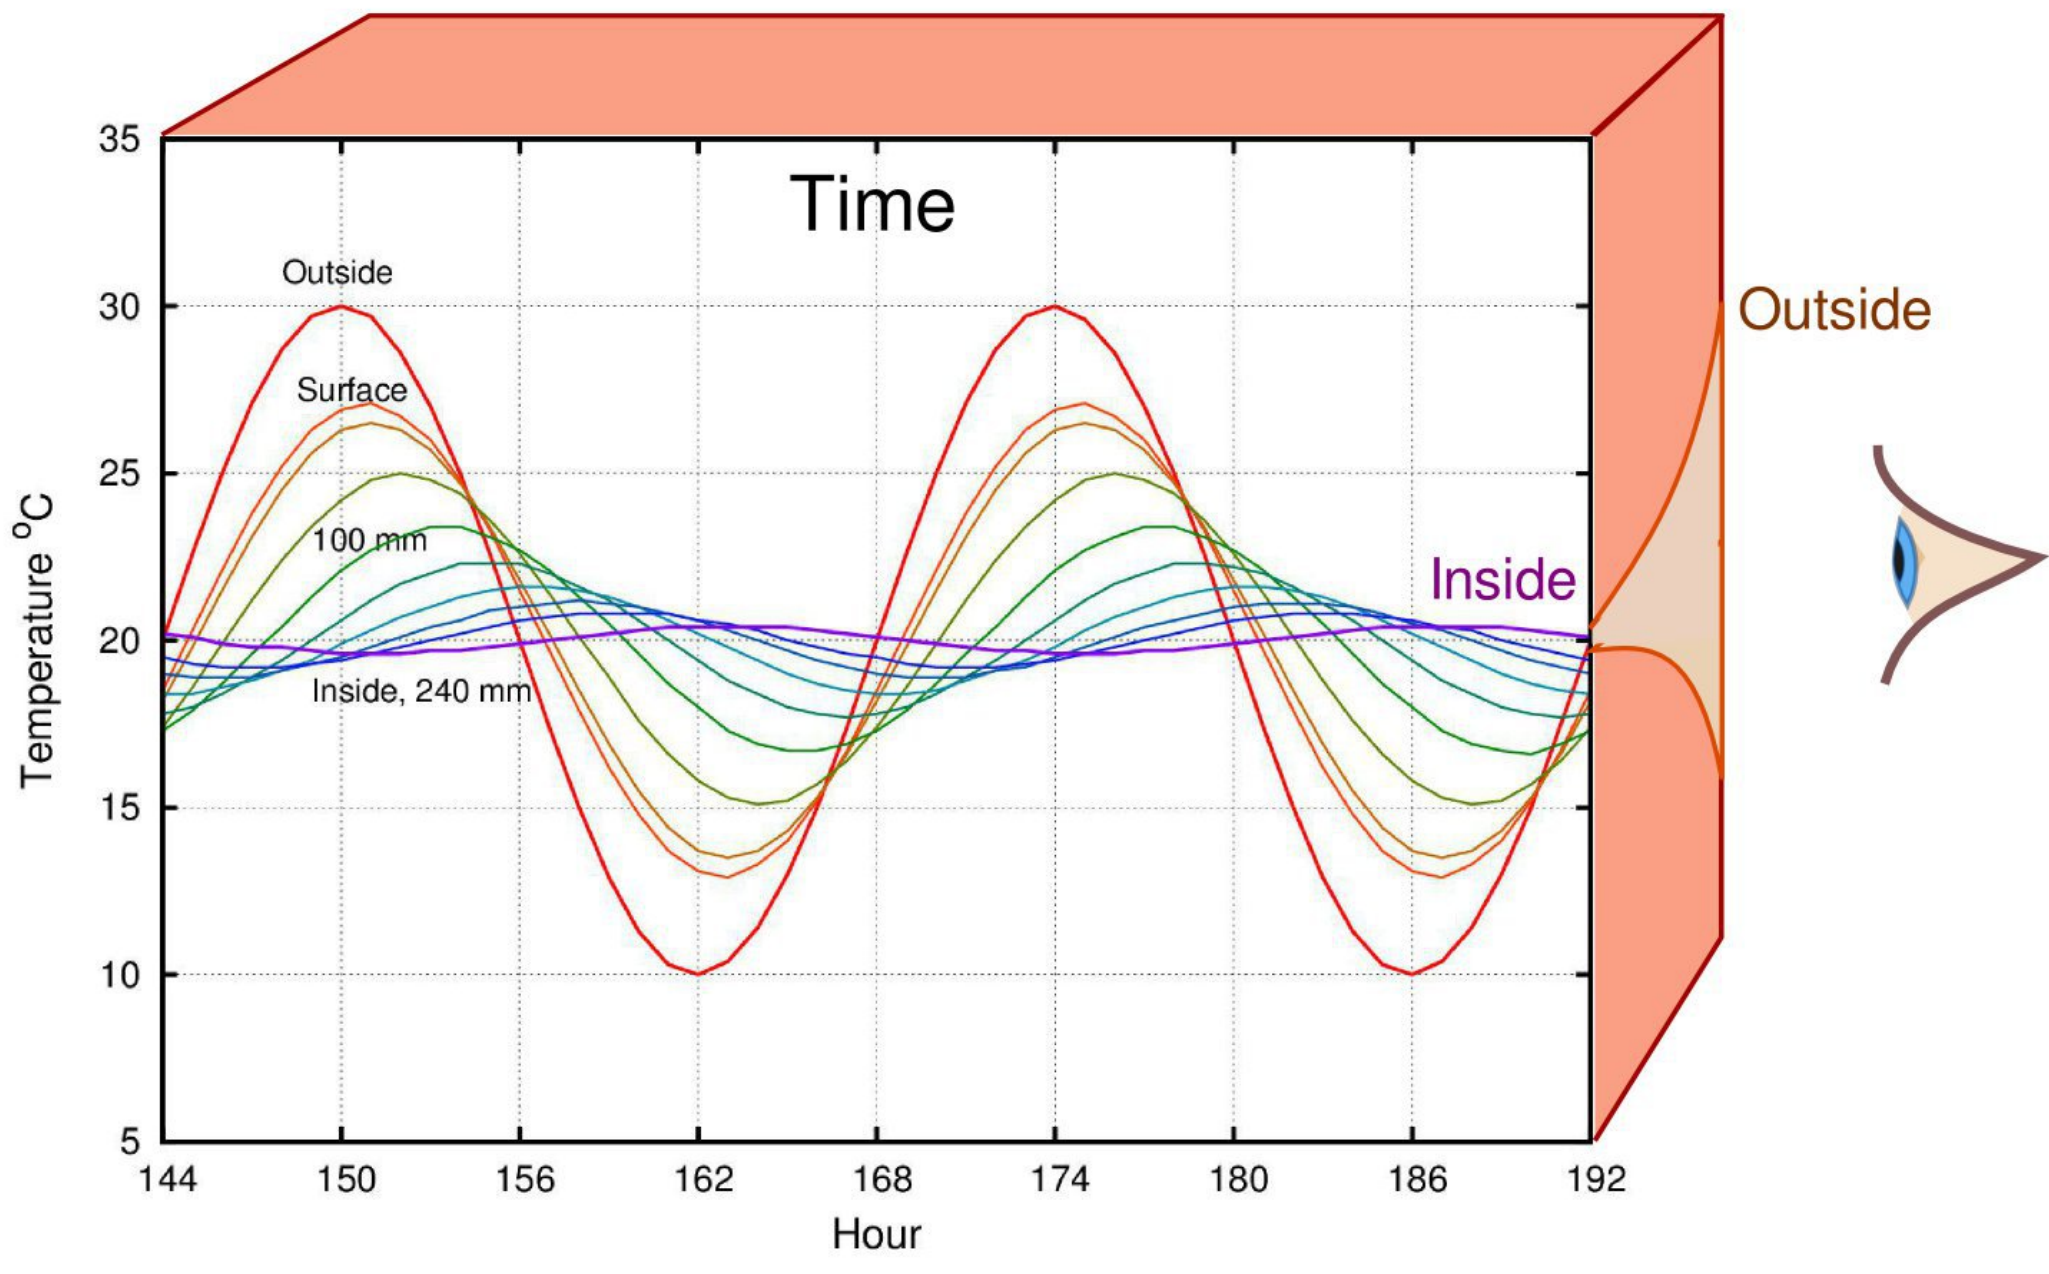
How the daily cycle of temperature penetrates a 240 mm thick solid brick wall

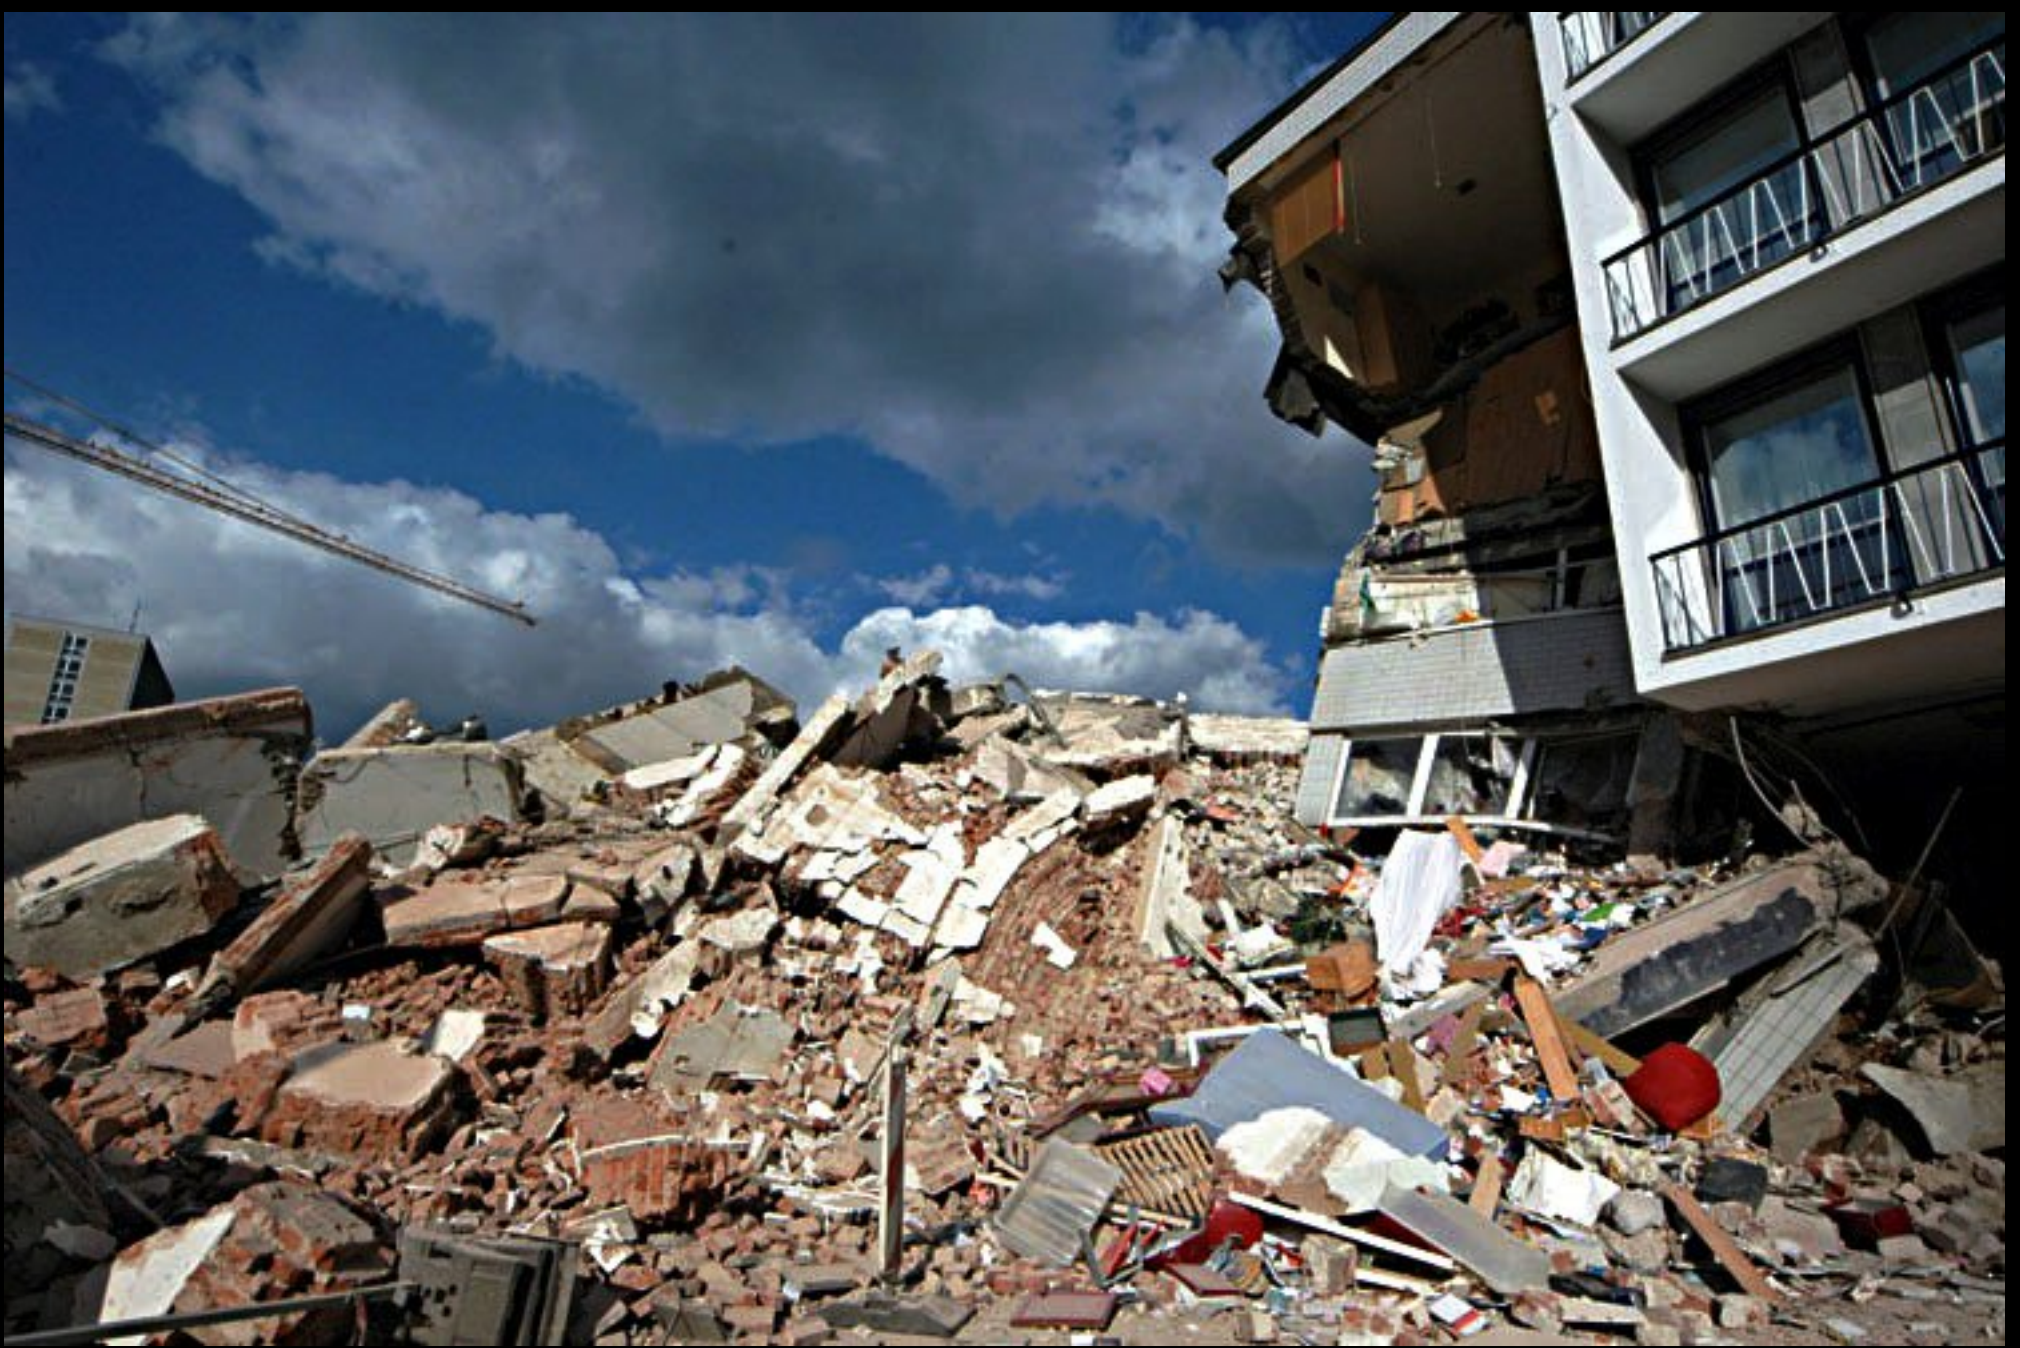
Wall sections of the Cologne city archive

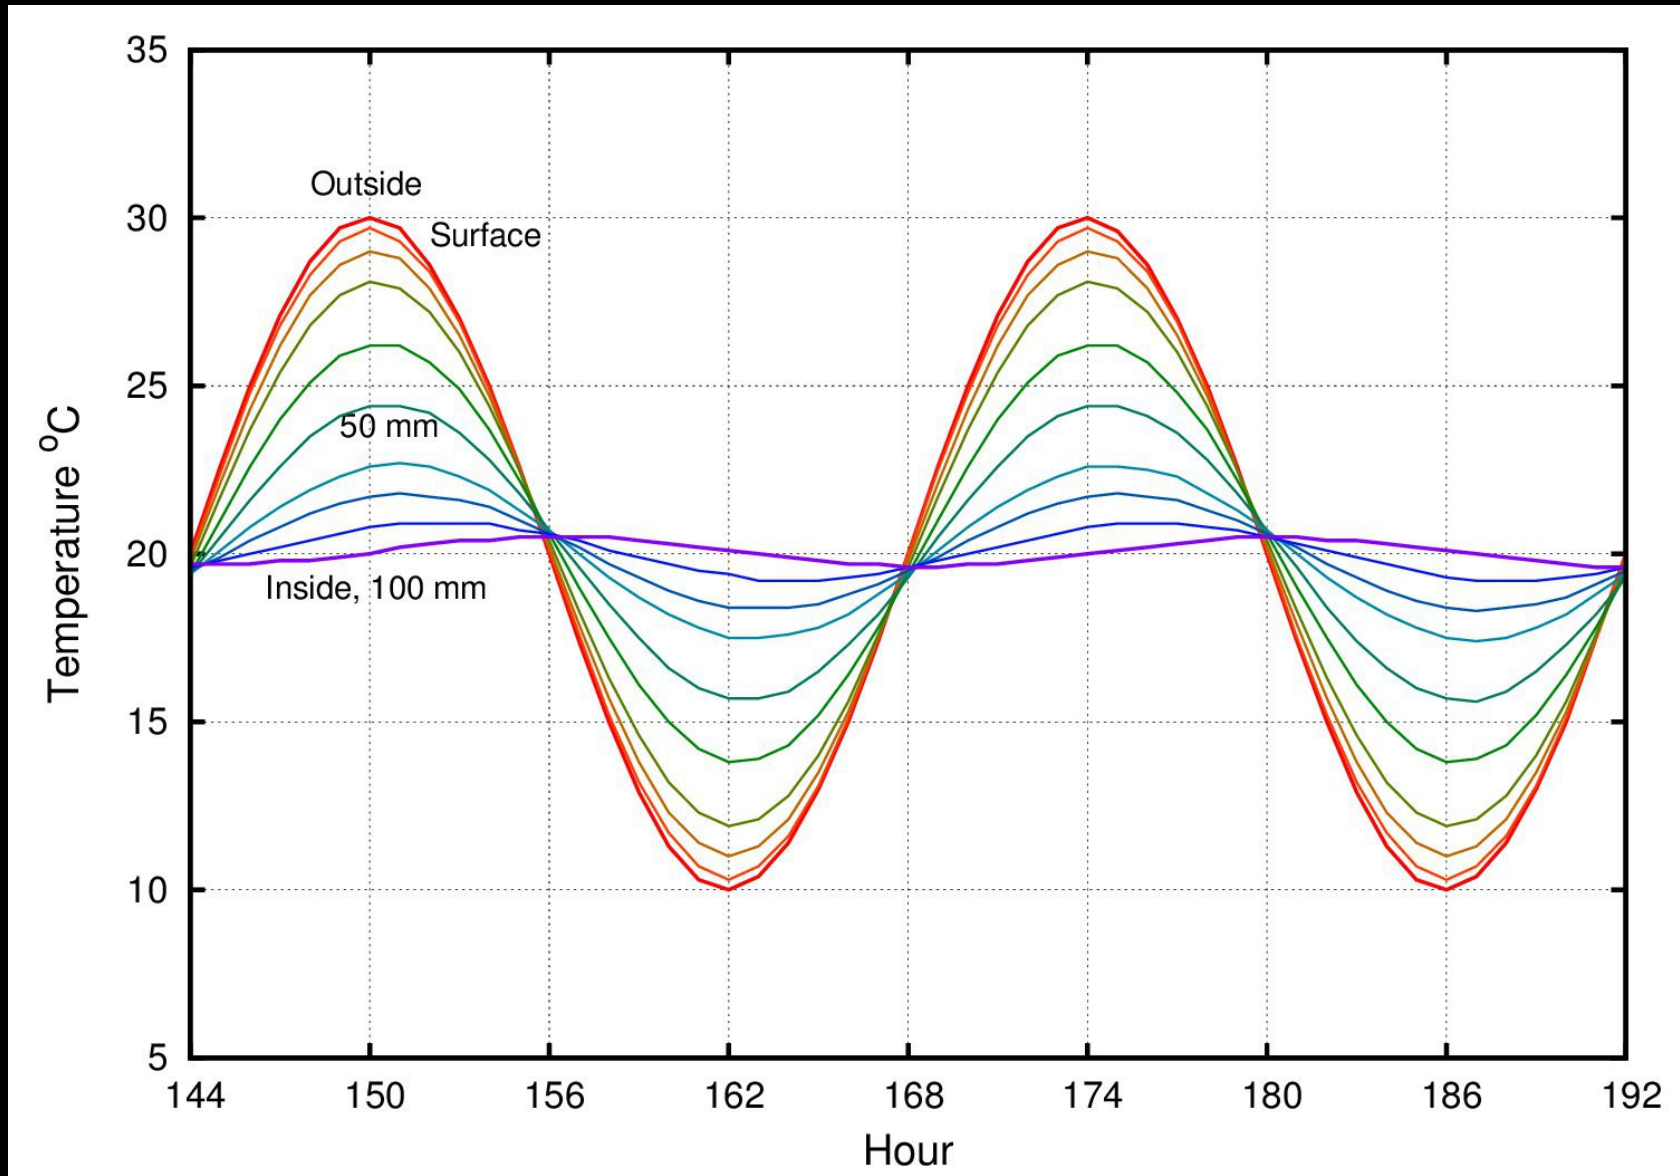
The evolution of temperature within a 100 mm foam wall

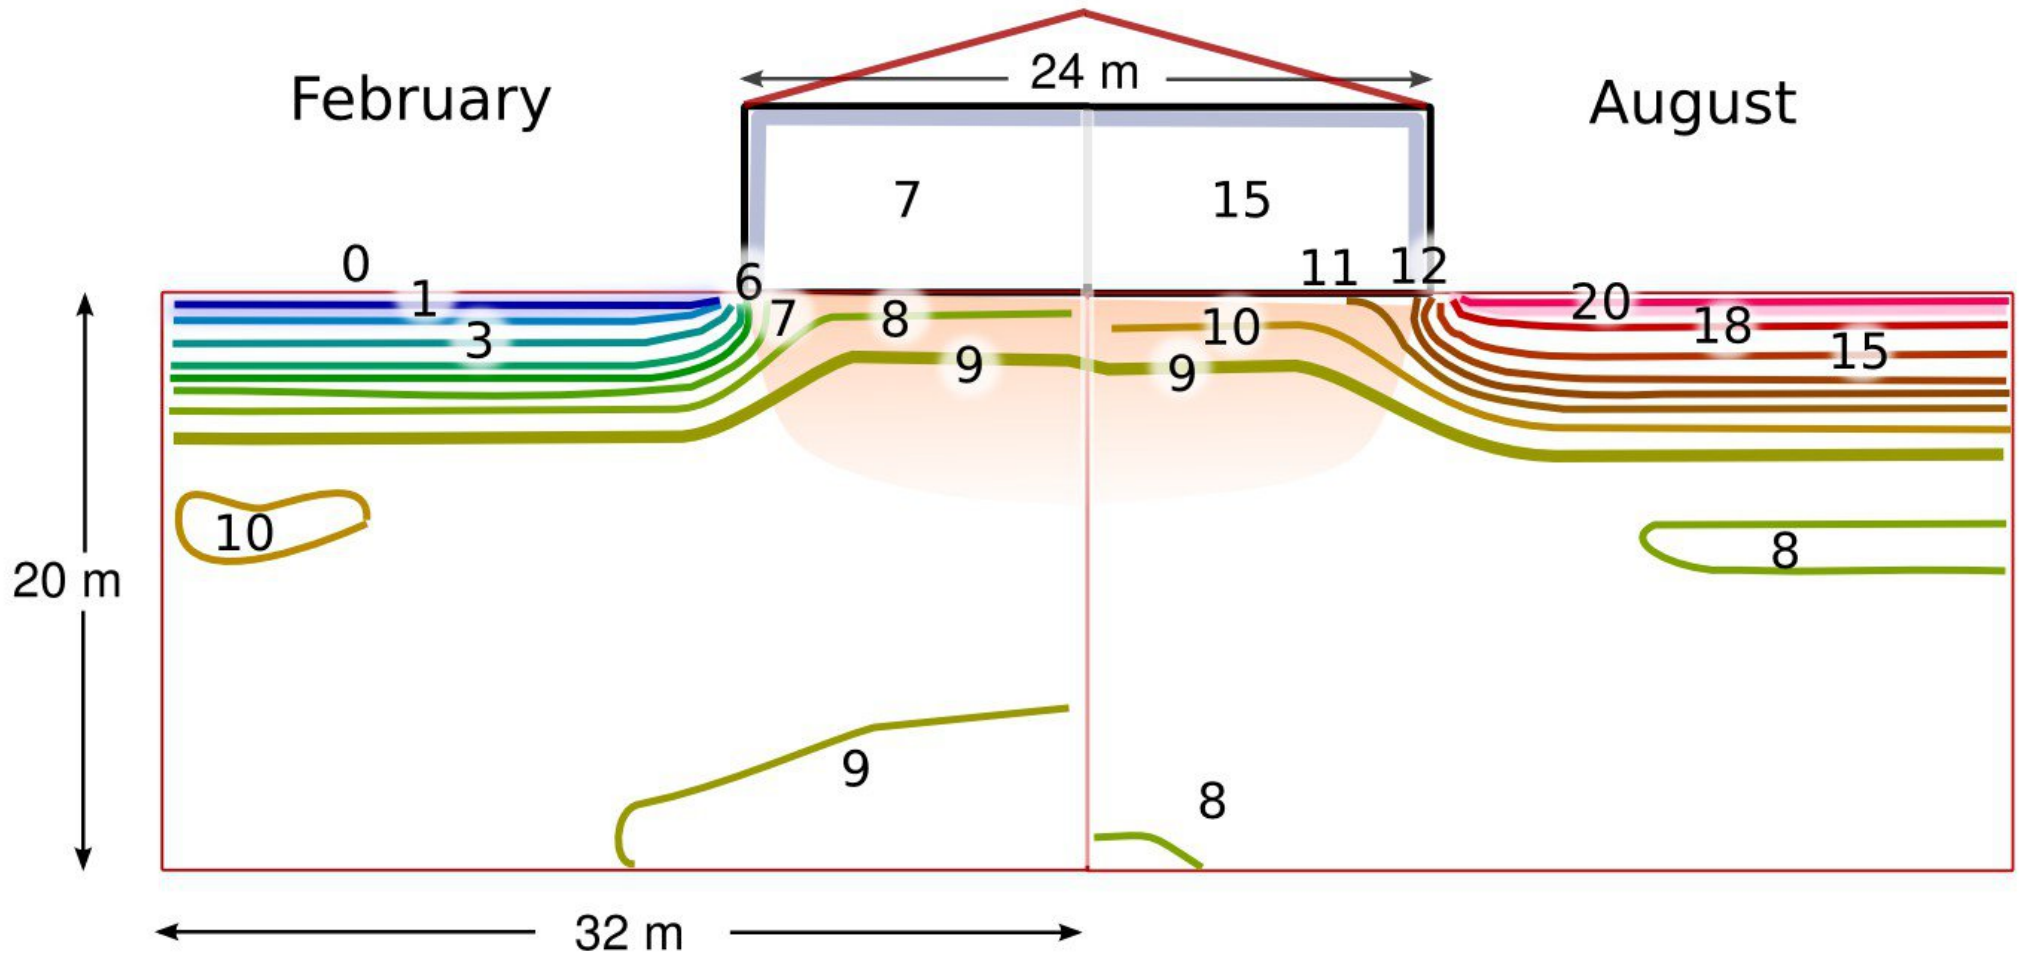
Simulation of the underground temperature contours under a museum store, showing how the ground acts as a huge thermal buffer for the building above

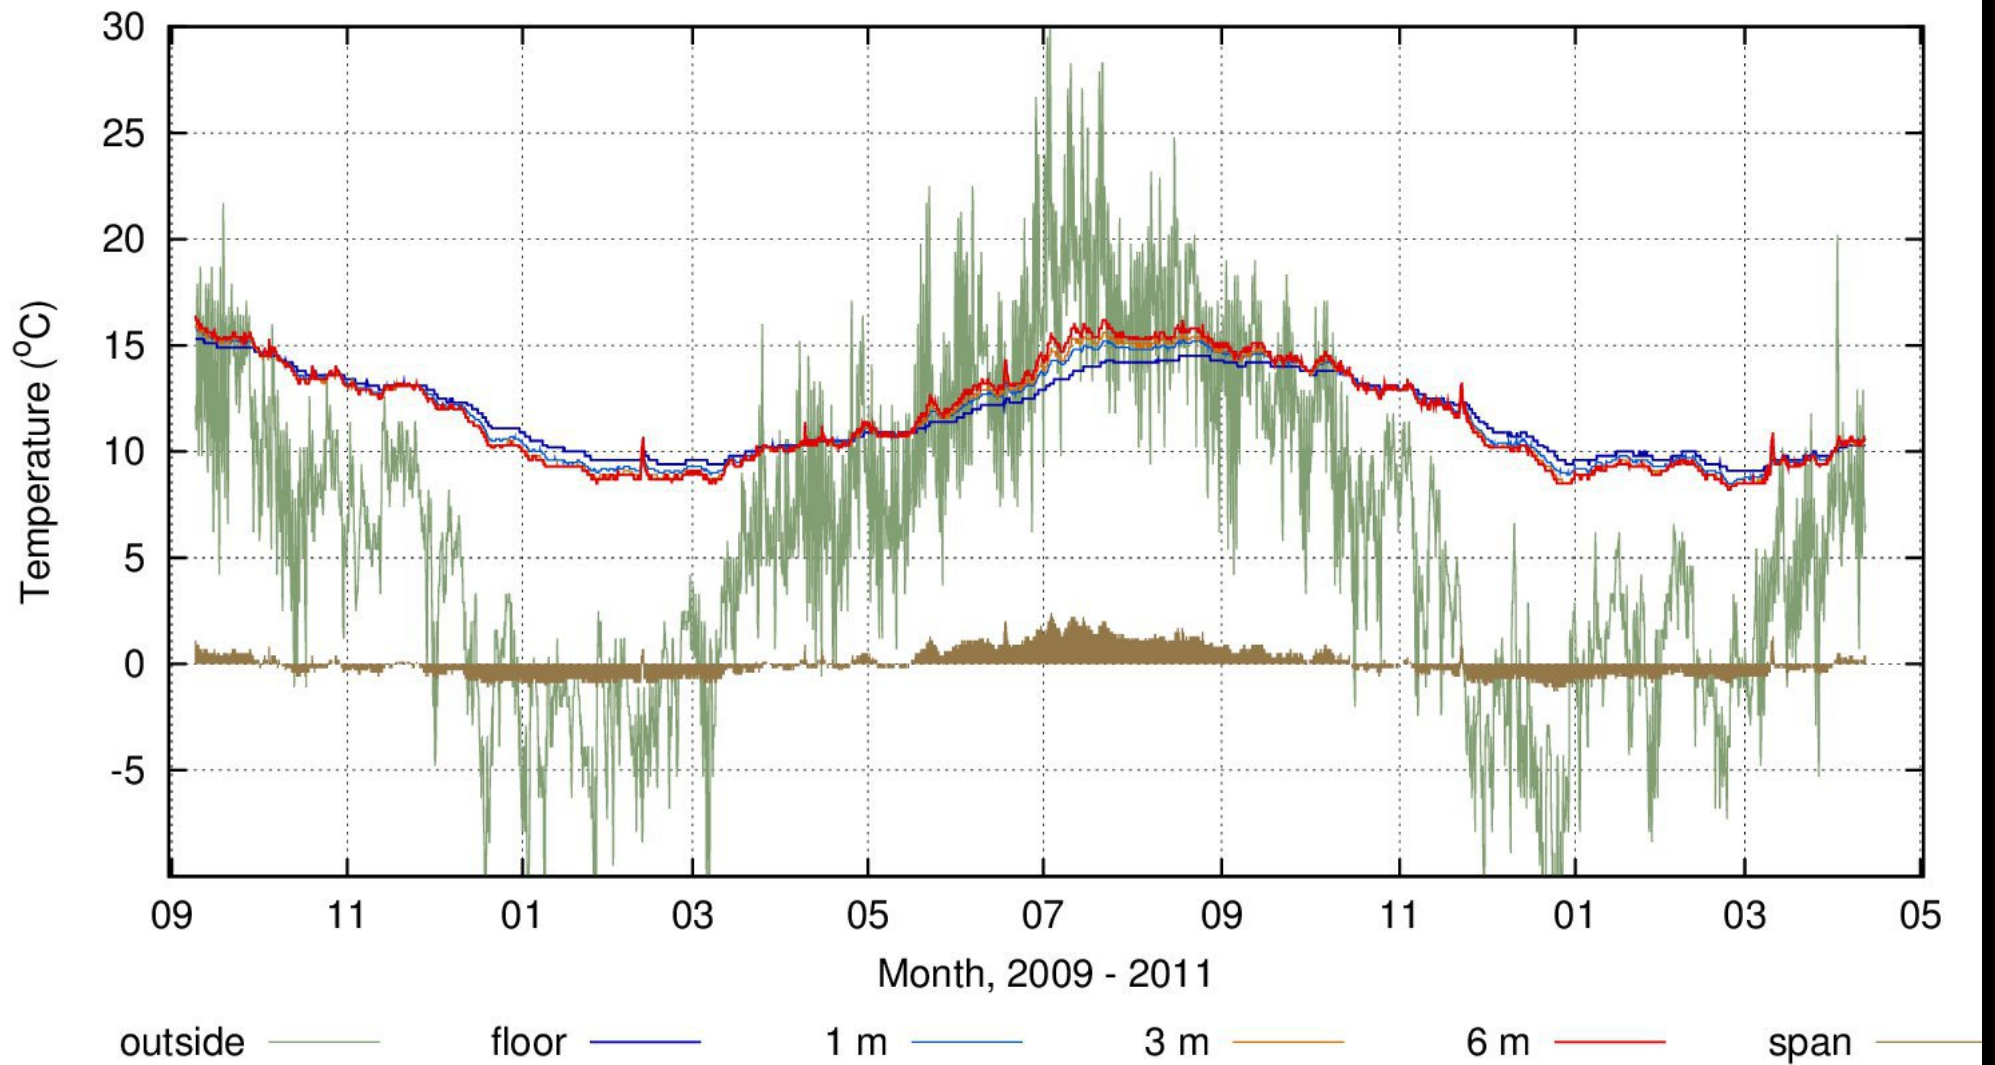
The annual temperature cycle at various heights within the museum store in Ribe. The annual cycle span is reduced to 8 K. There is very little temperature stratification

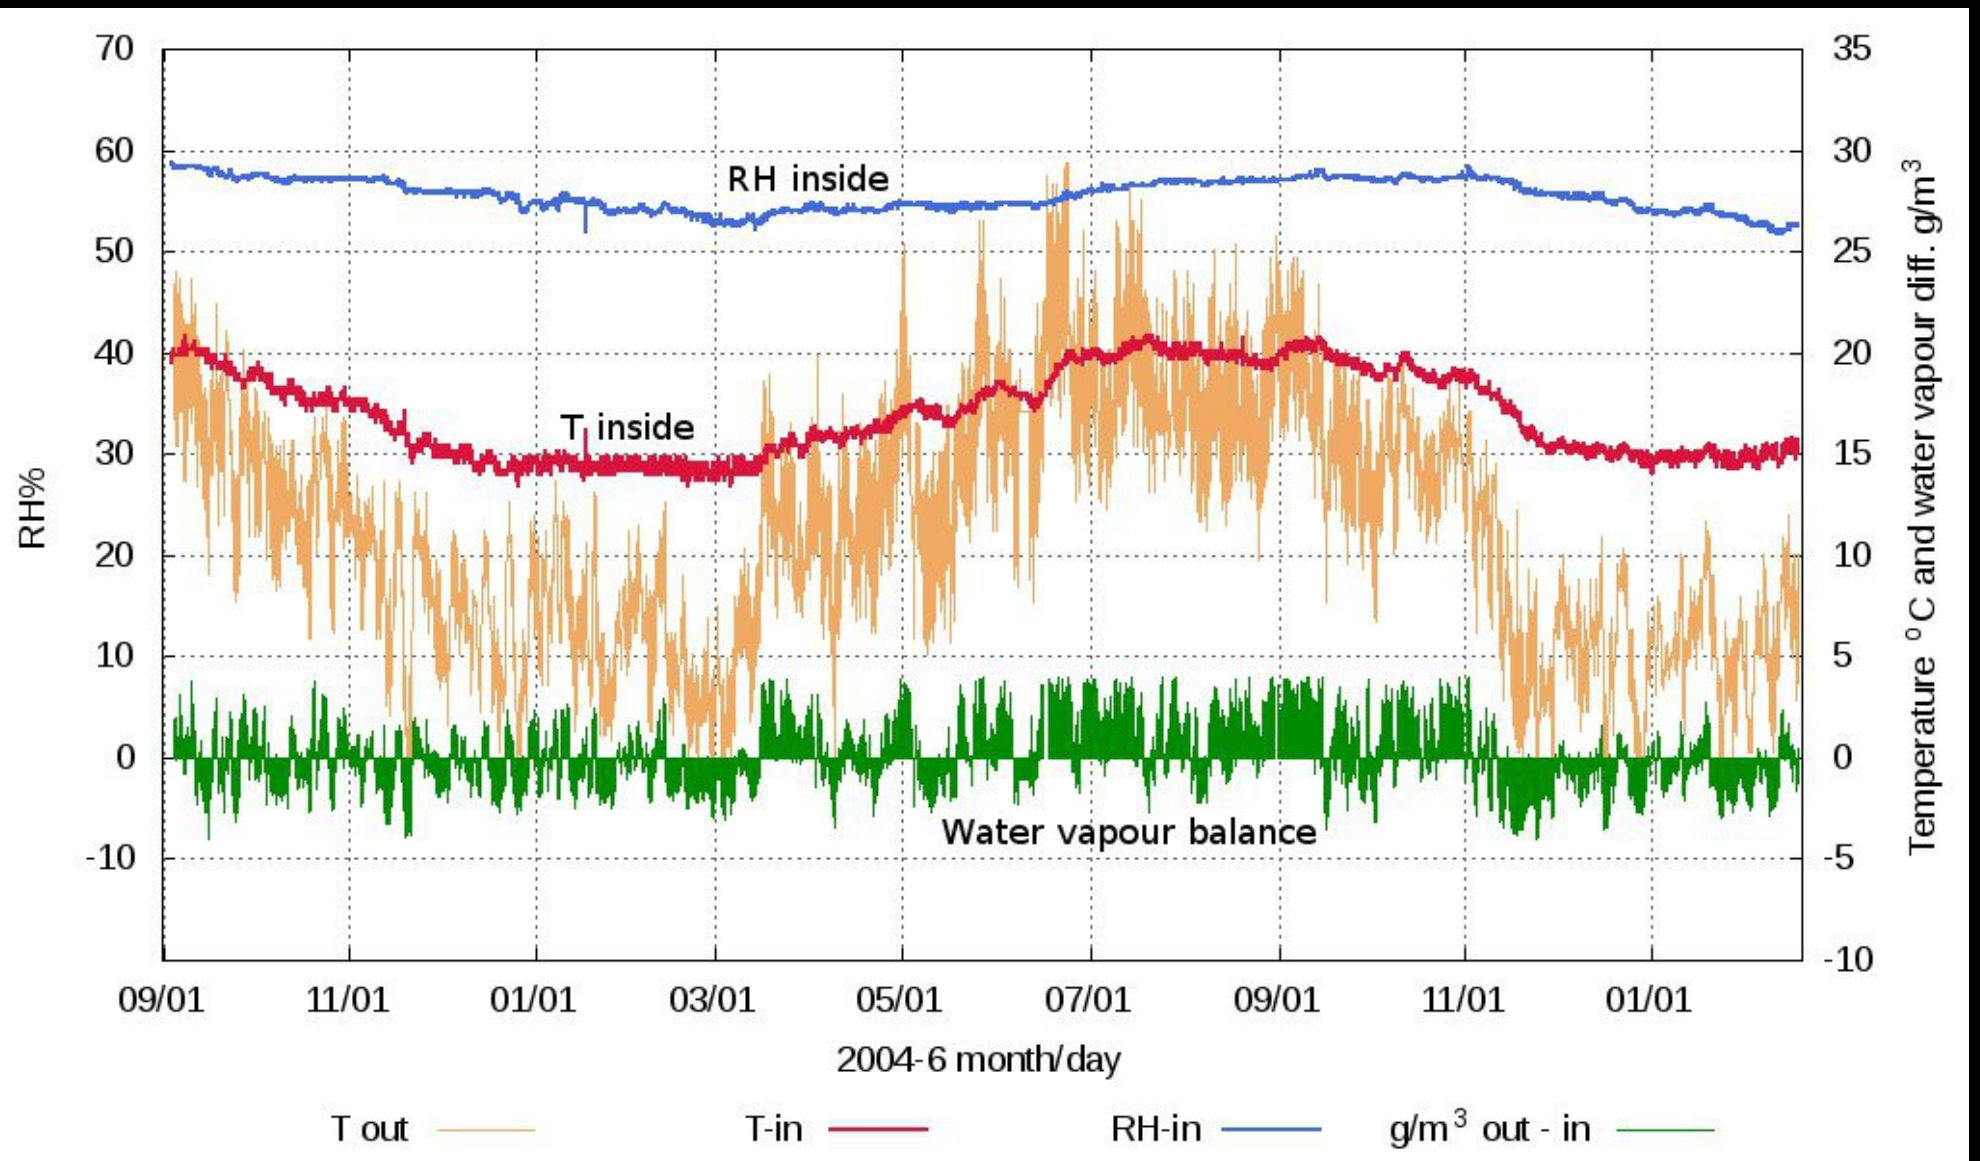
The climate within the Suffolk Record Office,
Ipswich UK.

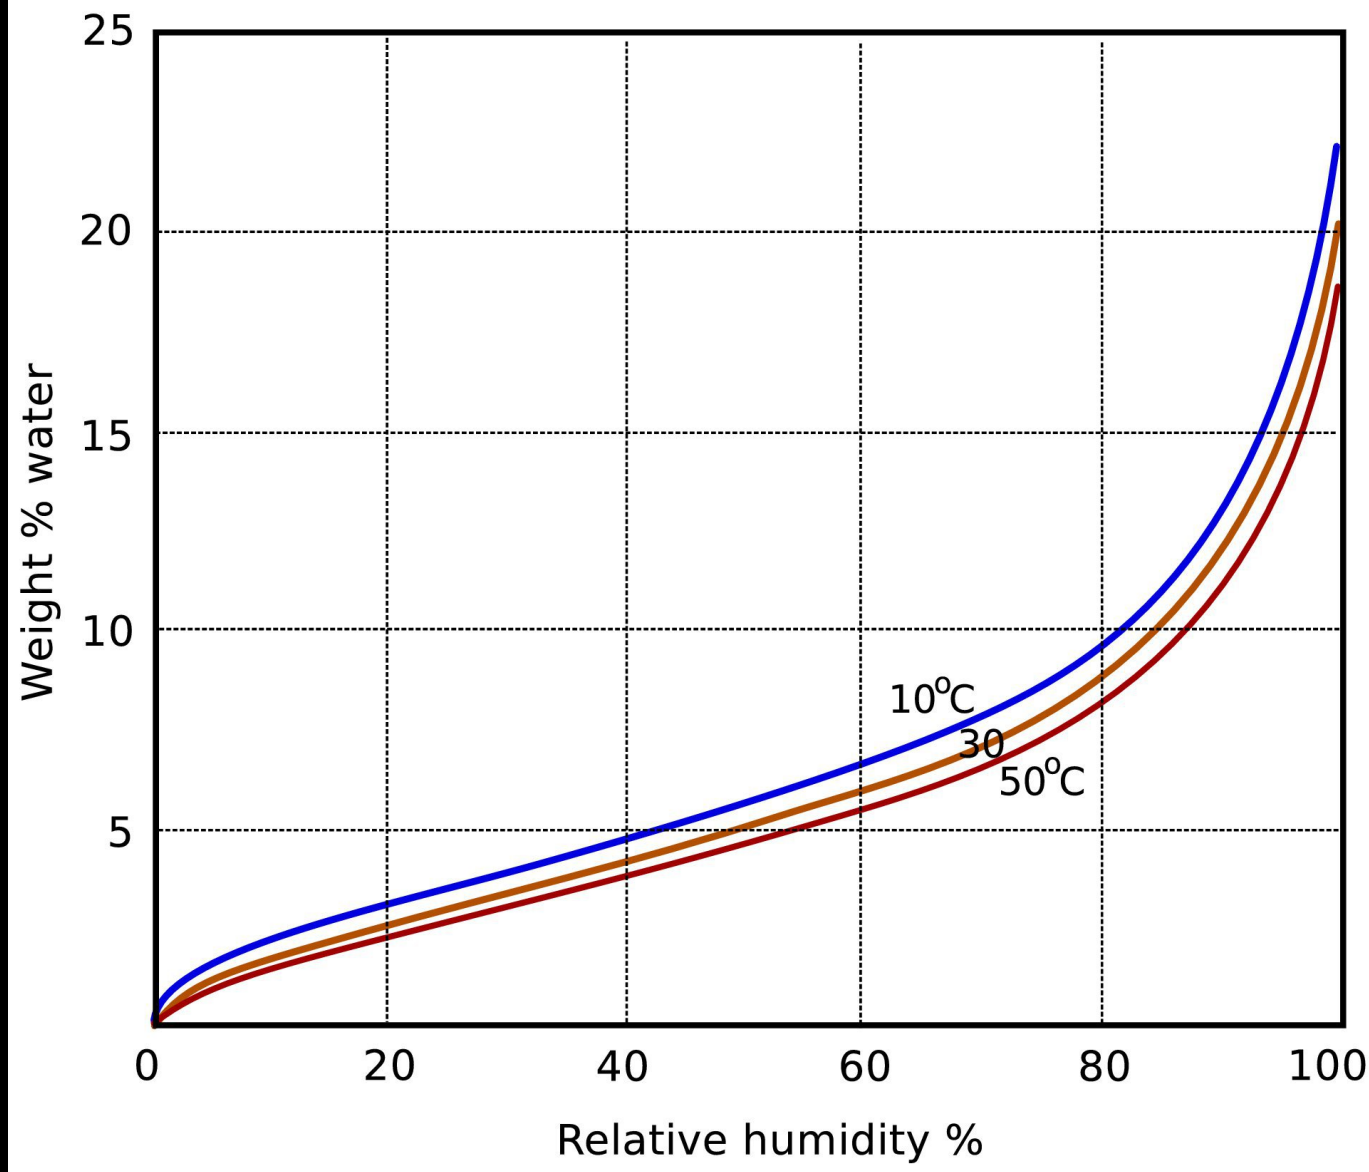
The equilibrium between sorbed water in cotton and water vapour in the space around it is scarcely affected by temperature

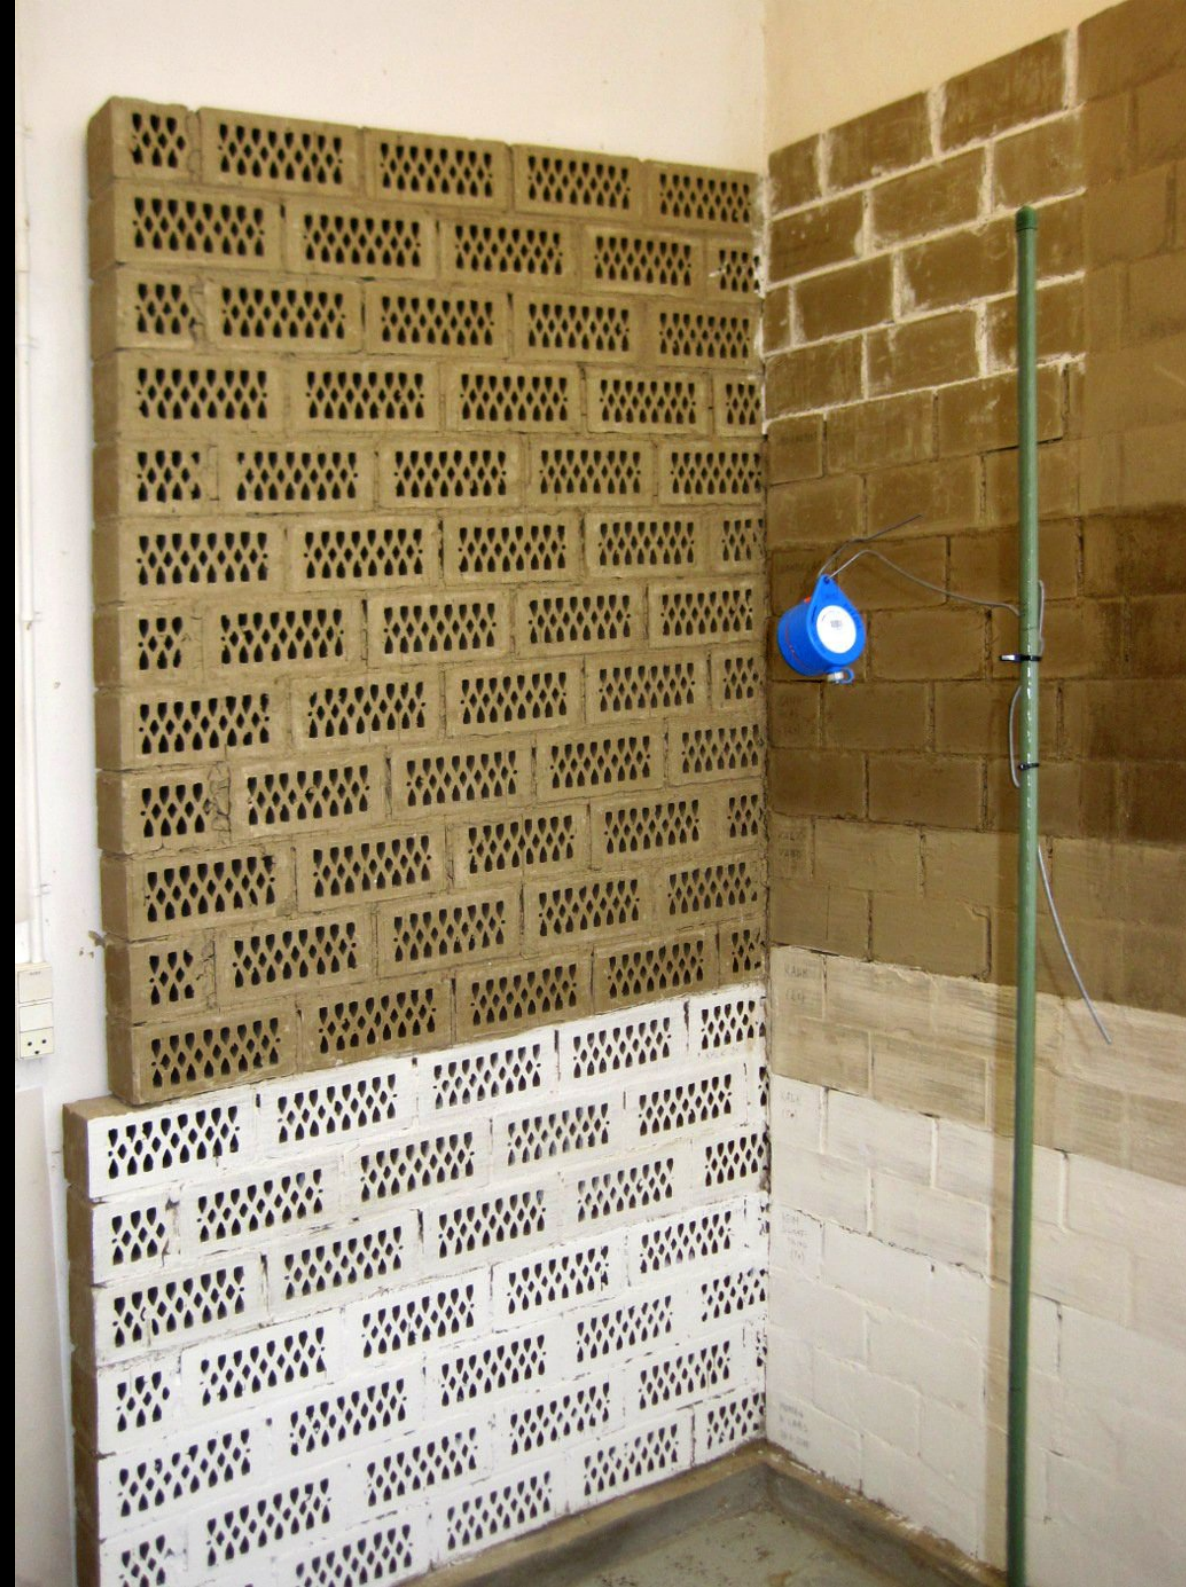
An experimental room partly lined with unfired, perforated clay brick, as a humidity buffer for stores without much absorbent material in the collection

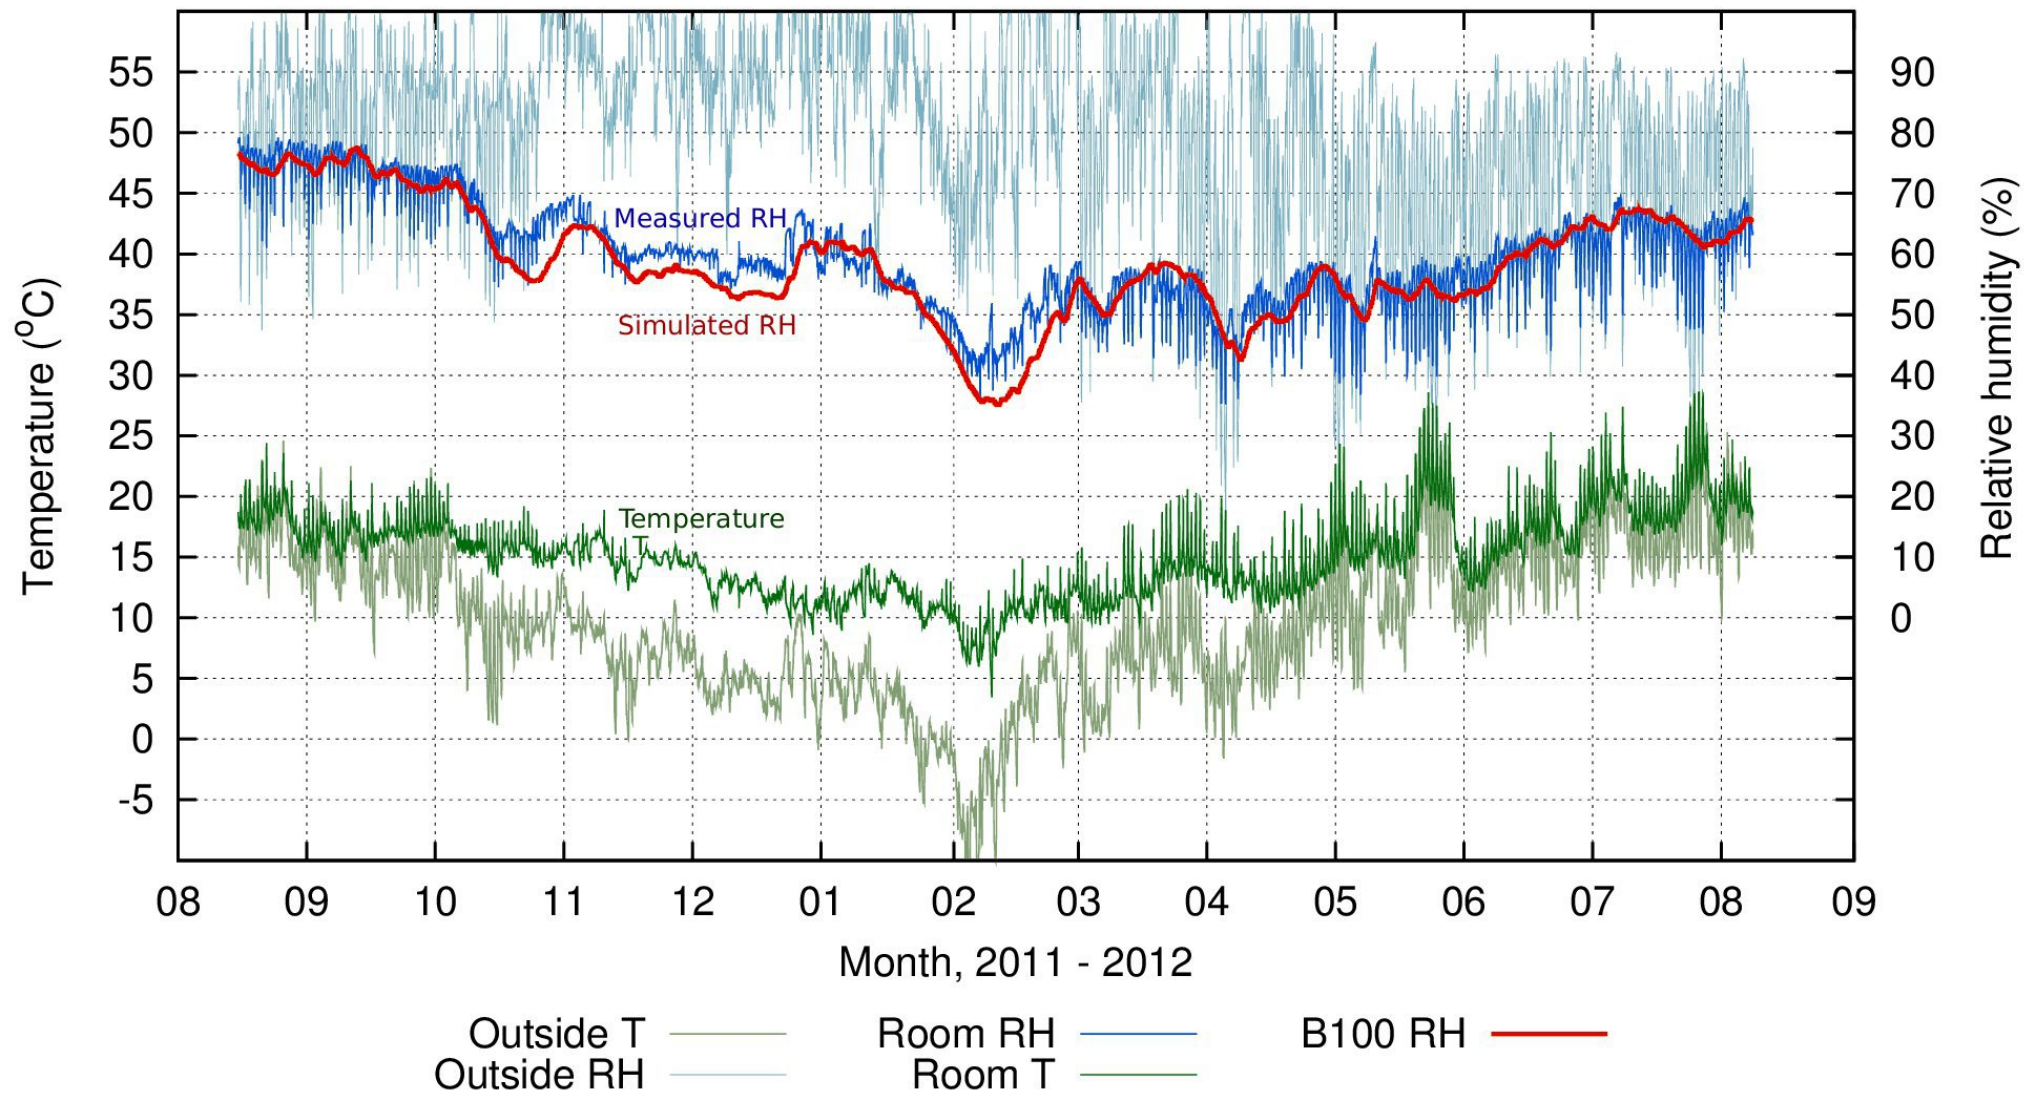
Temperature and RH outside and within the clay lined room. The red trace is the predicted RH. The spikes are due to direct sunlight temporarily overwhelming the buffer capacity of the clay
