Building to the new relaxed climate standards

Tim Padfield

Will PD5454 set us free to design low-energy museum buildings - or is it a disastrous concession to the energy pessimists, or is it not quite as generous as it seems?

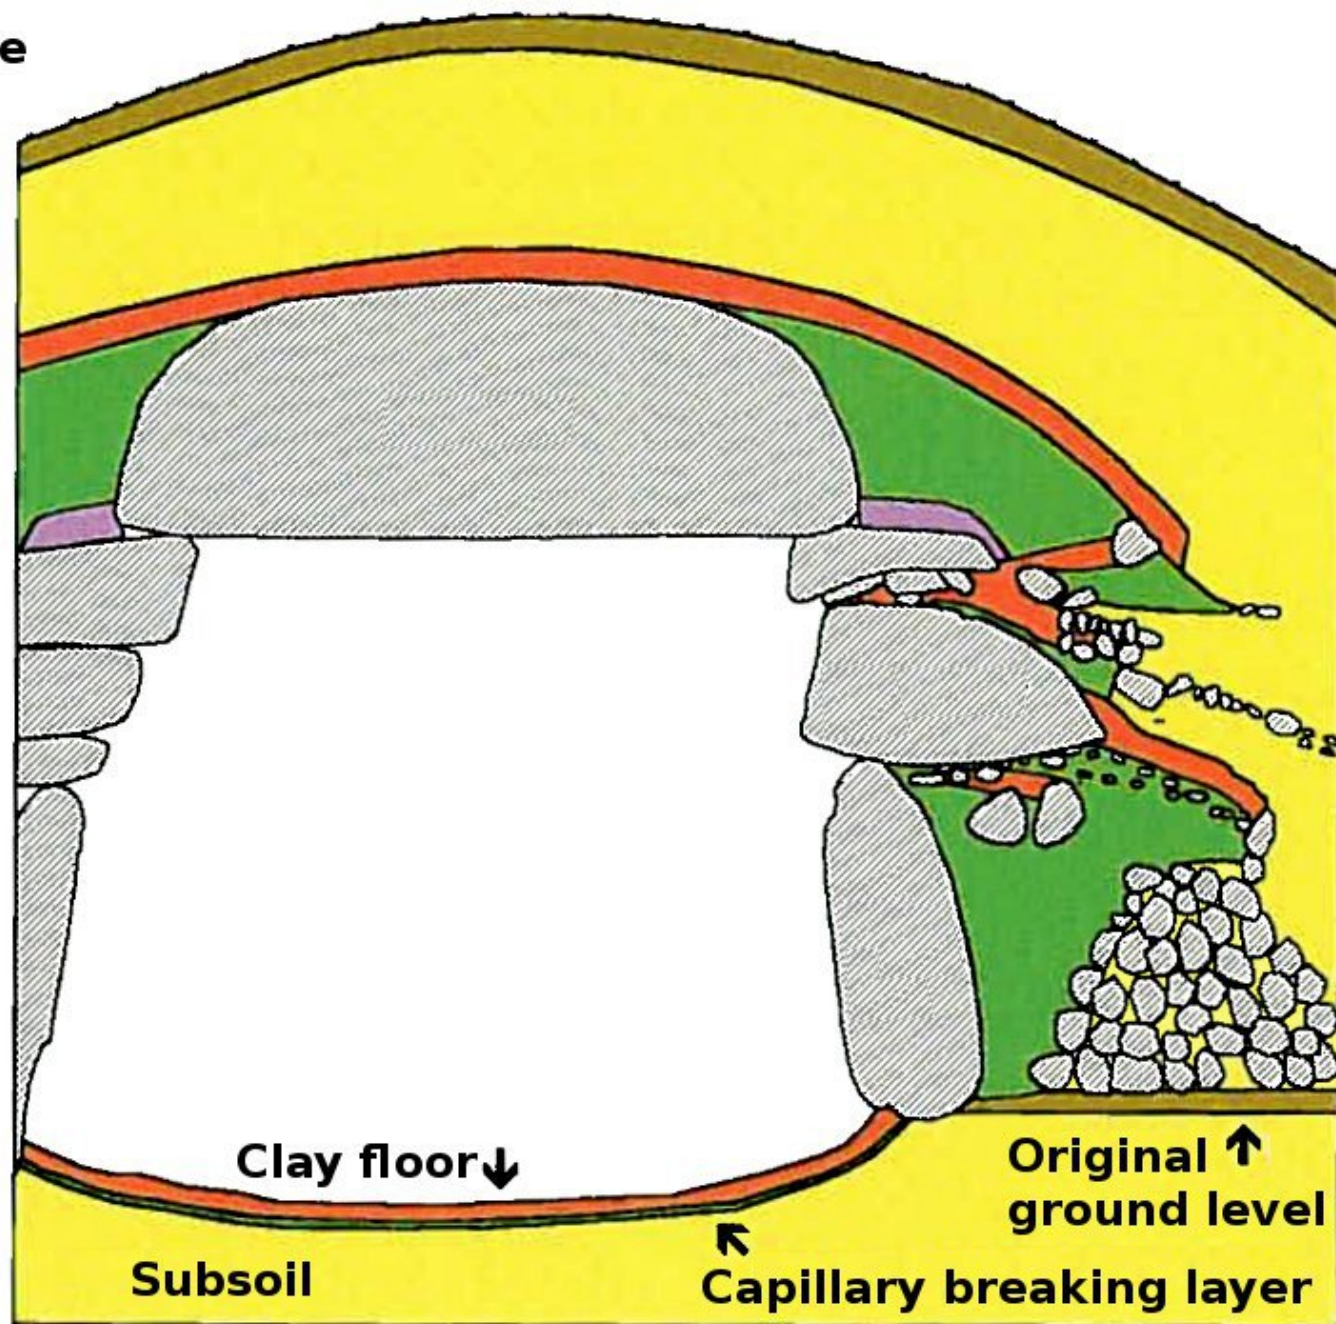
**Birkehøj passage grave
Denmark**

**Construction
technique**

-   Sand
-   Clay
-   Pebble gravel
-   Stone
-

Top soil
-

Broken flint
