# MANAGING EXTERNAL ENVIRONMENTS THROUGH PREVENTIVE CONSERVATION: THE INVESTIGATION AND CONTROL OF ENVIRONMENTALLY-CAUSED DETERIORATION OF DECORATIVE SURFACES IN THE MARLBOROUGH PAVILION, CHARTWELL, KENT

KATY LITHGOW, TOBIT CURTEIS AND LINDA BULLOCK

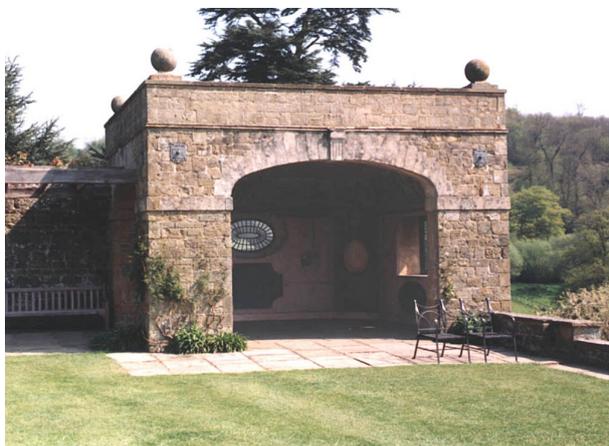
Figure 1. External view of the Marlborough Pavilion from the south

Located in the gardens of Chartwell, Sir Winston Churchill's country house in Kent, the small summerhouse known as the Marlborough Pavilion was built in the mid 1920s of clunch and dressed sandstone, with a lead roof. [1] (Figure 1). Open on two sides, the internal walls are rendered and painted, and embellished with slate and terracotta wall plaques, concrete figurative busts and a low relief painted slate frieze. The building was originally decorated in 1934 by John Spencer Churchill (1909-1992), Sir Winston's nephew, and again in 1949 as a 75th birthday gift for his uncle [2]. The scheme commemorates John Churchill, the first Duke of Marlborough, and victor of the Battle of Blenheim. The house and its gardens were donated to the National Trust in 1946 and occupied by Sir Winston and Lady Churchill in their lifetimes. (Figure 2)

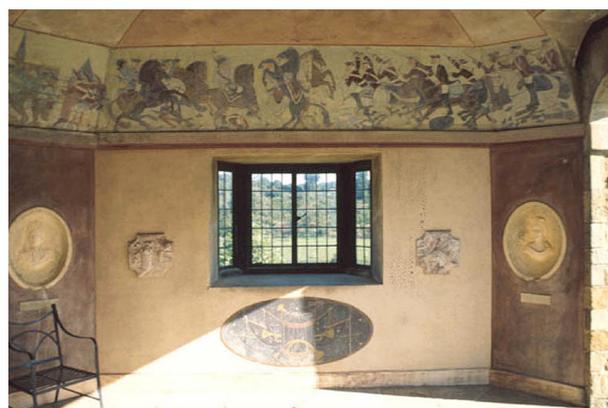
Figure 2. View of the Pavilion's interior before treatment

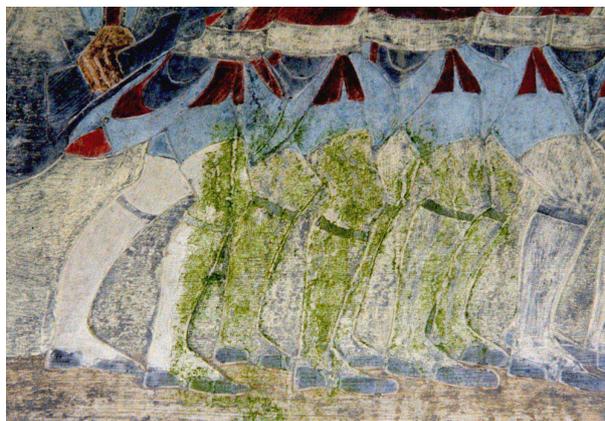
Figure 3. Detail of microbiological growth on the slate frieze

Deterioration of the paint layer was found to be widespread, with considerable delamination and flaking as well as extensive microbiological growth, mostly evenly distributed over large areas. ( figure 3) The nature and distribution of the deterioration indicated that while significant areas of damage were associated with microclimatic factors, including air movement and the building's thermal as well as hygral properties, some areas of damage were more likely to be caused by liquid water ingress.

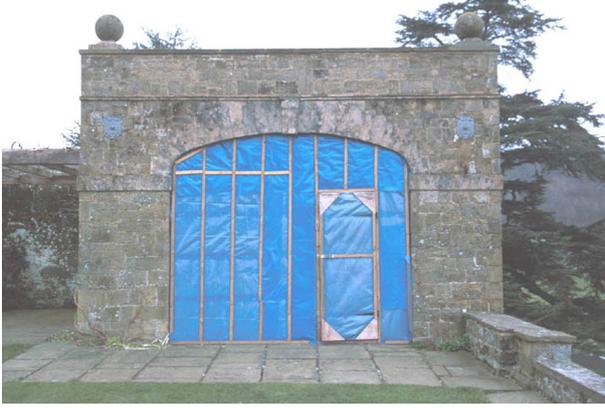
Figure 8. External view of the Pavilion with the initial plastic-covered enclosure

In order to reduce the disruptive effect of the wind, and to test if increasing the hygrothermal buffering improved the conditions, further tests were carried out by enclosing the open walls of the pavilion with uninsulated plastic panels inserted into the two wall openings. Monitoring data showed that enclosure reduced the influence of external water vapour concentration on the internal microclimate and also prevented rain entering. However, Although the internal microclimate was somewhat stabilised, enclosure caused the RH to fluctuate at very high levels (often over 90%). During this period the warm airflow generated by the heating tapes had little effect on condensation, apparently due to the overwhelming influence of the high RH.

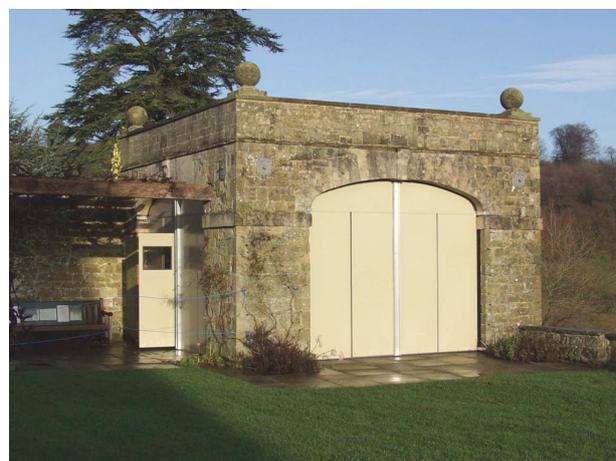
Reversible fixing methods that avoided damaging the Pavilion's historic fabric meant that the panels were made slightly smaller than the arched openings. The panels' edges were fitted with 'rubber' gaskets that could be expanded to fit by self tapping spring-loaded screws and bolts at the edge. Seals were formed of Plastazote® strips around the stone arches and brush strips ('Centaur') fitted at the top and bottom. The screen was constructed of aluminium framework with aluminium infill panels insulated with 22mm black Plastazote®. The foam

Figure 11. Detail of the construction of the enclosure

was adhered with a UPVA-based glue used to glue insulation to aluminium in the aircraft industry. The design included some points of cold bridging which could produce condensation, but were felt not to be an issue as there was no additional heat to create a significant temperature gradient.

In practice, this meant a modular system of interlocking panels with carrying handles, formed of rustproof brush-painted aluminium panels with stainless steel fixings. (Figures 11 & 12) The panels are self-supporting and interlock when in place, as well as locking into position from inside. They are erected by property staff (gardeners and house staff), and stored on a rack with a cover. Access is provided by one set of panels having a lap joint on one edge, enabling hinges and locks to be fitted. Viewing panels with rounded corners and rubber trim, enable visitors to see the interior (with illumination) while the enclosure is in place, and the conservation approach is explained with interpretation panels.
