THE INDOOR CLIMATE IN HISTORIC BUILDINGS WITHOUT MECHANICAL VENTILATION SYSTEMS

Morten Ryhl-Svendsen^{1*}, Tim Padfield¹, Victoria A. Smith², and Franco De Santis³

¹Department of Conservation, National Museum of Denmark

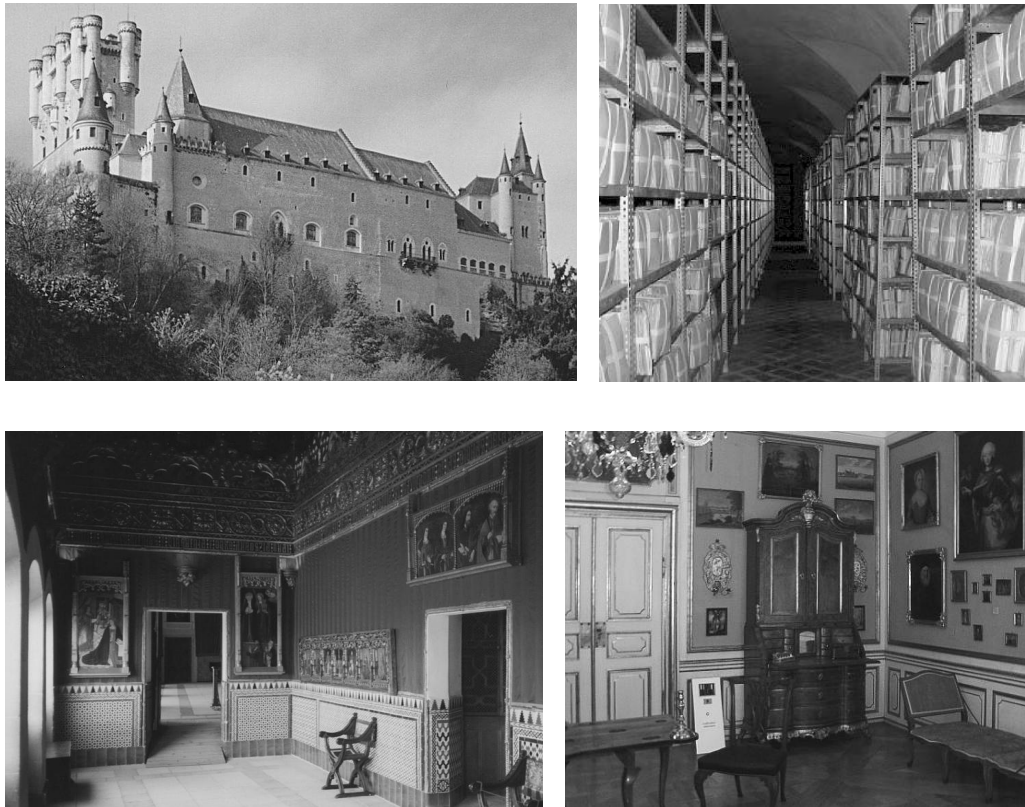
Figure 1. The sites. Top left: Alcazar Castle. Top right: Alcazar Military Archive. Bottom left: Alcazar Cord Room. Bottom right: National Museum of Denmark room 134.

the south side but also because of the showcase lighting. The third room discussed in this article is the “Military Archive”, which is located in a room previously used as a dungeon, on the north side, between the nearly vertical rock of the castle hill and an outer wall of masonry. This room is not open to the public.

The National Museum of Denmark, in central Copenhagen, is Denmark's primary cultural history museum. It was built as a royal palace in 1744 and has been a museum since 1846. The room we have measured “Room 134” is a small room built as an alcove off a long corridor with a row of windows. The outer wall is of brick, about 30 cm thick.

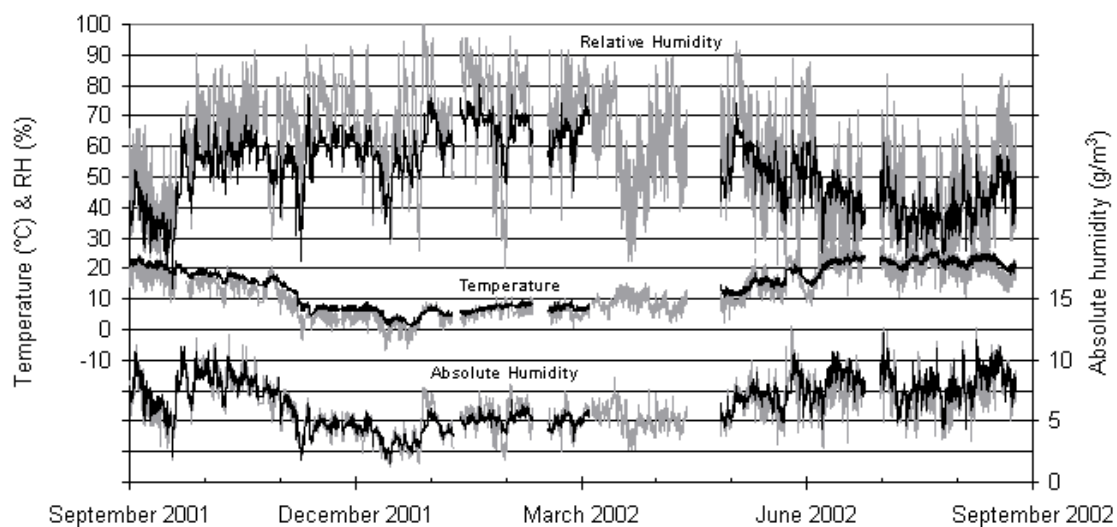
Figure 2. Alcazar Castle, Cord Room

The climate measurements in the three public rooms are presented as graphs covering the year from September 2001 (figure 2-4). The outside values are printed in grey, the inside in black. The climate in the archive is shown in figure 5, for a shorter period in April to May 2001, which displays some peculiarities of its microclimate. The bold lines are the inside climate.

The most notable feature of the climate in the three public rooms is that the outside and inside water vapour concentrations are nearly equal. The difference between inside and outside RH is therefore defined by the temperature difference. The Cord Room, which has no artificial heating, has a RH that follows that outside, but at a slightly lower value because of the slightly higher indoor temperature. The Military Museum and the National Museum room have a RH which is considerably reduced in the cooler months by the heating. In both rooms the temperature is allowed to drop below the human comfort ideal in winter, but this keeps the RH within the “comfort zone” of the exhibited objects, and the fabric of the buildings. The reduced daily amplitude of the indoor RH cycle is partly due to the more constant indoor temperature, partly to the limited air exchange and partly to moisture buffering of the interior furnishing. Moisture buffering itself contributes to the temperature stability, because of the heat absorbed and released on evaporation and condensation. Without measuring the air exchange rate we cannot separate the separate contributions of these various stabilising influences.
