# MUSEUM MICROCLIMATES

Contributions to the Copenhagen conference

19 - 23 November 2007

Edited by Tim Padfield and Karen Borchersen

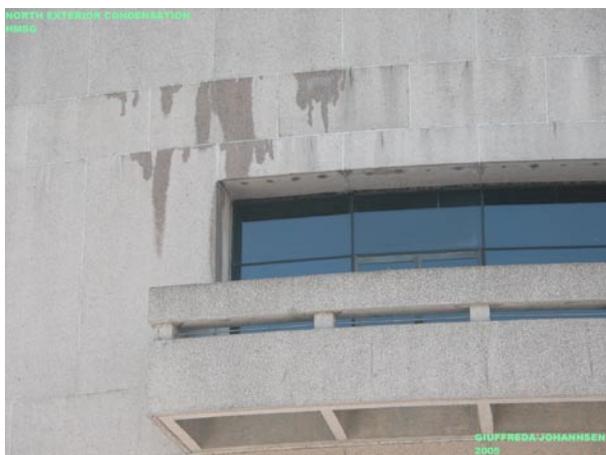
Figure 1. Condensed water leaking from the joints in the wall of the Smithsonian Institution’s Hirshhorn Museum and Sculpture Garden in the wintertime. (Photo by Gary Johannsen and Kevin Guifreda)

Figure 1 shows condensing water leaking from the exterior walls of the Smithsonian Institution’s

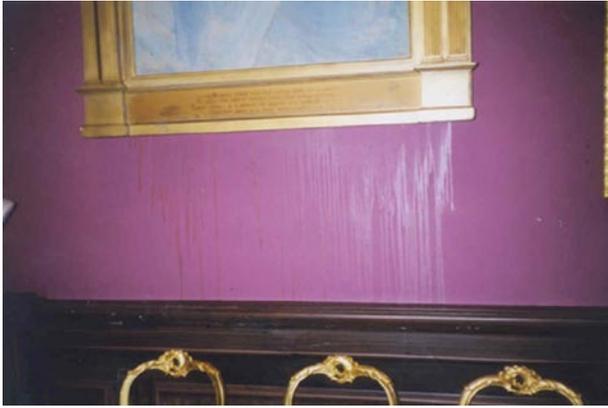
Figure 3. Condensed moisture running down the wall from behind one of several paintings at the Renwick Gallery of the Smithsonian Institution in Washington, D.C. (Photograph courtesy of Ehrenkrantz, Eckstut & Kuhn, Architects)

Figure 3 shows condensed water running down the interior face of an exterior wall from behind a painting at the Renwick Gallery of the Smithsonian Institution. The walls are 660 mm thick brick masonry walls having a 25 mm air space and a 25mm plaster finish. There is no insulation. The painting acted as insulation along the lower edge where there was contact with the wall. Moisture condensed at this lower edge. In this case the outdoor temperature was around  $-10^{\circ}\text{C}$  and the temperature and relative humidity of the interior spaces was  $21^{\circ}\text{C}$  and 50%, with a dew point of  $10^{\circ}\text{C}$ .

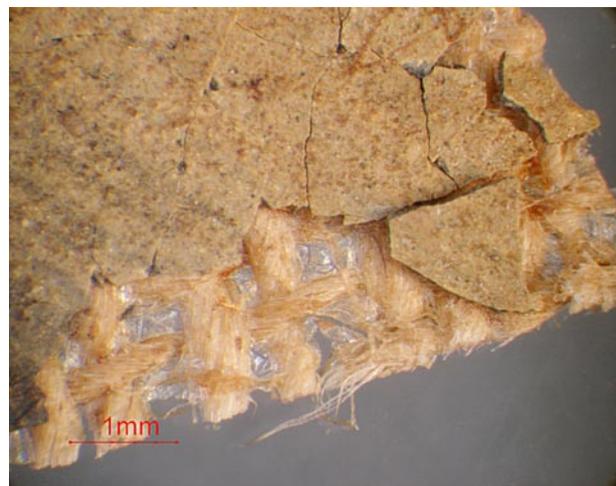
Figure 5. A detail of the same 19th century Italian painting shown in Fig. 4 but looking from the front. (Photograph courtesy of Melvin J. Wachowiak)

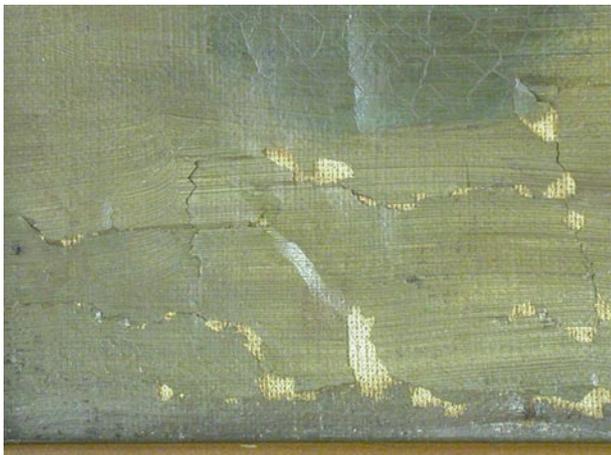
Figure 13. A detail of a 19th century Italian painting. It is clear that total separation of the paint and ground layers from the canvas has occurred. The amount of moisture was sufficient to cause cracking of the design layers and failure of the bond at the glue layer. The canvas shrank, and the paint cleaved from the canvas. (Photo by Matteo Rossi Doria)

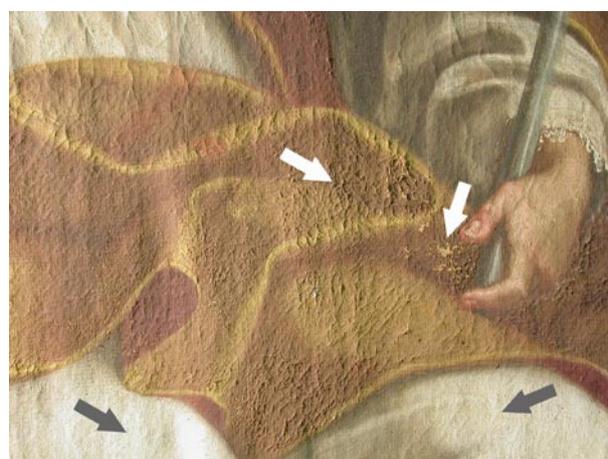
Figure 15. A detail of a painting containing both white lead paints (blue arrows) and paints made with the earth colours, ochre and sienna (red arrows). This painting was damaged by wet walls. (Photo by Matteo Rossi Doria).

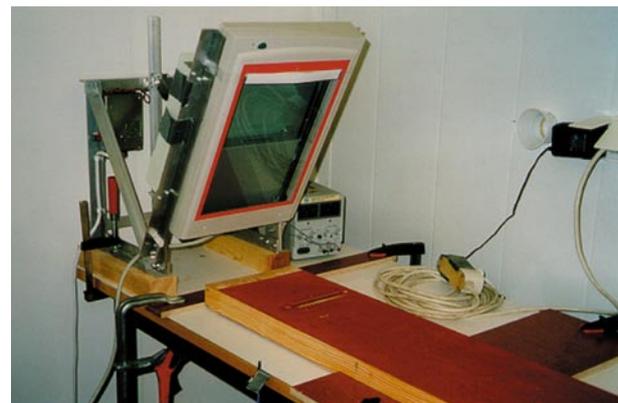
Figure 2. The picture shows the set-up of the climate room with the test piece lying on the workbench. The measurement scale can be seen as a light stripe in the upper part of the plank. The scanner has been moved to the side of the test piece. Photo: Tom-Nils Nilssen

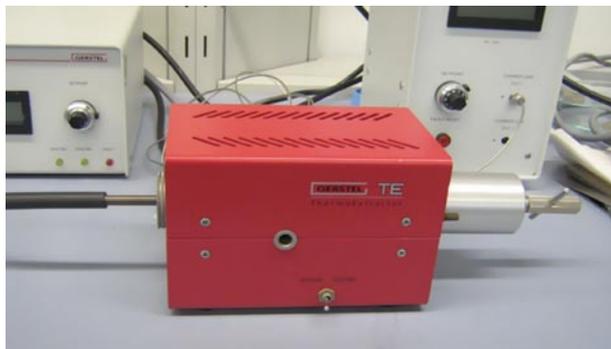
Figure 1a. Thermal Extractor TE2

In close cooperation with manufacturers of furnishings and equipments for museums, products of the following material classes were chosen as representative for screening emission analysis: 1) lacquers/coatings, 2) adhesives/sealants, 3) wood-based products, 4) other construction materials (e.g. aluminium board, ceramic and plastic plates) and 5) textiles. A screening of organic vapour emissions was accomplished using thermal extraction

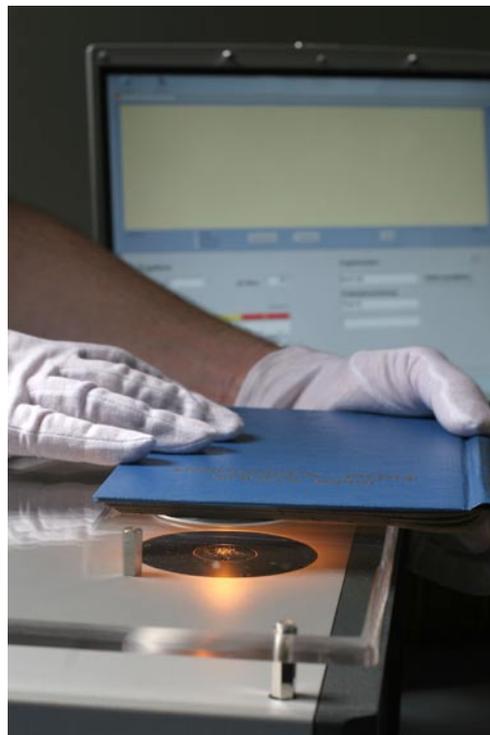
Figure 2. The SurveNIR instrument for non-destructive evaluation of paper chemical and mechanical properties based on chemometric evaluation of NIR spectra.

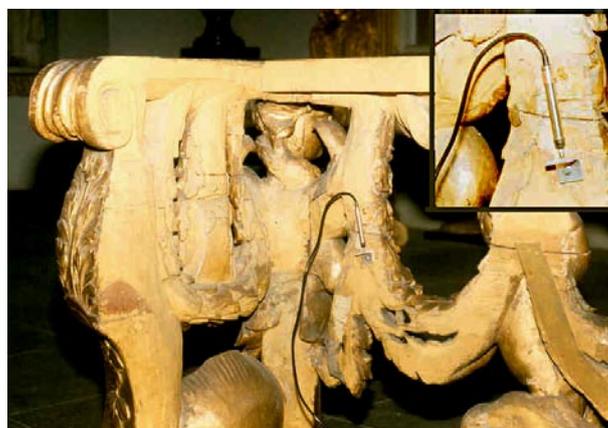
Figure 1. Transducer attached to rear of table

about the size and shape of a ball-point pen. The body of the sensor was held by an  $\Omega$ -shaped bracket on one side of the crack, while the movable ball end bore against an L-shaped stop on the other side of the crack (Fig. 1). This arrangement allowed opening and closing of the crack, and expansion and contraction of the wood to be measured.

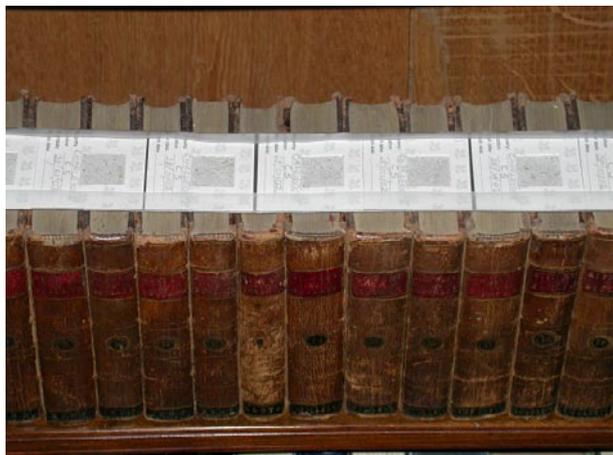
Figure 2. Close-up showing five of twelve sticky samplers attached to slide mounts and inserted in a bearer strip on a library bookshelf. Every three months one dusty sampler was removed and stored in a rigid case until the end of the three-year monitoring project.

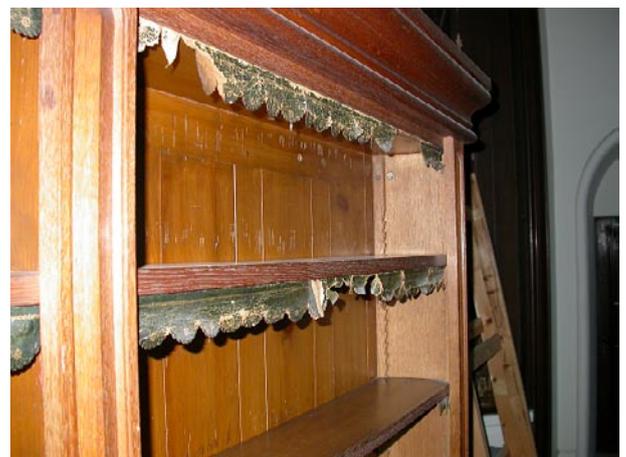
Figure 8. Damaged dust falls at Penrhyn Castle (National Trust), demonstrate the extent of cumulative abrasion that occurs between book spine and dust fall when books are removed from and returned to the shelves.

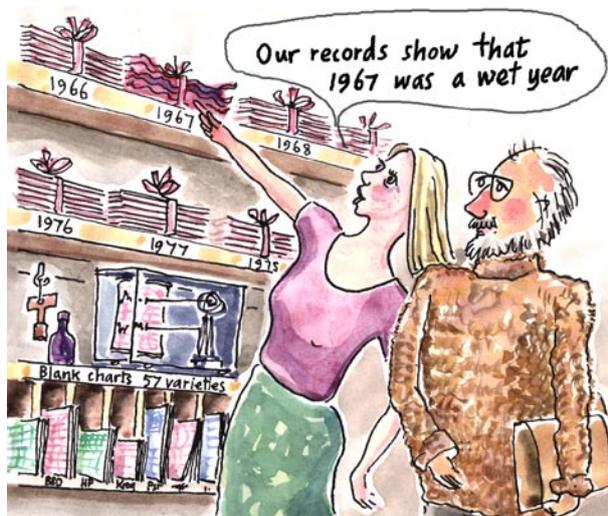
Figure 1. The human readability of analog records produced by thermohygrographs gives many advantages. For quality control, rather than research, the thermohygrograph still has a role to play in museums.

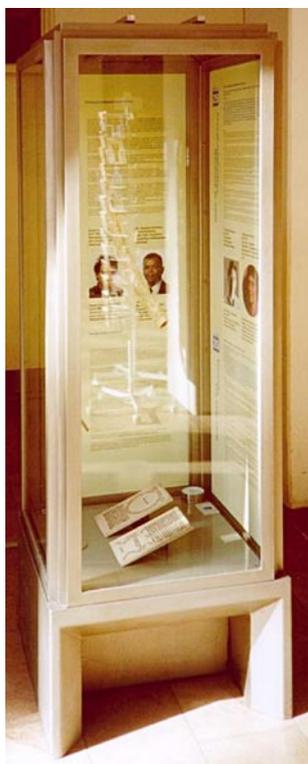
Figure 3. A carved ivory tusk from Africa, almost invisible in the glare of the sunlight warming its showcase. The room temperature and RH were acceptable but a datalogger within the case registered an extreme local climate (figure 4)

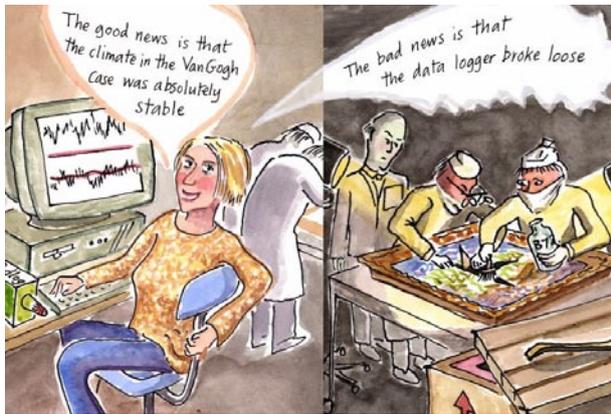
Figure 5. Estimation of proofed exposure to climate requires the datalogger to be always close to the object it is monitoring. This is particularly true in transport cases, where the climate recorder must be at the same temperature as the object to report true values of the RH at the object.

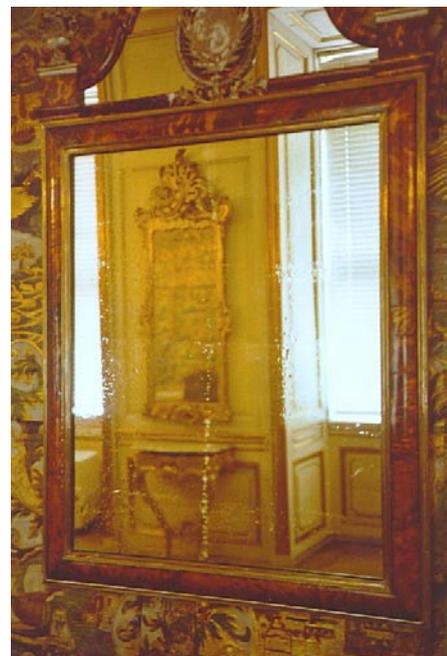
Figure 6. A silver mirror damaged by exposure to  $-30^{\circ}\text{C}$ . Physical damage is difficult to see on less optically perfect objects. The record of the appearance of an object before cooling is seldom detailed enough to convince that no change has occurred.

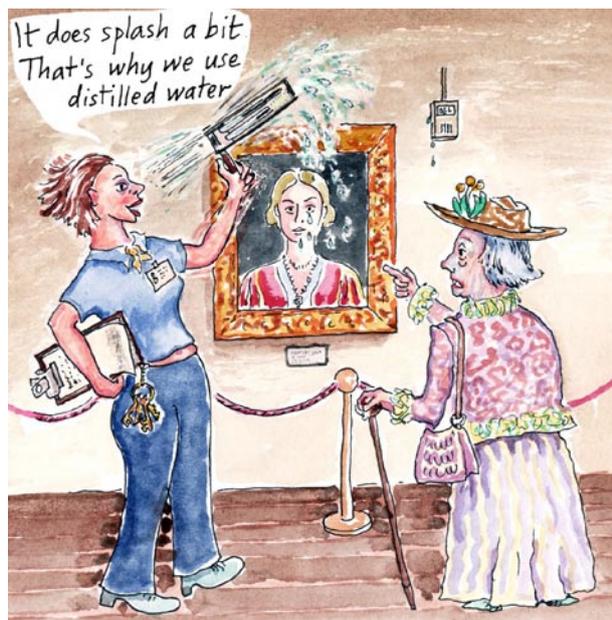
Figure 9. The psychrometer is suitable for in situ calibration, if the wick is free of film forming chemicals and radiant heating of the wet sensor is prevented. There are also transportable dew point sensors, which don't need wetting.

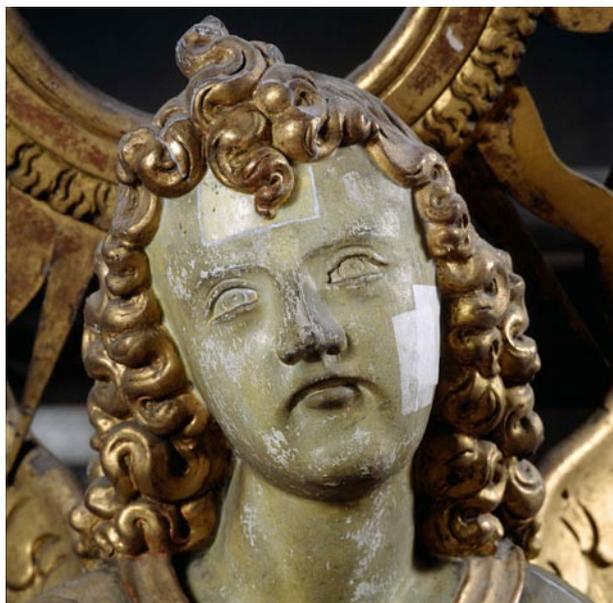
Figure 2. Detail of the altarpiece in Sct. Olai Church in Helsingør. The paint has cracked and partly delaminated due to variations in relative humidity caused by constant heating. Photo by Roberto Fortuna, the National Museum of Denmark.

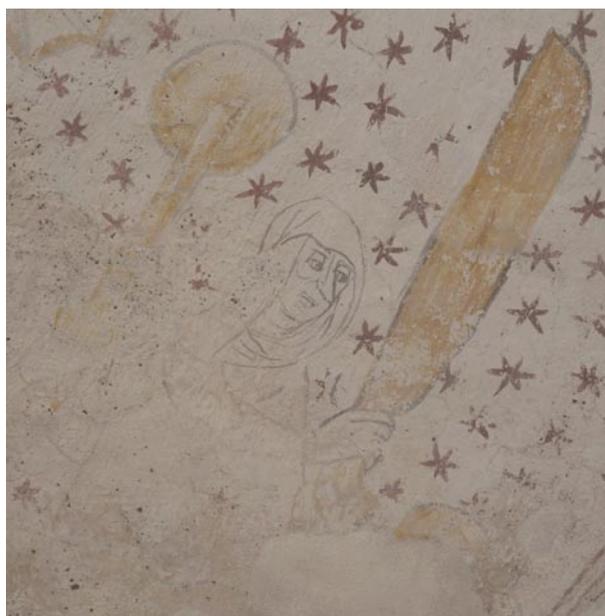
Figure 3. Detail of the wall paintings in Rorby church near Kalundborg. The paintings deteriorated by the precipitation of salts due to diurnal fluctuations in the relative humidity caused by intermittent heating. Photo by Roberto Fortuna, the National Museum of Denmark.

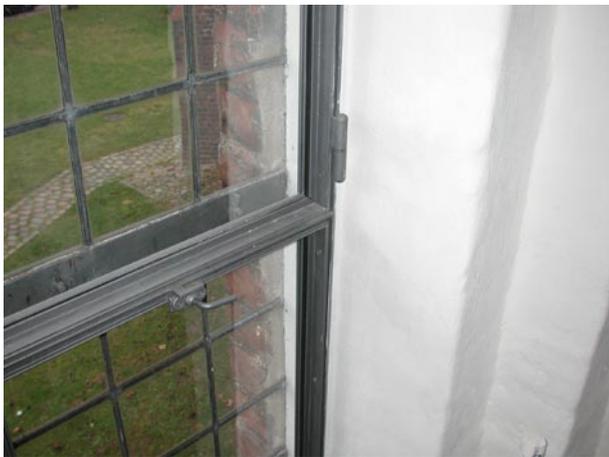
Figure 5. Detail of the windows in Sct. Olai church. The framing for the double glazing was custom designed to fit the original leaded windows. Photo by Poul Klens Larsen

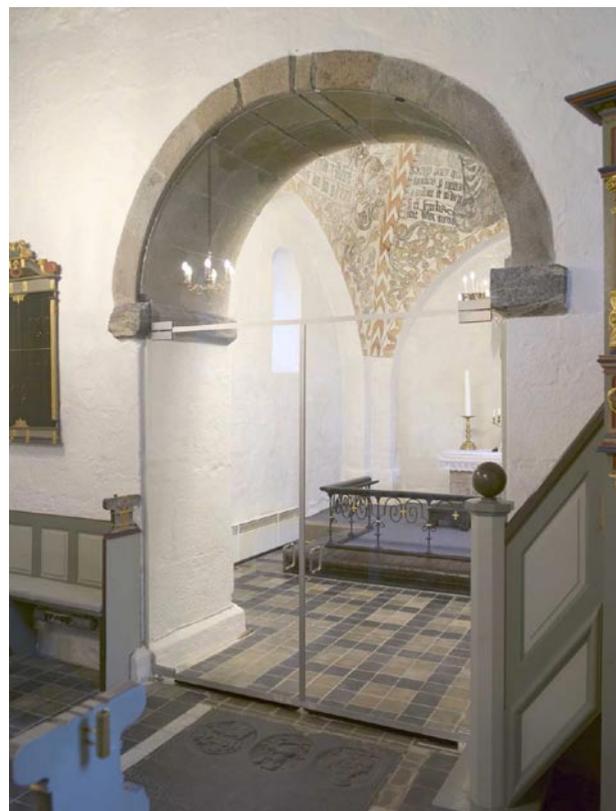
Figure 8. View through the glass door in the chancel arch in Dybe church. The lime painting in the vault is visible in the chancel. The heating elements on the wall below the vault are controlled by a hygrostat to keep the RH at 70-80% all year. Photo by Roberto Fortuna, the National Museum of Denmark.

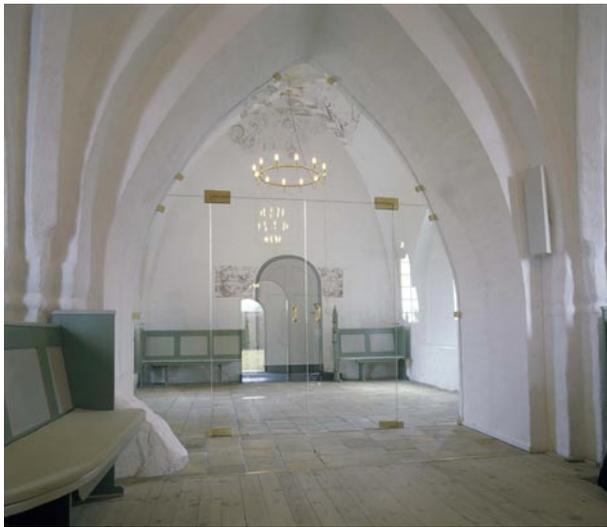
Figure 9. View through the transparent wall into the chapel in Ølsemagle church. Fragments of the wall paintings are visible on the wall and in the vault. The chancel is unheated, so a cool and humid climate is maintained all year, except for special occasions when the glass door is opened. Photo by Roberto Fortuna, the National Museum of Denmark.

It was decided to restore the paintings and prevent further decay by climate control. A glass door was installed to separate the chancel from the nave. The door would remain closed at all times, except for the services, when it was opened for one hour. The climate in the chancel was regulated with the help of a hygostat, turning on a little heat to keep the RH in the range 70% - 80%. One should be aware that the RH measured inside the chancel is not the same as the climate at the surface of the vault. In winter the RH is higher at the surface because the temperature is slightly lower, but in summer the RH is a little lower because the attic is heated by sun radiation. But the RH is still much more stable than in the nave, which is heated at irregular intervals over the winter. This simple installation has now worked for 3 years and no damage has been observed.

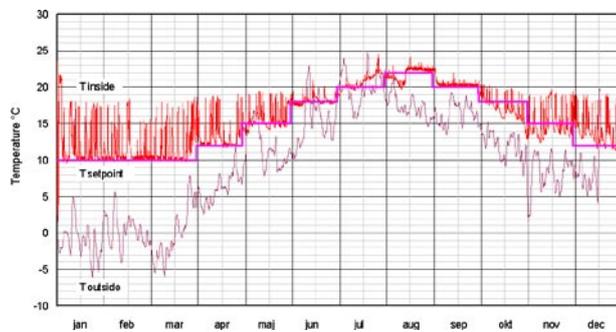
Figure 13. Climate records from Ollerup church, located on Fyn. The temperature is adjusted stepwise to a new set point for each month. The church is heated to 18°C for services.

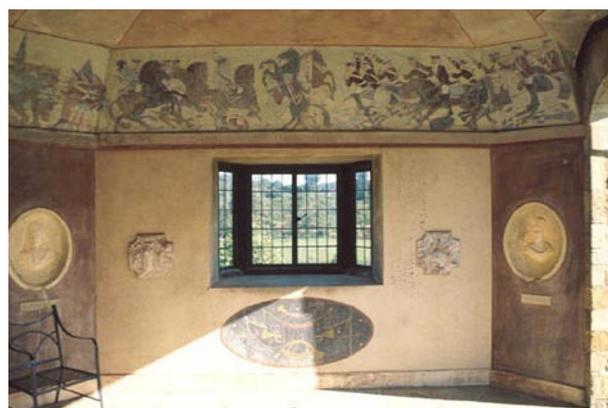
Figure 2. View of the Pavilion's interior before treatment

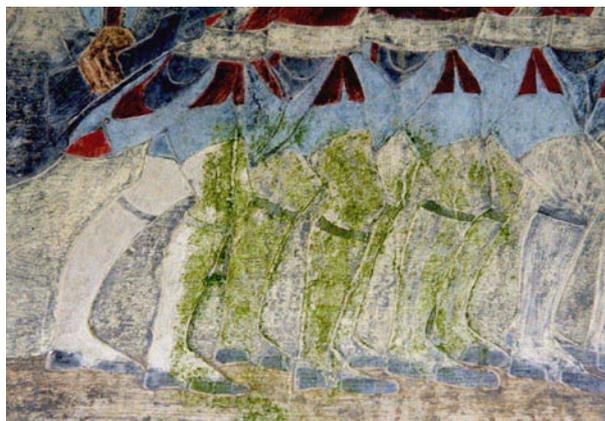
Figure 3. Detail of microbiological growth on the slate frieze

Deterioration of the paint layer was found to be widespread, with considerable delamination and flaking as well as extensive microbiological growth, mostly evenly distributed over large areas. ( figure 3) The nature and distribution of the deterioration indicated that while significant areas of damage were associated with microclimatic factors, including air movement and the building's thermal as well as hygral properties, some areas of damage were more likely to be caused by liquid water ingress.

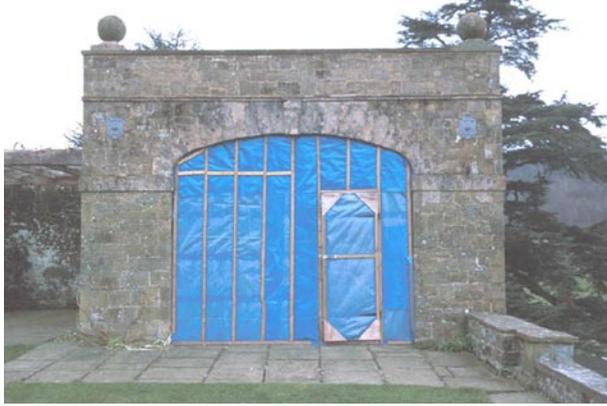
Figure 8. External view of the Pavilion with the initial plastic-covered enclosure

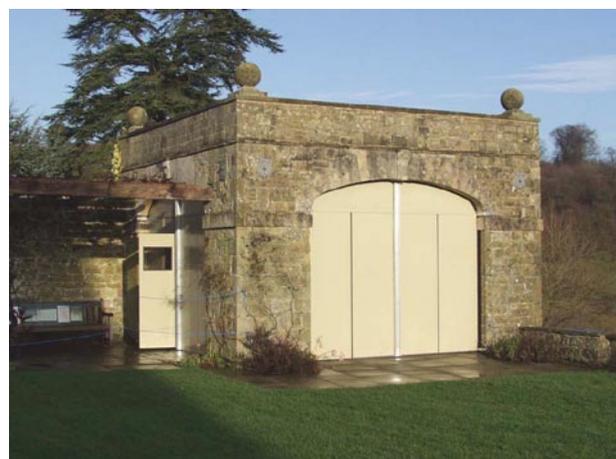
Figure 11. Detail of the construction of the enclosure

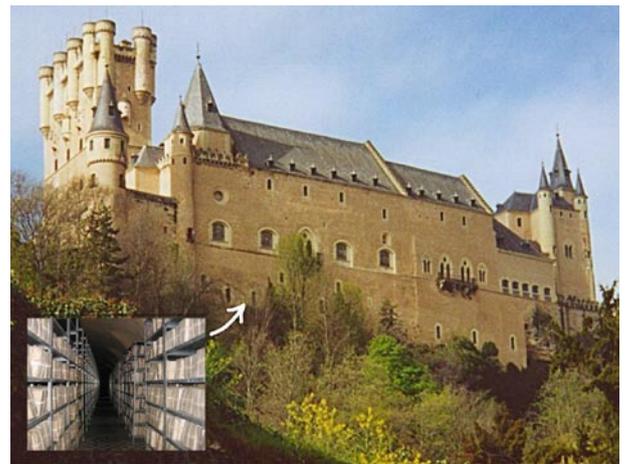
Figure 2. North facade of the Alcazar of Segovia, Spain. The narrow windows just visible over the shrubbery illuminate the military archive. The insert, bottom left, shows the interior of the archive.

An example of an almost natural archive climate is the military archive of the fortress (Alcazar) of Segovia in Spain (figure 2). The archive is in the basement

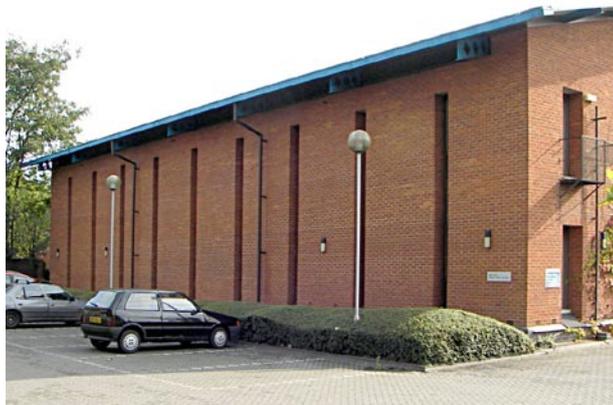
Figure 4. The Suffolk Record Office, Ipswich UK. The walls are 630mm thick, half of which is brick. It was built in 1990. The architect was Henk Piekma.

In temperate climates, heating will reduce the RH without significantly increasing the rate of degradation of the collection. This is known as conservation heating. If the room is also heavily buffered against RH change, summer heating can be avoided. The room will cruise through the summer period with a constant RH, far from water vapour equilibrium with the outside air. A good example of this approach is the Suffolk Record Office in Ipswich, UK (figure 4). The two storey building has narrow recessed windows. The wall is faced with 112 mm brick, then there is a ventilated cavity. Inside this is 110 mm of insulating block, then a second, unventilated cavity, then 300 mm of brick and a coat of 13 mm plaster on the inside. The attic space is ventilated. The building

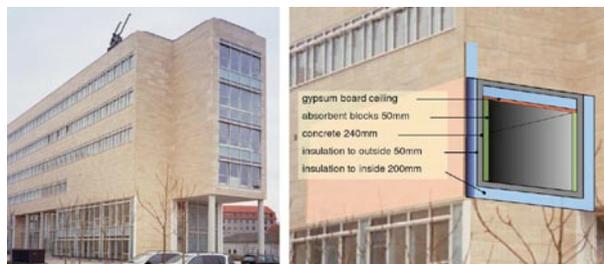
Figure 6. The building of Copenhagen University which houses the Arnamagnæan archive behind the windowless section of facade. On the right is a section through the archive. Note the thermal insulation against the interior of the building and the comparatively thin insulation of the outer wall. As a consequence, the archive temperature lies about midway between the outside temperature and the temperature of the core of the building.

In the Arnamagnæan archive of Copenhagen University, Denmark [3], shown in figure 6, the temperature is raised pseudo-passively, by leaking heat in from the adjacent corridors and rooms, which are maintained at a temperature for human comfort. The winter temperature outside is allowed to influence the archive temperature through thin insulation on the two outside walls, with thicker insulation on the walls towards the interior. A

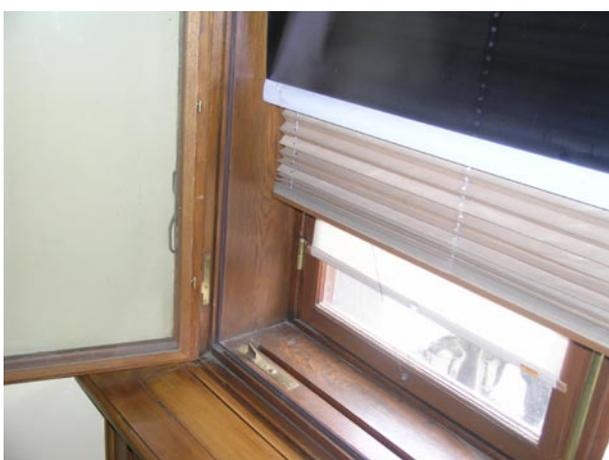
Figure 2. Sun protection measures in the windows of the Collection of Antique Musical Instruments.

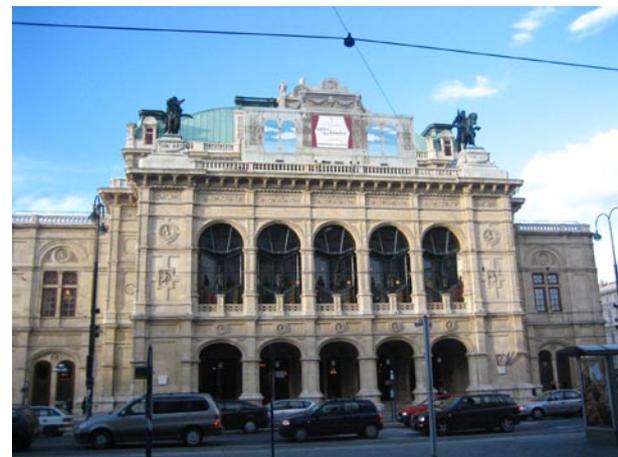
Figure 13. During winter, the arches of the loggia of the Wiener Staatsoper are closed by a movable glass construction.

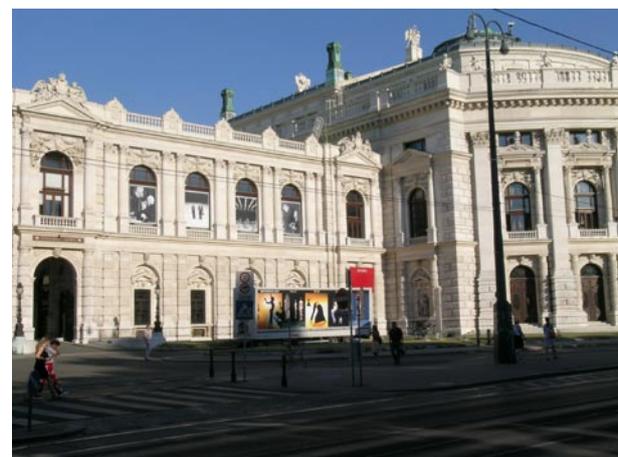
Figure 14. Eight windows of the main facade of the Wiener Burgtheater are covered up with big photographs of actors.

2) Eight windows of the main façade of the Burgtheater are covered up with big photographs of actors (serving as an optimal sun protection for the stair-case and gallery, fig. 14).

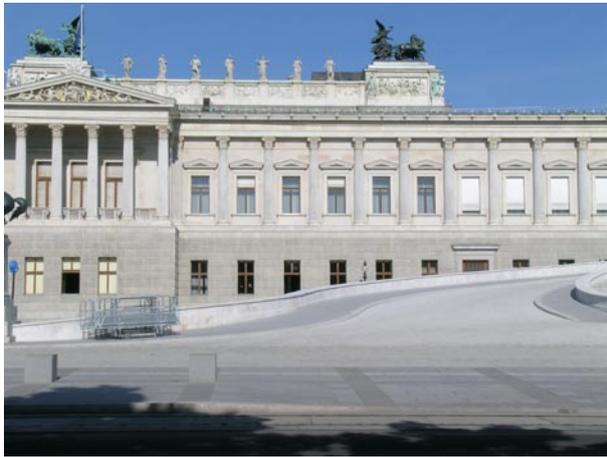
Figure 15. Twenty-six windows of the main facade of the Parliament are supplied with outer shading by means of plastic roller jalousies.

3) Twenty-six windows of the main façade of the Parliament are supplied with outer shading by means of plastic roller jalousies to protect our representatives from over-heating (fig. 15).

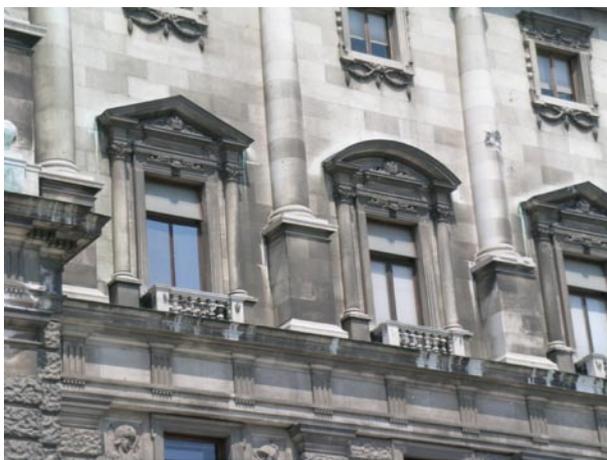
Figure 16. Prototype of the optimized outer shading (left) next to the situation since 1991 (middle) and a PC-pane without coating but with an expanded metal blind behind it, mounted in a frame in front of the window (right).

In comparison with these examples, the proposal for the SAM looks very inconspicuous: Fig. 16 and 17 show the prototype of the optimized outer shading (left) next to the situation since 1991 (middle) and a PC-pane without coating but with an expanded metal blind behind it, mounted in a frame in front of the window (right). The frame has to be fixed in a distance of c. 20mm for cooling the pane by convection. Because of the high extension-factor of PC (0,07mm/°C/m) the pane has to be mounted “swimming” in the frame. It is important for an “invisible” construction that the frame holding the pane has the same colour as the window frame and that the inner contour of the shading frame follows the visible dimensions of the glass pane (without the putty rabbet), so that reflecting and non-reflecting parts, seen from below, show exactly the same dimensions as the other windows of the building without outer shading.

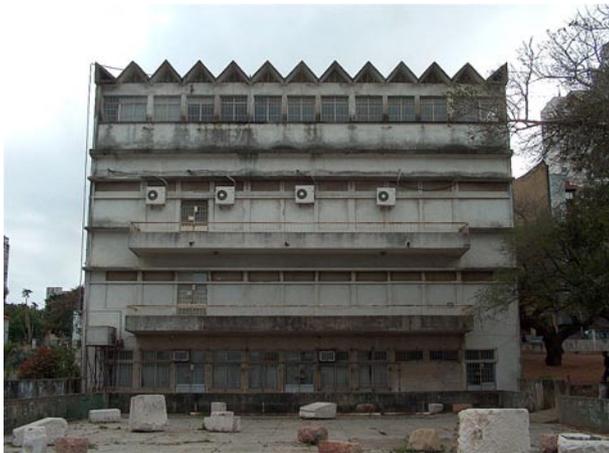
Figure 2. Rear view of the museum showing air conditioners on the first floor and dehumidifiers in the basement

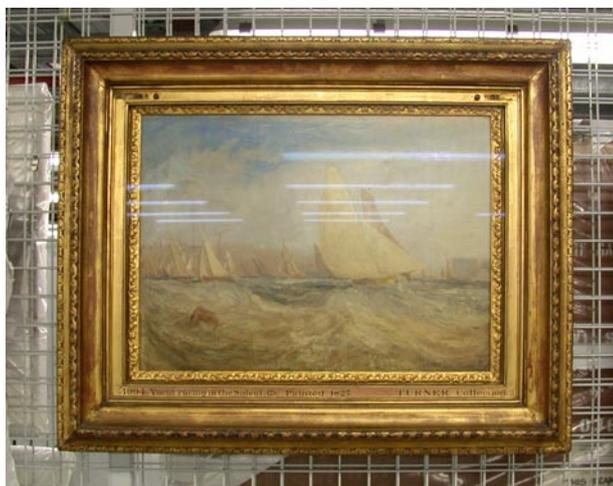
Figure 1. A nineteenth century gallery frame on a J.M.W. Turner painting (*Sketch for East Cowes Castle, the Regatta Beating to Windward, no2, 1827, Tate N01994*). The inset door allows glazing to be removed. © Tate, London 2007

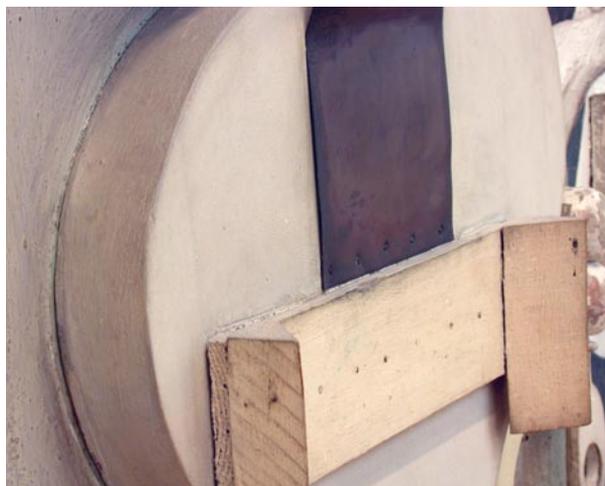
Figure 2. An unvarnished oil painted relief by Ceri Richards (*Two Females, 1937-8, Tate T00307*) which cannot be protected on display and has accumulated considerable dirt particularly on the top of horizontal surfaces. © The estate of Ceri Richards

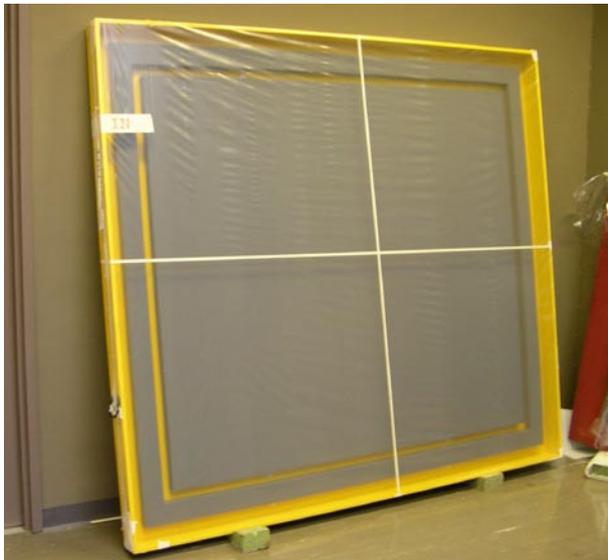
Figure 4. An unvarnished painting with a vulnerable surface protected when off display, during handling, storage and transit, by an L-section frame wrapped in polythene. The reverse is protected by a backboard either attached to the storage/transit frame or to the painting stretcher.

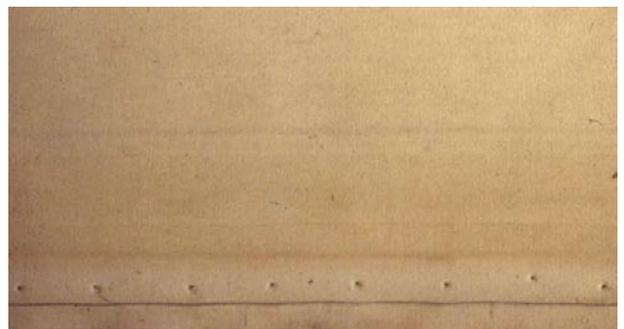
Figure 5. The reverse of a painting on cotton duck removed from its stretcher revealing brown discoloration associated with the stretcher.

An interesting example is brown staining on the reverse of a painting by Morris Louis [22]. The unpainted cotton canvas has darkened most not at the extreme edges where the canvas is in good contact with the acidic wood of the stretcher but further into the canvas plane over the chamfered front surface of the stretcher and particularly where the wooden stretcher has an open joint between two sections of wood. This indicates that material is being given off by the stretcher but its ultimate effect does not simply depend on proximity. Whether the pollutant emitted is an aldehyde or a resin acid is not known but we could speculate that the degradation product, or emission, is transported by air currents and perhaps oxidised before it reacts. The need to understand such details reliably has become urgent for planning long-term storage in microenvironments. Louis's response was to paint the front of his stretcher (fig. 5)

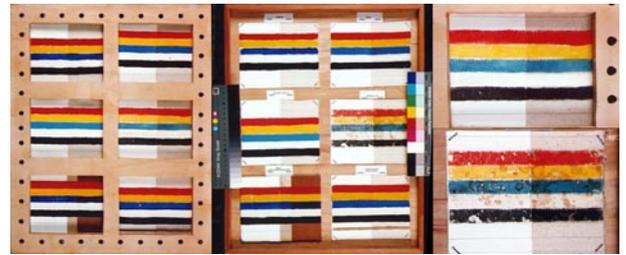
Figure 4. painting replicas exhibited with (left) and without (center) the protection of the glass box at the MAC-PE, and details (right) of the egg tempera samples protected by the glass (above) and unprotected (below).

The results showed that, in warm humid museums, a glass box, if well built, is efficient in creating a safe microclimate and protecting exhibited paintings from microbial deterioration. The glass boxes presented many advantages: 1) climatic stability due to a good sealing and a certain amount of buffering materials; 2) microbial control; 3) dust control; 4) extra protection for works on loan; and 5) UV radiation control, if UV filters is applied to the glass. The disadvantages were: 1) visual interference; and 2) its incompatibility with some conceptual works of art.

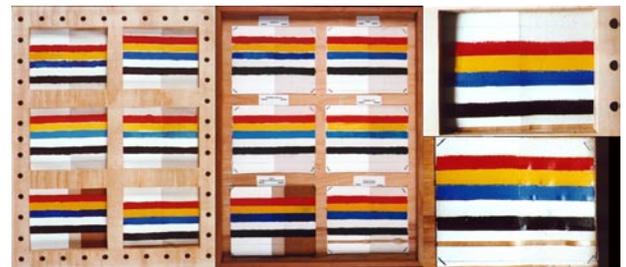
Figure 5. painting replicas exhibited with (left) and without (center) the protection of the glass at the MAC-USP, and details (right) of the mixed media - acrylic, oil and Kraft paper on canvas samples, protected by the glass box (above) and unprotected (below), showing the paper undulations.

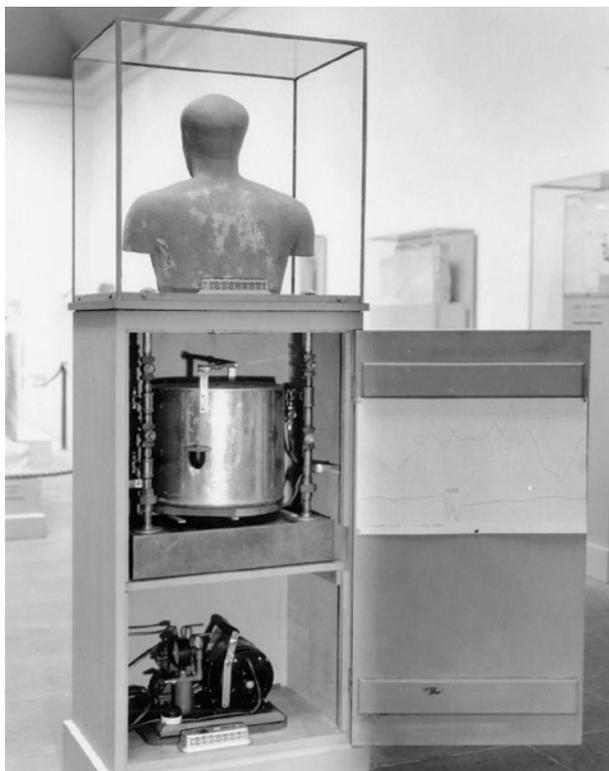
Figure 2. Electrically assisted passive humidity controlled display case, 1938

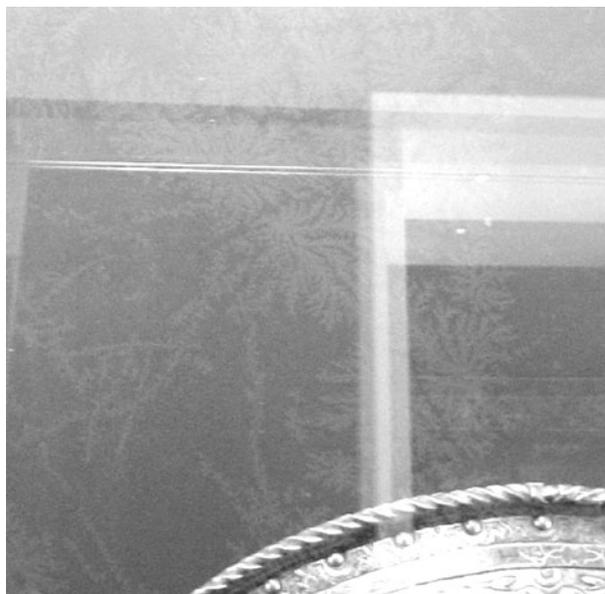
*Figure 3. Trapped pollutants create pattern on glass*

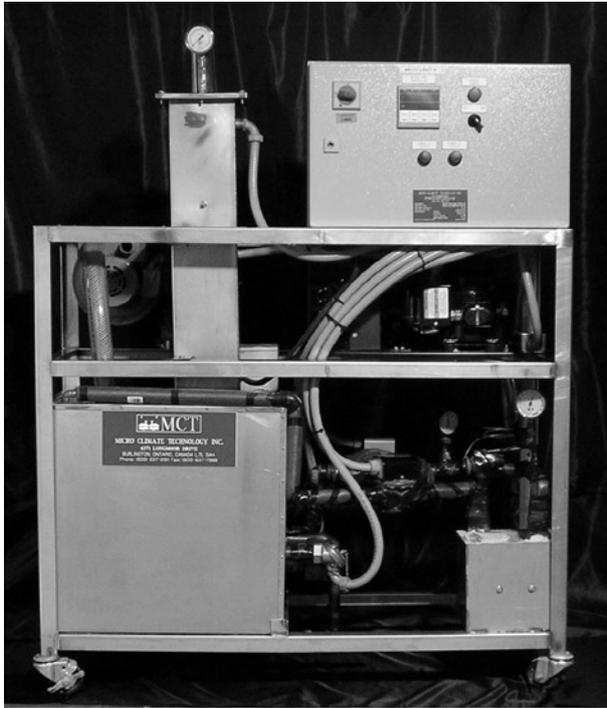
Figure 4. An early constant volume generator for positive pressure delivery, 1994

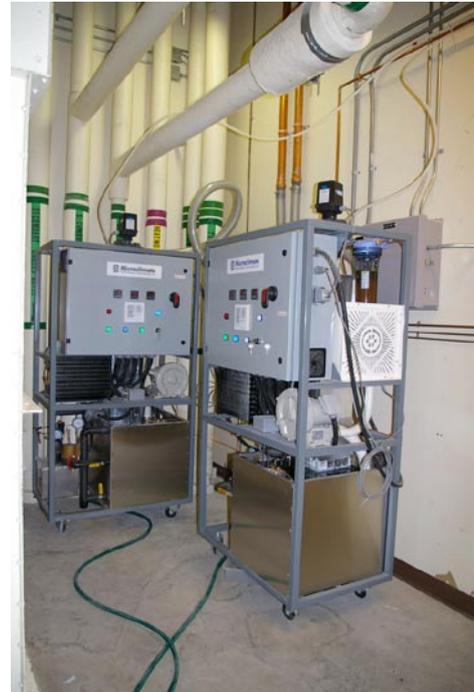
Figure 5. Two MCG 40s serving the Japan Gallery. On the closer machine can be seen the air filter (white grille), ion exchange cylinder and protective three-way valve (black unit on top of the machine)

In the latest generation of the machine, the MCG 40, a sensor located in the gallery space monitors the RH output from the machine and the ambient temperature, and allows the MCG to adjust its output to maintain a stable RH level even with fluctuating temperatures. This is an advance on the earlier

The same sensor, coupled to a three-way valve, also provides critical fail-safe protection for the artefacts in the cases. So long as the supplied RH falls within the set limits, air flows to the cases. If the RH deviates from the acceptable range, the valve rotates to block the air flow to the cases, routing it instead into a non-sensitive space such as a mechanical equipment room, until such time as the RH of the supply air is restored to acceptable levels. Thus in the event of mechanical failure of a machine, or a power interruption followed by a restart, the displays are protected from the

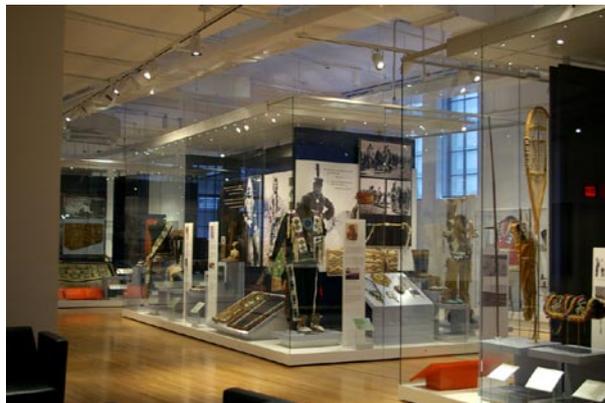
*Figure 7. Large display case in Canada's First Peoples Gallery. Some cases in the Gallery of Africa, Americas and Asia Pacific will be larger still*

size, necessitates mixing materials, and therefore imposing a compromise RH. So in the Canadian First Peoples gallery, all controlled cases are supplied with 40% RH, as a compromise between the lower value desired by the metals conservator, and the higher value desired for organic materials.

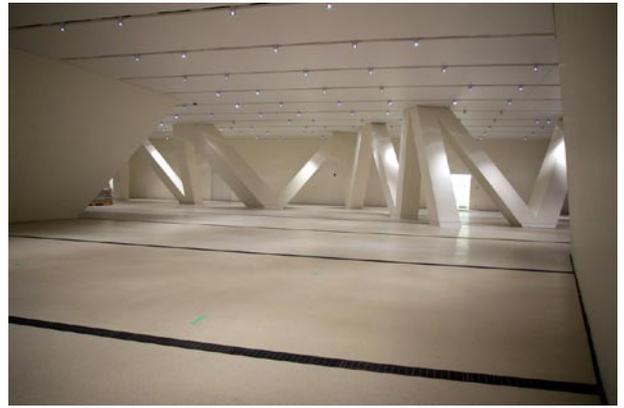
Figure 8. Garfield Weston Exhibit Hall, showing HVAC air supply grilles in the floor

runs in open cable trays above the cases, and drops down to a specially designed flow valve. In addition there are shut off valves for each case so that they can be isolated from the main run. Adjustments are easily performed. In the Crystal, all the services run below the floor, sandwiched between layers of concrete, in a space which is actually the supply air plenum for the HVAC system. A series of grids runs at 16 ft intervals across the floors to allow air into the gallery, from where it is exhausted at ceiling level. The RH control piping runs through the plenum and comes out under the grid a foot or so outside the perimeter of the display cases, to allow access to the shut-off valve, before being routed under the case to come up through the case floor into the display volume. Not only is the piping much less accessible, it will also be heated in the winter and cooled in the summer by the HVAC system.
