Real Time Corrosion Monitoring with Automated Corrosion Loggers – End-user Testing in the New Collections Centre of the Swiss National Museums

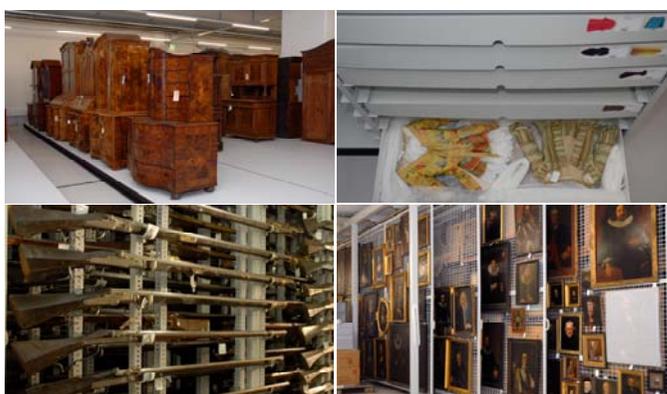
4 different storage areas.
