CASE STUDIES IN HUMIDITY BUFFERING BY POROUS WALLS

Humidity buffering in the real world

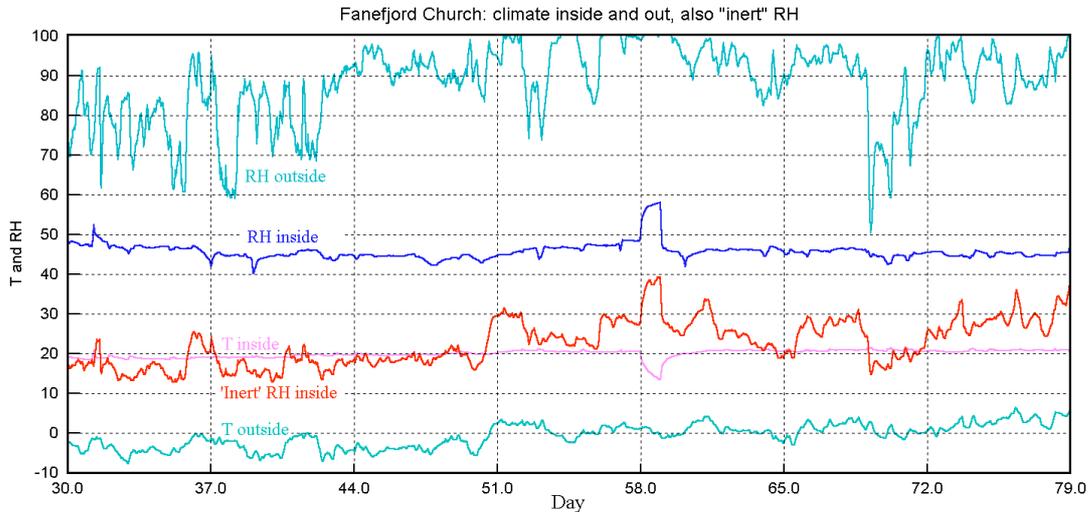
Figure 6.2 The climate inside Fanefjord Church. The red line marked 'Inert' RH is calculated from the water content of the outside air raised to the inside temperature. The measured RH is much higher. This humidification is attributed to movement of water inwards through the wall, so that the RH across the wall tends to equality, rather than the vapour pressure, as orthodox theory would suggest. Climate data from Poul Klenz Larsen.

The climate inside and outside the church is shown in figure 6.2. The inside RH is lower than that outside, as expected, because the

church is heated. The diagram also has a line showing the expected inside RH, calculated from the water content of the outside air, operated on by the inside temperature

The observed RH is higher than it should be and is remarkably stable at about 45%. There must be some source of water which humidifies the church, so that the interior water vapour concentration is higher than that outside.

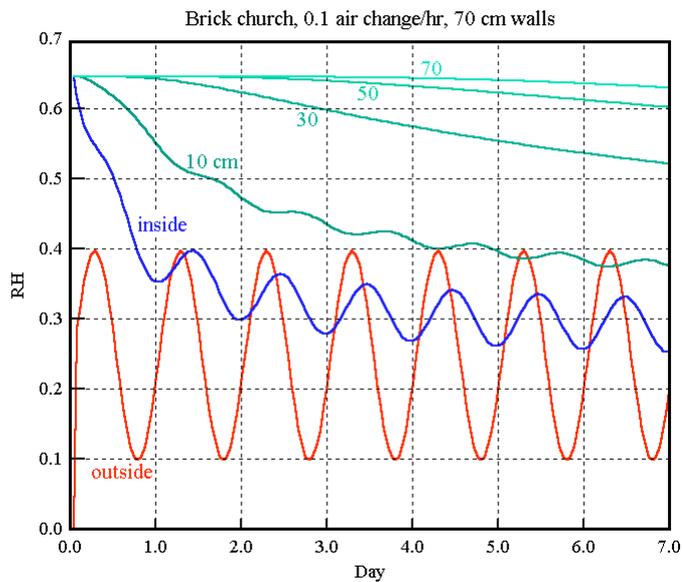
Figure 6.3 A computer model of a brick building with 0.1 air changes per hour, as measured in Fanefjord Church. The model simulates the onset of the heating season by using a very low outside RH of air at the same temperature as the church interior.

The computer model predicts that the interior RH will only be buffered by the walls over a period of about a day, with the long term adjustment to the average prevailing RH substantially complete after about a week. The observed buffering must be caused by another mechanism altogether.

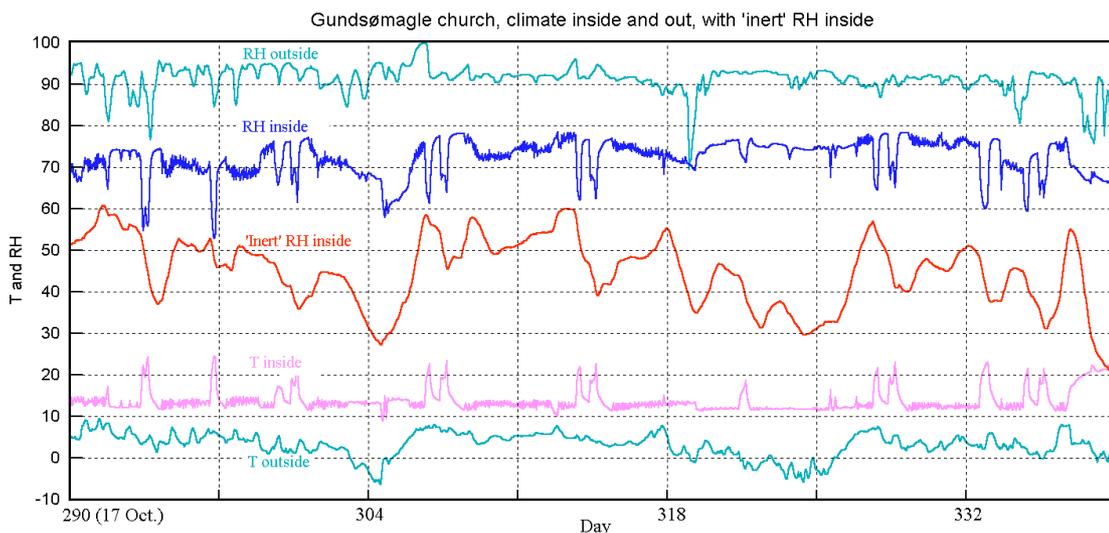
Figure 6.5 The microclimate in Gundsømagle Church, Zealand, Denmark. The curve in the middle shows the theoretical course of the RH in the church if the only source of moisture were the outside air. The curve is smoothed to take account of an air exchange rate of about 0.1 per hour.

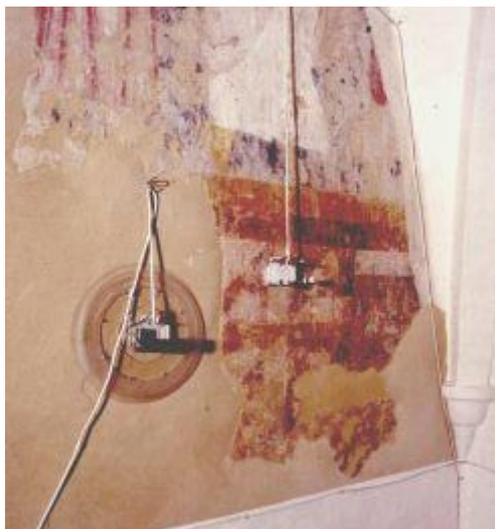
Figure 6.6 Measuring devices resting against the north wall of the choir of Gundsømagle church. The white box measures surface temperature and room temperature and RH. The circular cup measures temperature and RH in the enclosed space within 10 mm of the wall, and also measures the surface temperature.

The white box hanging from a string and resting very delicately indeed against the painting, is measuring the surface temperature of the wall and the RH and temperature of the room air. It can do both because the boundary layer, that is the transitional layer of air between wall and room, is only about 20 mm thick. The round device is a shallow acrylic cup, 200 mm in diameter, with its opening against the wall. A silicone membrane is stretched slightly around the perimeter to give an elastic seal against the irregular plaster surface. The temperature and relative humidity are measured inside the container.

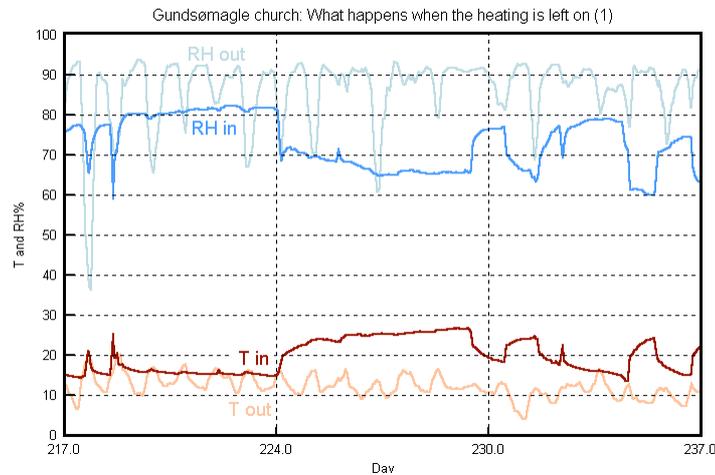
Figure 6.7 The climate during a three week period. In the middle week the heating was left on. Notice how the inside RH varies in the opposite sense to the temperature, as expected for the RH in a mass of air subjected to a varying temperature.

The series of pictures that follows builds up the interpretation of the climate step by step. The first picture shows just the measured climate in the church and outside.

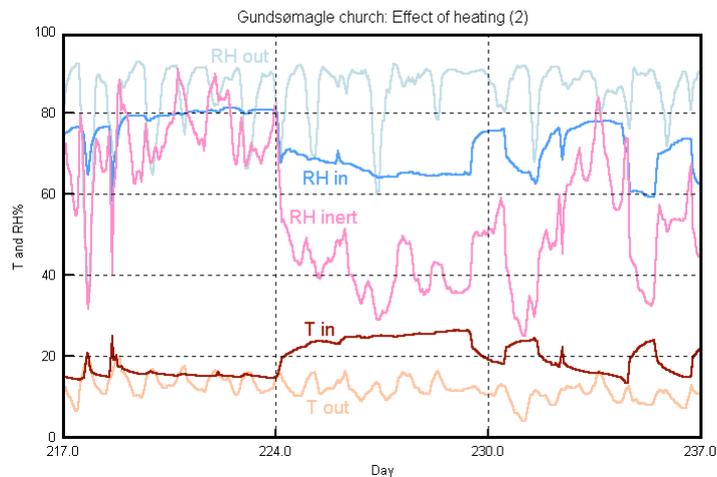
Figure 6.8 The new curve is the imaginary course of the RH calculated with the water vapour content of the outside air raised to the inside temperature. The calculated RH drop caused by heating is twice the measured drop.

The next graph adds the theoretical RH calculated from the water content of the outside air and the temperature of the inside air.

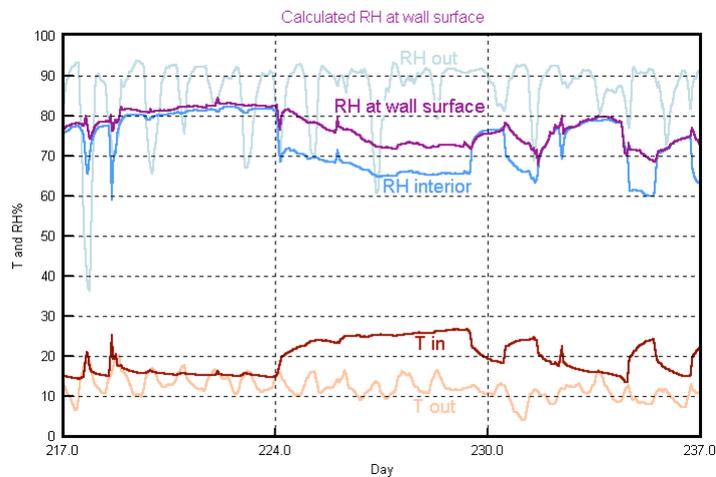
Figure 6.9 The RH calculated for the wall surface is added. This cannot be measured because the boundary layer is thin compared with the bulk of a RH sensor, which would also disturb access to the wall at the point of measurement.

One possibility is that the walls release water vapour. When the RH falls because of the sudden rise in temperature, the wall should release water into the air to compensate. The wall will only release water vapour until the RH at its surface is again in equilibrium with its water content. In the next diagram the RH at the wall surface is calculated. This is obtained by taking the temperature and RH of the air in the church and calculating the water vapour content. This water vapour content and the wall temperature are then used to calculate a wall surface RH.

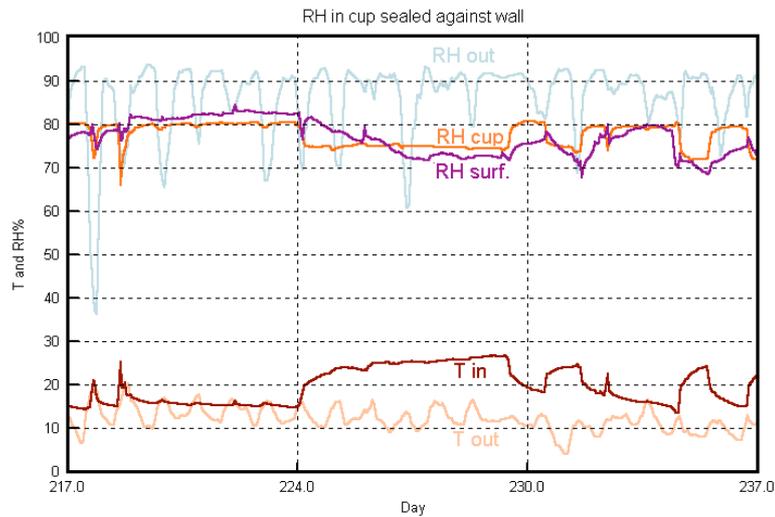
Figure 6.10 The RH within the cup sealed against the wall is shown in this diagram. In the stagnant air within the cup the RH is buffered perfectly by the wall. The small step down during the heating period is caused by the position of the RH sensor within the boundary layer.

The case for humidity buffering by the wall is reinforced by a separate experiment in which the same cup was placed against the floor. The RH in the cup did indeed rise, but at a rate so slow that the floor could not function as the main source of water.

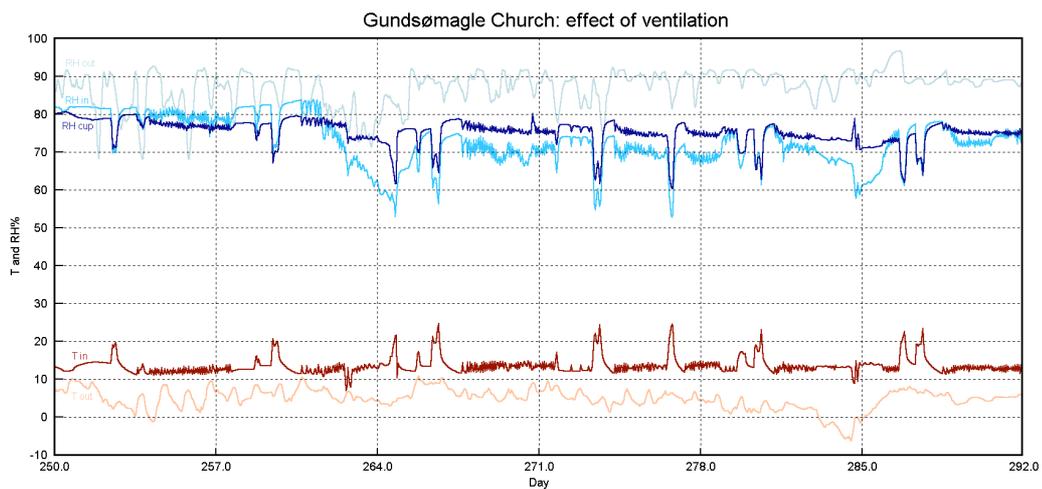
Figure 6.11 A longer extract from the climate record, showing two periods, around days 260 and 285, when the church was ventilated. The RH in the cup, the upper bold line, responds a little to the ventilation but much less than the air in the church. The church RH does not fully recover from the ventilation beginning on day 260. Recovery after day 285 is aided by a period of high outside RH.

The final graph in this series, figure 6.11, shows the climate over a longer period. The climate in the sealed cup is compared with the climate in the church. On about day 260 and again at day 285 the church was aired. The climate in the cup does show the influence of this influx of dry air, but not nearly as much as the room air.

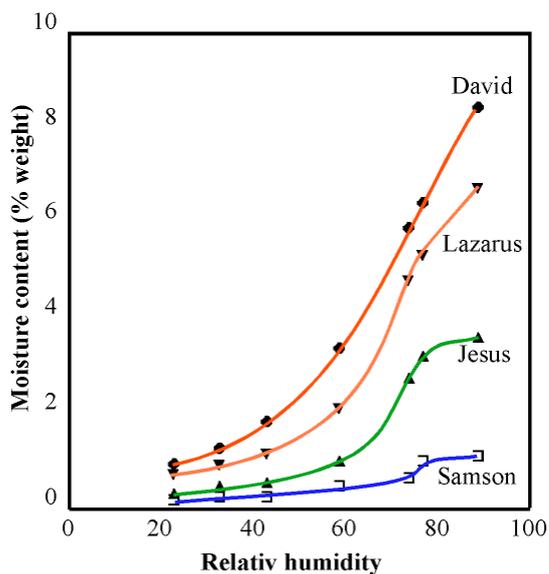
Figure 6.12 The sorption isotherm of lime mortars from Fanefjord Church (23). The samples are taken near the figures painted on the vault.

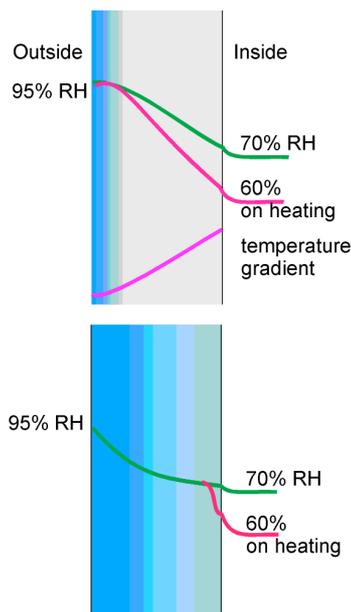
Figure 6.13 Two models for RH buffering by church walls during brief periods of heating.

In the top diagram a reservoir of capillary water just within the outside surface of the wall feeds vapour into a linear vapour pressure gradient through the scarcely absorbent pores of the wall.

The observed response to heating of the church interior can be explained in this way: at a steady state one would expect that the RH gradient would fall in a linear manner through the wall. The greater part of the thickness of the wall, which will be below 90% RH, will contain very little water compared to the outside layer. It will function as a nearly inert, porous medium which allows steady diffusion of water vapour from the reservoir in the outside surface layers. The linear gradient is established by water vapour passing into the church under the influence of the lower RH caused by heating the outside air that leaks in. When the church is suddenly heated further for a service the air falls in RH, thus steepening the gradient through the wall. The establishment of a new equilibrium is quite rapid in a porous wall with low buffer capacity.

Such a wall will have a less uniform RH through it, because the water capacity ensures a slower movement of water, controlled by the history of the weather. Such a wall has a buffer capacity at the inner surface. The moisture stress imposed by sudden heating will be taken up by the inner surface layers of the wall.

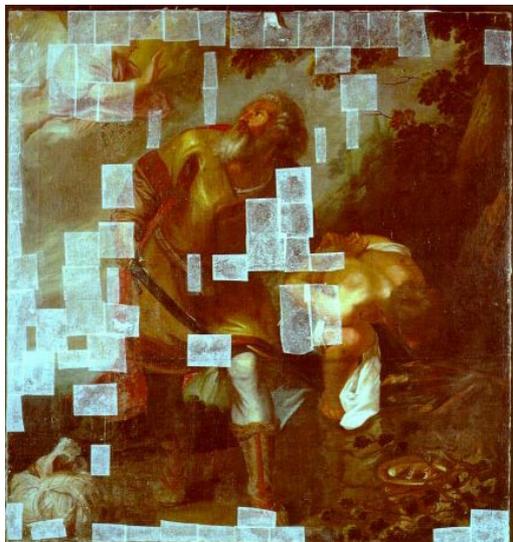
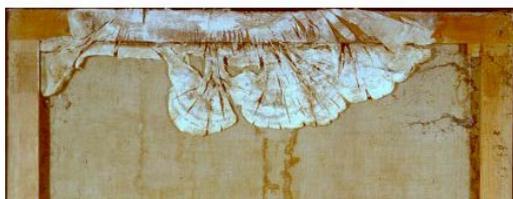
Figure 6.16 An 18th C. oil painting by Isaac Isaacsz. The white squares are temporary repairs. Below is a portion of the back of the picture showing the dried remains of the fruiting body of the Dry Rot fungus.

Conservators are generally rather anxious about the welfare of pictures that hang on the outer walls of houses. This anxiety proved reasonable, in this particular building. When the conservator took down one painting for repair a baroque addition to the original architecture was revealed: a well grown fruiting body of the dry rot fungus, *Serpula lacrimans*, clinging to the back of the canvas.

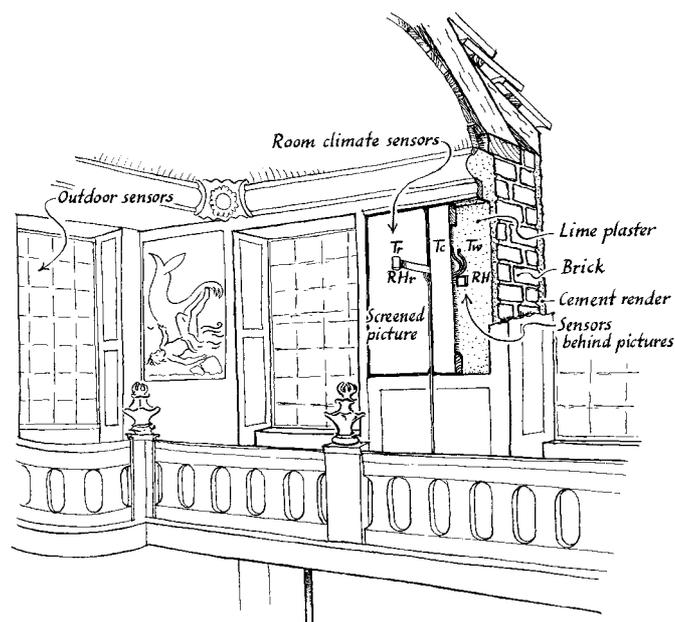
Figure 6.17 The wall structure, showing the placing of sensors to investigate the microclimate behind the painting. The sensor assembly behind the test pictures consisted of a RH sensor and thermocouple within a radiant heat shield in the middle of the space (about 40 mm) and two springy thermocouples, one touching the back of the canvas, the other touching the surface of the wall.

The two pictures were set side by side in the recess, as shown in figure 6.17. Temperature and humidity sensors were placed in front of these pictures and in the air

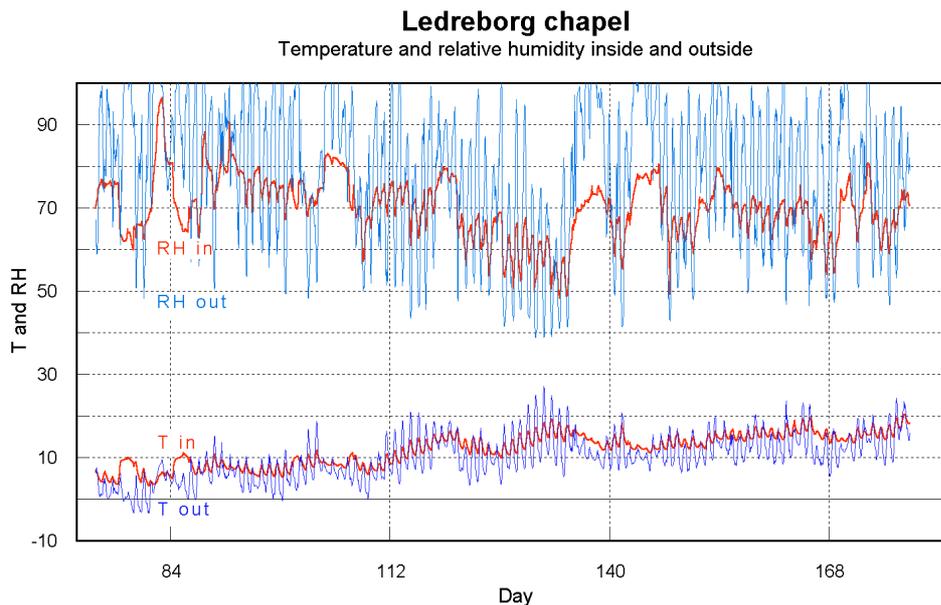
Figure 6.18 Temperature and relative humidity inside the chapel and outside. The chapel was only heated on two brief occasions at the beginning of the period.

The climate measurements are summarised in three graphs. Figure 6.18 shows the outside (dotted) and inside temperature and relative humidity (RH) for a 15 week period

starting on the 14th. March 1994. The inside relative humidity is generally a moderated version of the outside RH. The daily cycles of RH are caused mainly by the daily temperature cycle acting upon room air that is rapidly exchanging with outside air. The outer door has no lobby, the door at the balcony level is poorly fitting and the windows are not particularly airtight. The room is high and open, encouraging convective air exchange (the "stack effect").

The temperature and humidity cycling is only moderately damped out by the room. The abundant wood panelling is a fairly good thermal insulator, reducing the stabilising influence of the thermal inertia of the wall. The paint on the wood prevents moisture movement which would stabilise the relative humidity.

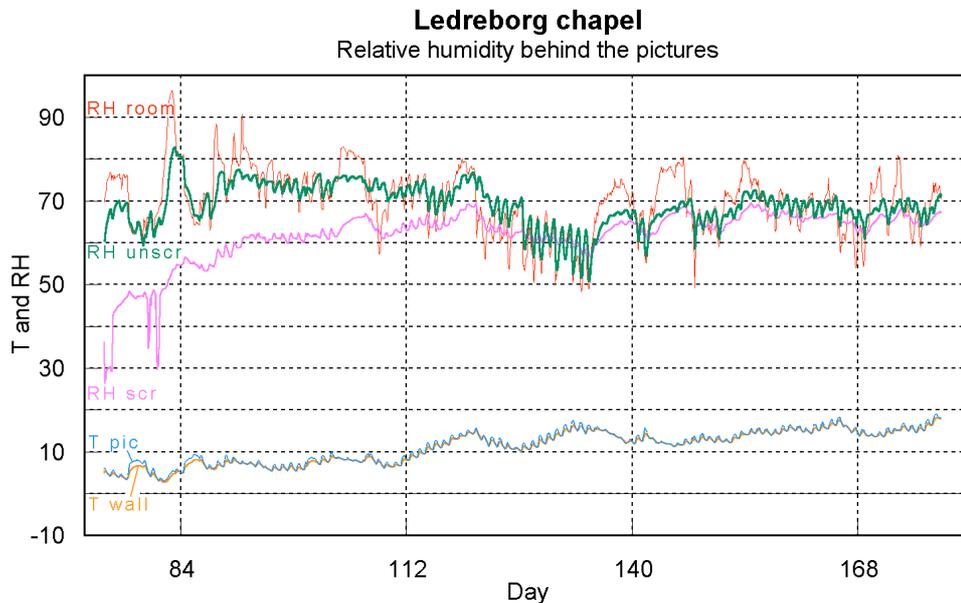
Figure 6.19 The microclimate behind the two test pictures. The protected picture comes much more slowly from the 40% RH of the painting workshop to the high RH of Ledreborg. After a few weeks, however, both paintings have much the same RH behind the canvas, within the accuracy of measurement of the sensors.

Figure 6.19 shows the microclimate around the paintings. The upper curves show the RH in the room (dotted) and at the back of each of the two experimental paintings. Both the polyester-protected canvas (the line rising from 30% RH) and the unprotected canvas (bold line) had been stored for several weeks in a room at about 40%RH. The unprotected canvas came rapidly to equilibrium close to the running average of the RH in the chapel, while the protected canvas came slowly to equilibrium with its new surroundings over a period of about two months. At the end of the measuring period the two RH traces have converged. The RH behind both canvases is more stable than that in the room.

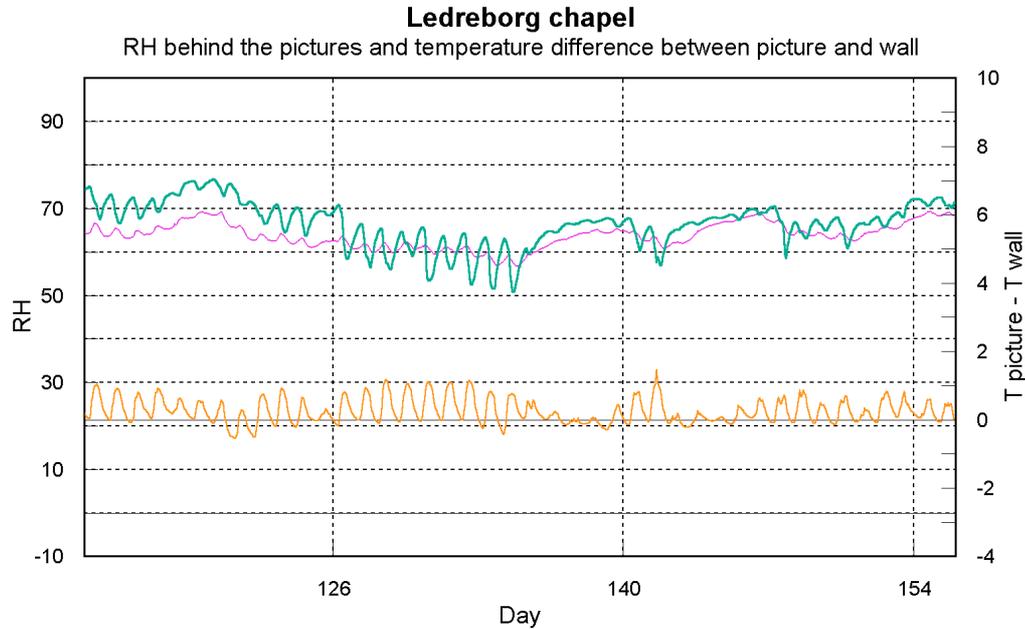
*Figure 6.20 Relative humidity in the space between the picture canvas and the wall. Notice just after day 121, for example, that the RH cycles are in opposite phase. This is the evidence for buffering by the wall behind the unscreened picture. The screened picture has small RH peaks that approximately coincide with temperature peaks at the canvas. This RH pattern is characteristic of a closed container filled with abundant buffer, in this case the canvas. The unscreened RH has larger RH peaks when the temperature difference is at a minimum. This can be attributed to buffering of RH by the wall **at the wall temperature**. This buffered air warms up to the canvas temperature with consequent fall in RH.*

These observations can be explained by assuming that the wall is controlling the RH to a constant value *at the wall surface*. This air then convects away from the wall to the back surface of the painting, keeping the exact water content it acquired when it came to equilibrium with the wall surface. Because the picture canvas is at a higher temperature than the wall, the air warms up and therefore drops in relative humidity.

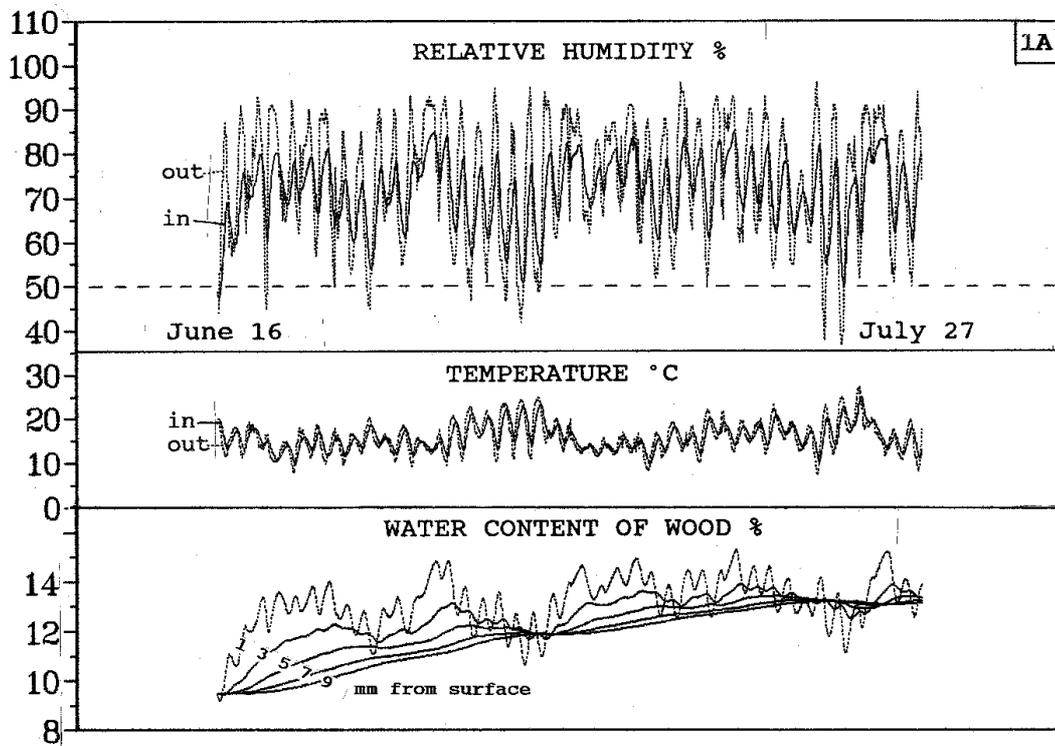
Figure 6.22 The modelled performance of the museum store with a small amount of wood. The outside climate is the dotted lines. The buffering is poor, worse than that of Ledreborg chapel shown earlier. Notice the rapidly varying water content in the surface layers of the wood: a sign of the physical stress suffered by museum objects stored in such conditions.

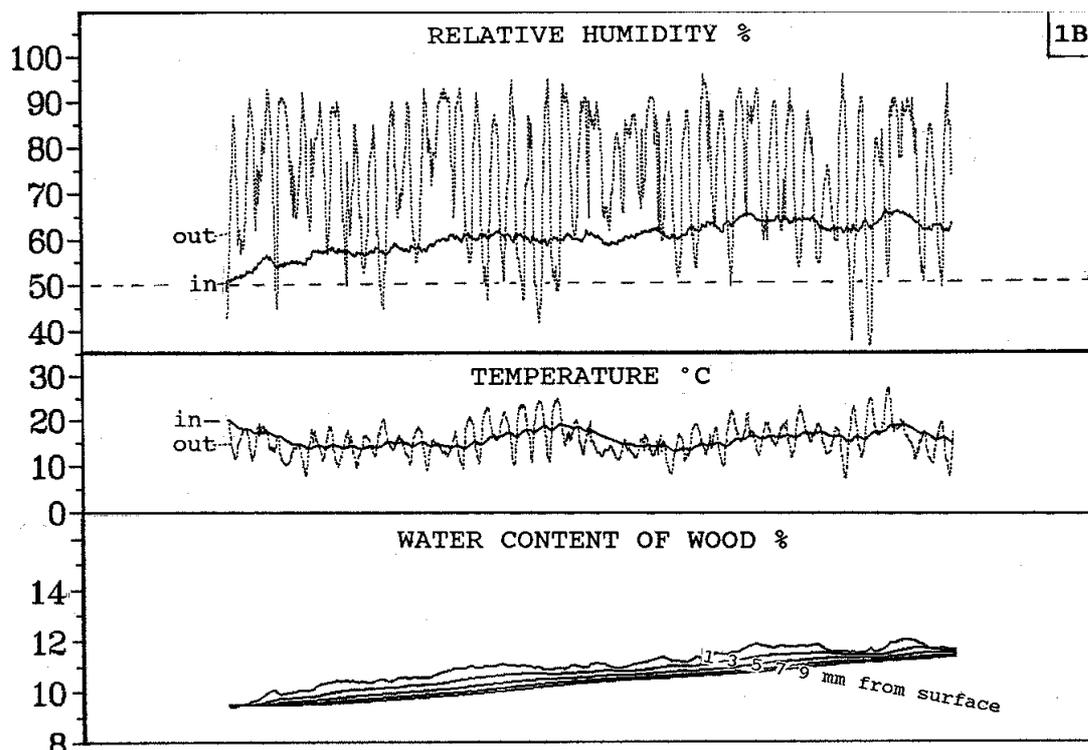
Figure 6.23 Climate buffering by an abundance of wood in a storeroom. Both RH and temperature are moderated but the room RH is slowly rising to the unacceptably high (for museum objects) average RH of the Danish climate.

When the store room is reasonably full of objects and containers, including many that are water absorbent, the humidity buffering, and also the temperature buffering are much improved.

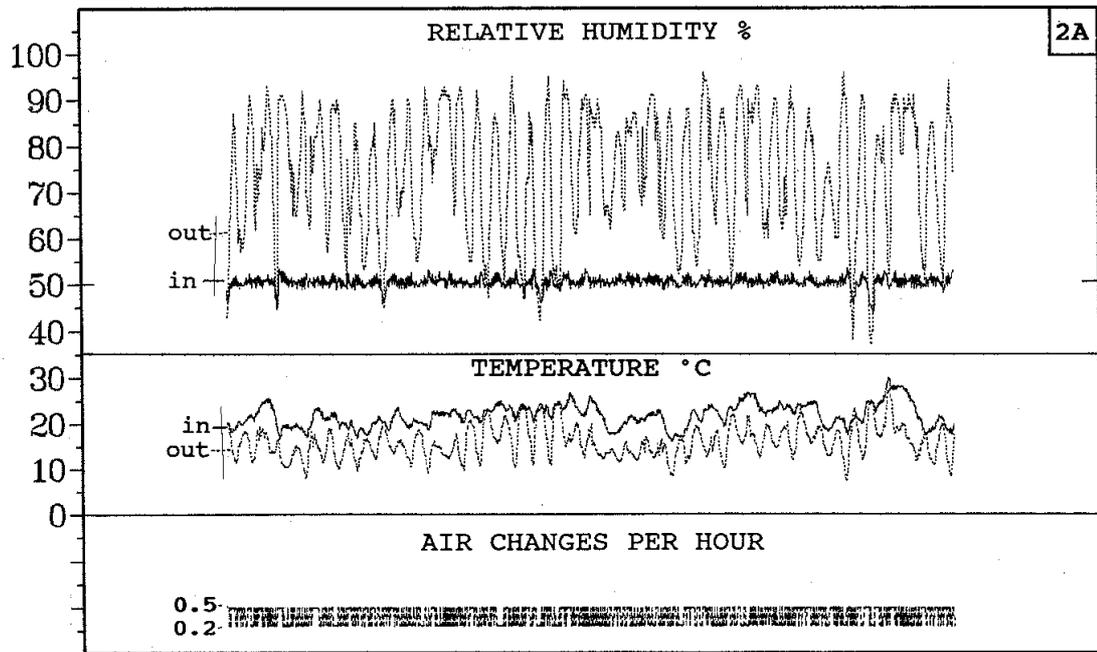
Figure 6.24 The control strategy used here is to warm the room to constant RH, using the fact that the RH of an enclosed body of air falls with rising temperature because the saturation vapour pressure increases while the actual vapour pressure remains the same. In the lightly buffered room the process works well.

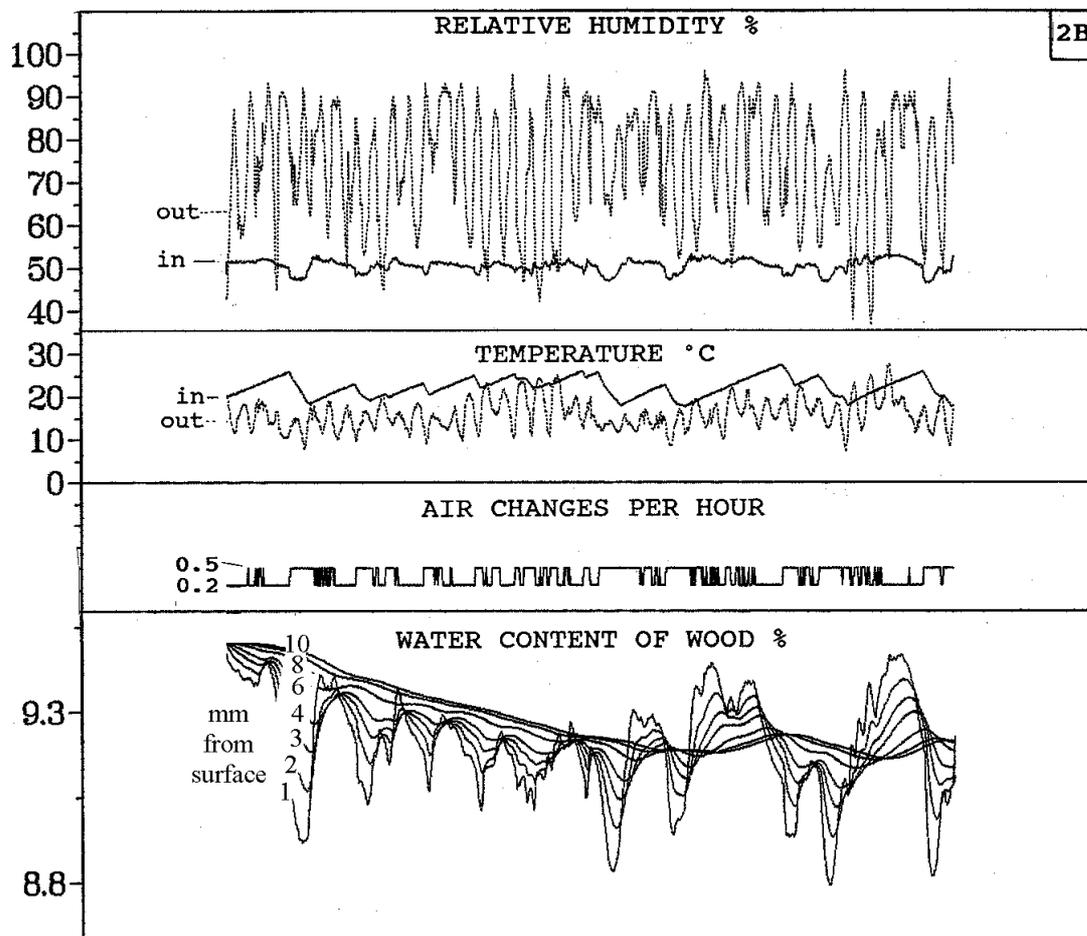
Figure 6.25 Heating to constant RH in a room full of absorbent materials. The sawtooth pattern of the temperature cycles is caused by positive feedback: a rise in RH provokes a rise in temperature, which causes a further rise in RH. The absolute water content of the air increases until the leakage of outside air with much lower water content puts a stop to the rise of the indoor water concentration. The temperature then nosedives as the fall in RH provokes a cooling response from the air conditioner.

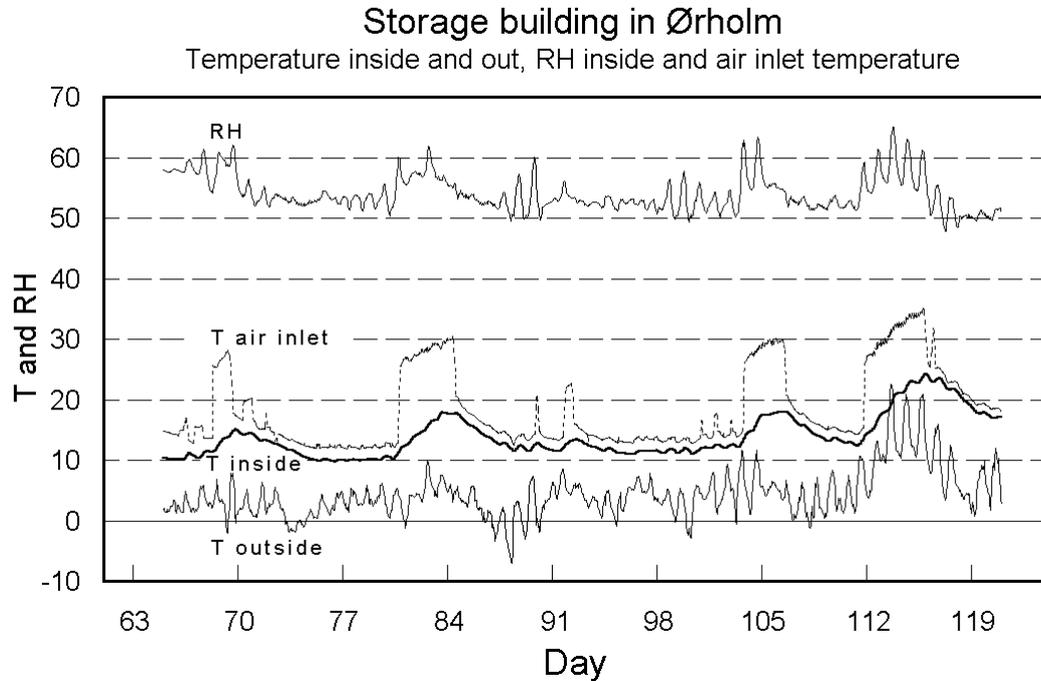
Figure 6.26 Climate data for nine weeks in the new museum storage building near Brede. Temperature oscillations are caused by positive feedback in the control system. A rising RH calls for more heating, which then causes a rise in RH because of release of water by the collected objects, supplemented by the cellular concrete walls. The dotted curve with sharp rise and fall is the temperature of air blown into the interior.

Further investigation revealed that the dehumidifier had failed. The control computer reacted to this failure by dredging up the old program which controlled the RH by heating. The real climate is a bit different from the model, but the model did not have the heating power of the real building, as shown in the sharp temperature rise of the air blown into the building (dotted line). Also, the model was capable of cooling the air by ventilation to the outside, a refinement not found in the real building.

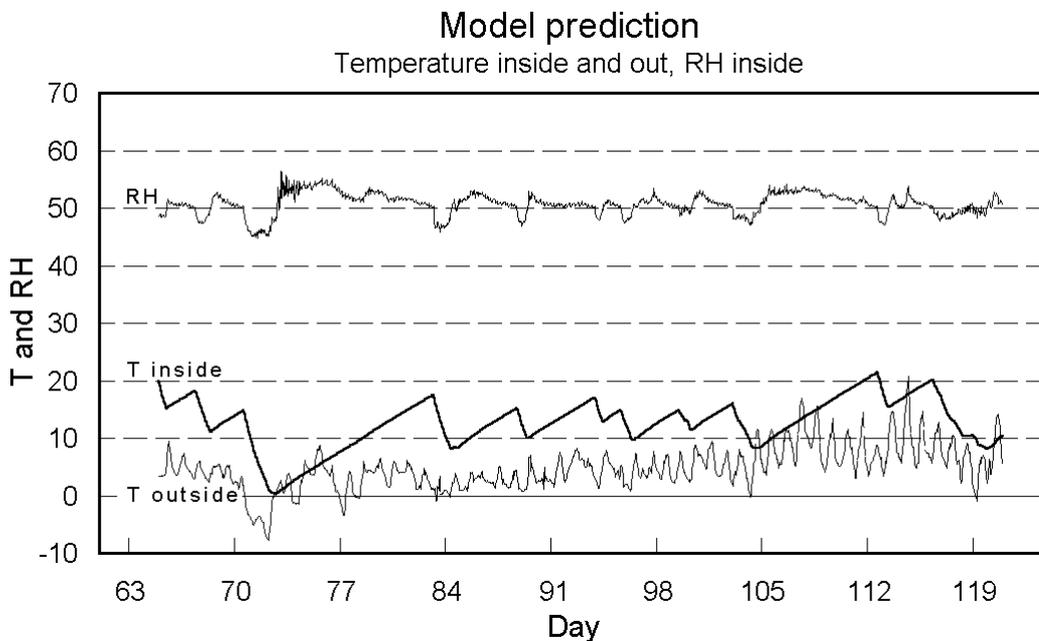
Figure 6.27 The computer model based on the outside climate for the period shown in figure 6.26. The heavy sawtooth line is the indoor temperature. The steeper decline in temperature is due to active cooling by ventilation in the model, which was not available in the real building.

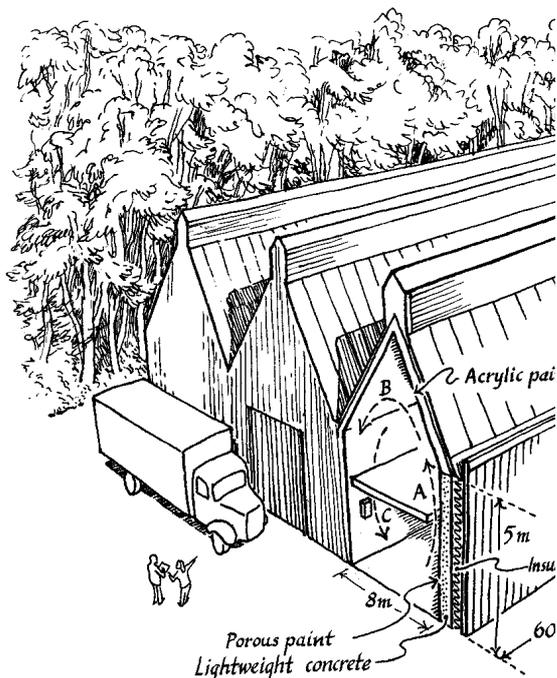
Figure 6.28 The large storage hall in Ørholm, north of Copenhagen. The climate is buffered to some extent by the cellular concrete walls, which are covered with limewash but most of the climate buffering comes from the stored objects. The mechanical air conditioning dehumidifies to achieve a reasonably constant RH.

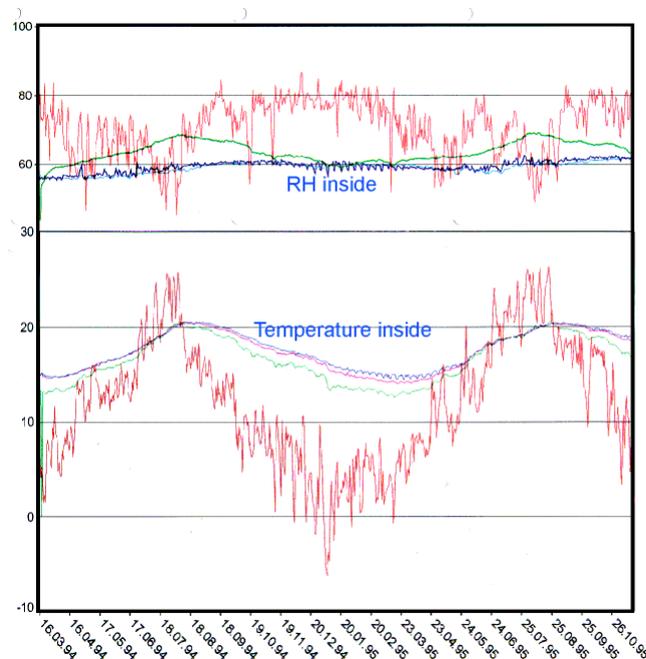
Figure 6.29 Climate in and around the State Archive of Schleswig-Holstein, in Schleswig. The massive brick building and the stored papers provide good temperature stability and very impressive RH stability. Data from Lars Christoffersen.

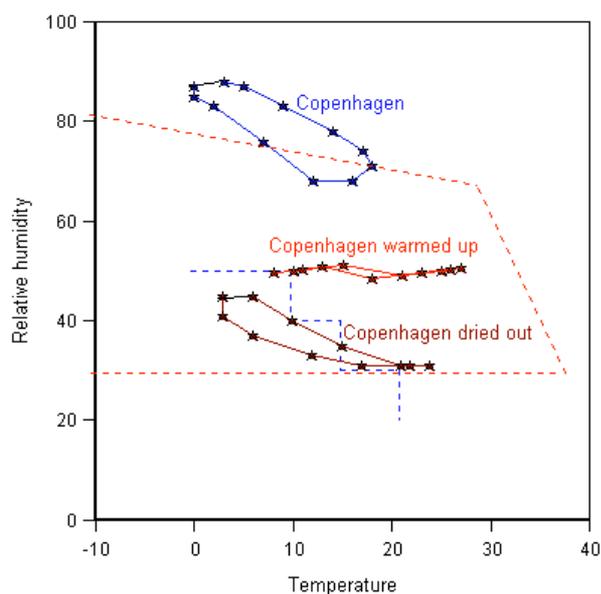
Figure 6.30 A diagram made by joining the RH and T values for each month into a ring of stars. The outdoor climate in Copenhagen, the upper constellation, is the starting point. If the air is warmed up to 50% RH the average temperature will rise, as shown by the rightward shift of the middle constellation. An alternative would be to dehumidify the air. This causes a smaller temperature rise, as shown in the lowest constellation. The zigzag line is the maximum RH and temperature allowed by the ANSI standard for storage of photographs. The large dotted trapezium encloses the area of non-destructive storage.

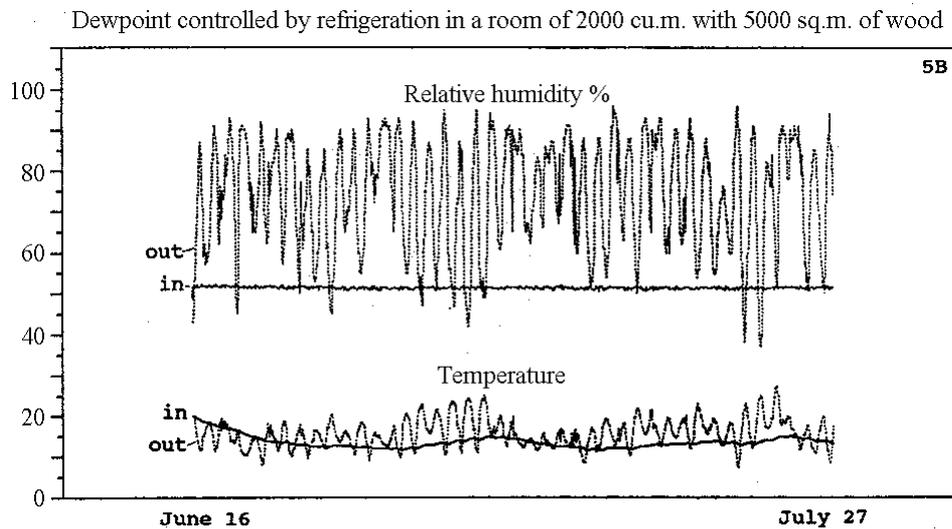
Figure 6.31 The calculated climate in a museum store dehumidified to 50% RH. The heat generated in the dehumidifier is discarded to the outside, rather than pumped into the room, as happens with a standard dehumidifier.

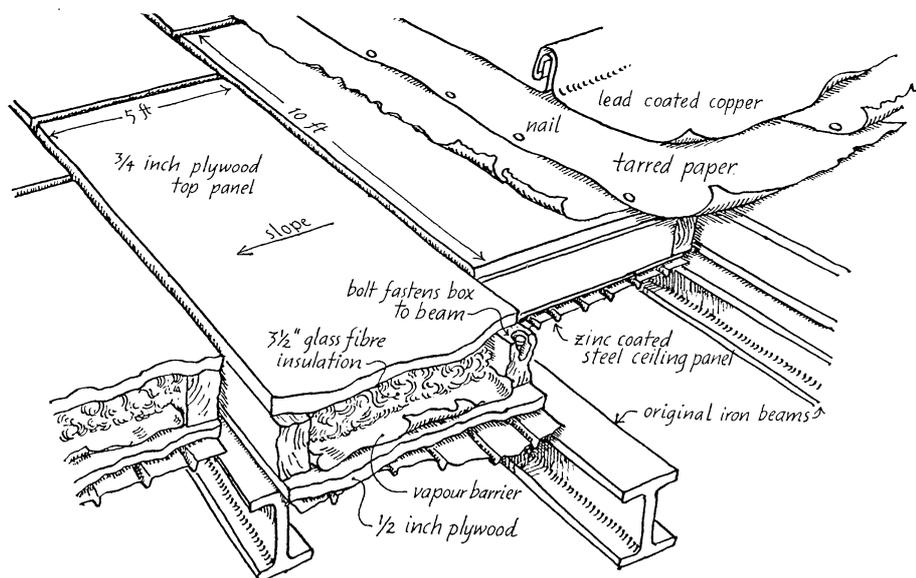
Figure 6.33 The design of the new roof of the Arts and Industries Museum

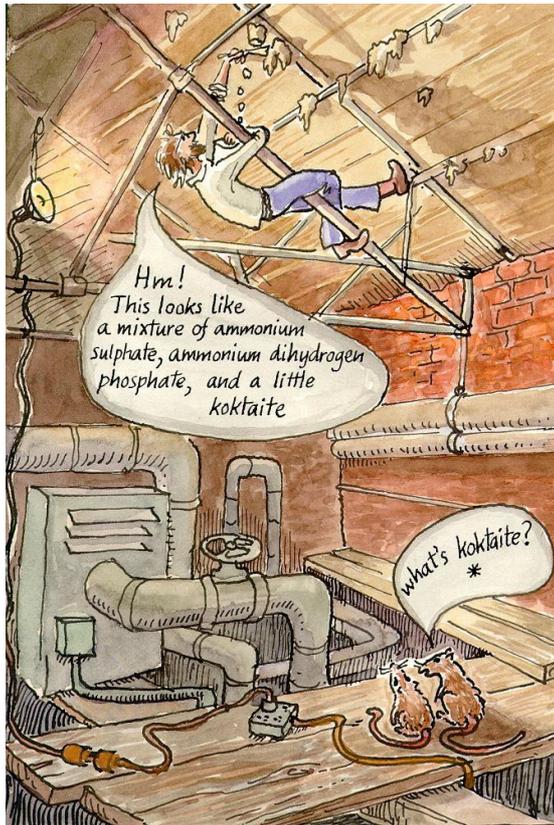
Figure 6.34 Fireproofing salts formed stalactites hanging from the ceiling panels, revealing that the water came from the roof. *Koktaite is a hydrated calcium ammonium sulphate.

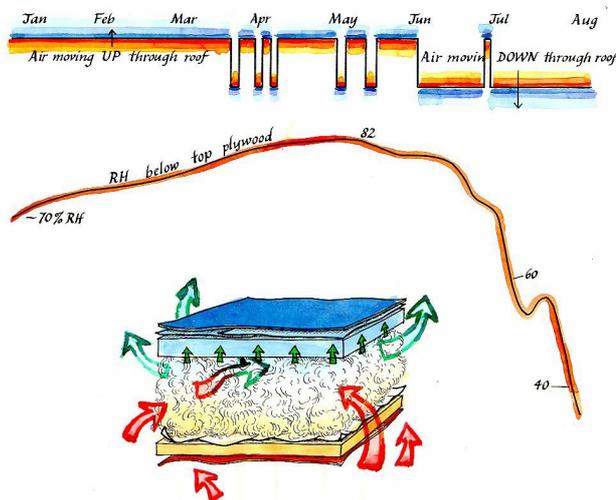
Figure 6.35 A plot of the direction of air flow through the roof is at the top. The curve below shows the steady increase of RH just below the upper plywood layer, indicating that water vapour from the humidified museum air is reaching the plywood and is being absorbed into the wood. The process is aided by the fireproofing salts that also absorb water at high RH.

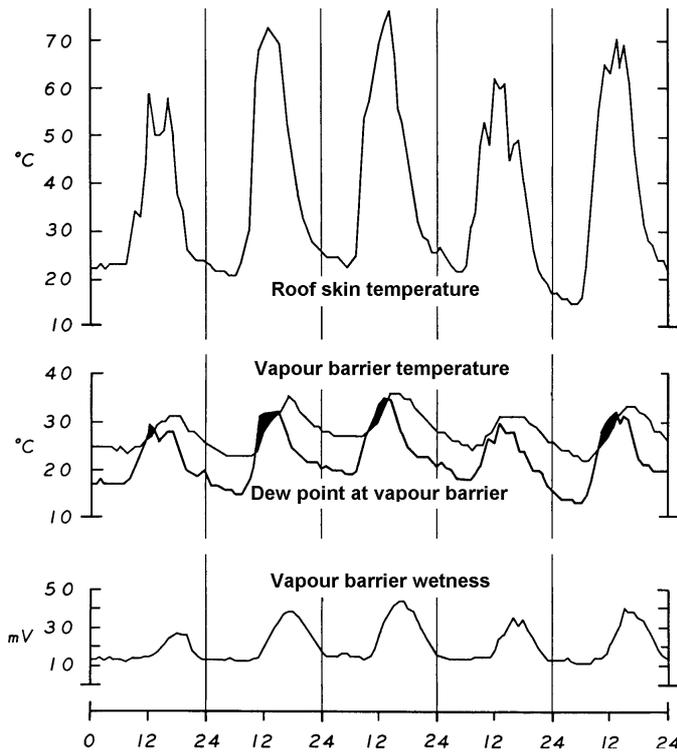
Figure 6.36 Traces over five days from several sensors mounted within the roof structure. Notice the solid black fill at times when the vapour barrier was cooler than the dew point of the air just above it. At these times water condensed on the polyester vapour barrier.

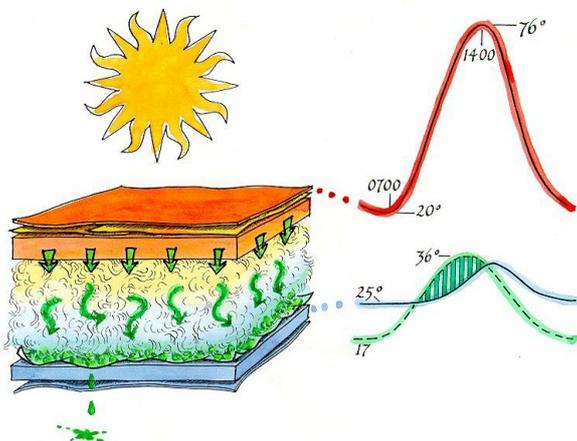
Figure 6.37 A pictorial summary of the condensation process in the roof of the Arts and Industries Museum on a sunny spring day.

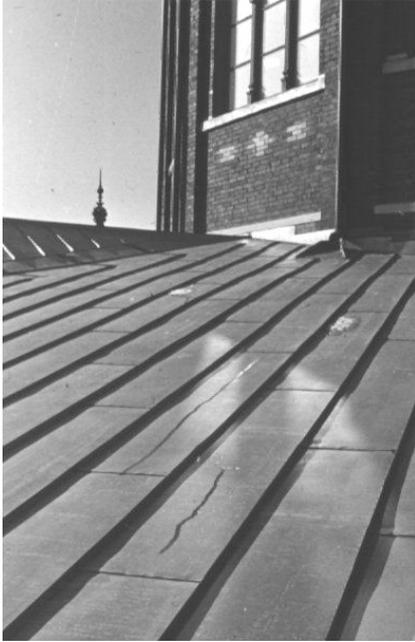
Figure 6.38. Trickles of water emerging onto the roof. The water is distilled from the underlying damp plywood and condenses in periods when the roof skin is cooler than the wood below.

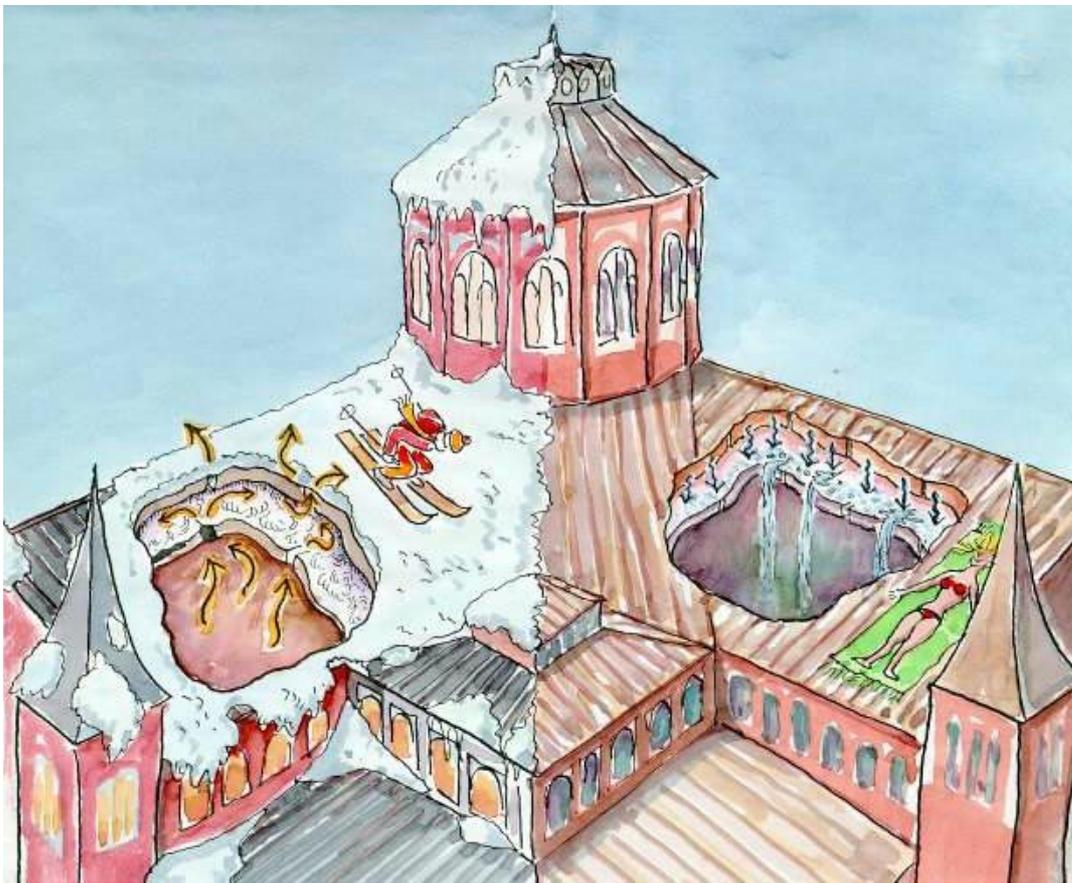
Figure 6.39 A summary of the annual cycle of water movement in the roof of the Arts and Industries Museum. In winter, on the left, warm, buoyant air forces its way up through the roof, depositing water in the cold upper plywood. In summer, on the right, the clear sunlight warms the roof. The water is released and diffuses down, helped by the downward flow of warm air into the now cooler interior. It condenses on the vapour barrier, accumulates in drops which, after a while, join together and move off down the shallow slope to the nearest crack in the ceiling. From there a shower of rain, with dissolved fireproofing salts from the wood, cascades into the exhibition hall below. The entire process is governed by the interplay of absorbent and non-absorbent materials in the complex roof structure.
